CONDITION MONITORING OF FABRIC-REINFORCED CONVEYOR BELTING USING DIGITAL X-RAY IMAGING

JH Fourie¹, MJ Alport², JF Basson², T Padayachee²

¹ Eskom Holdings (Pty) Ltd, ² Advanced Imaging Technologies (Pty) Ltd

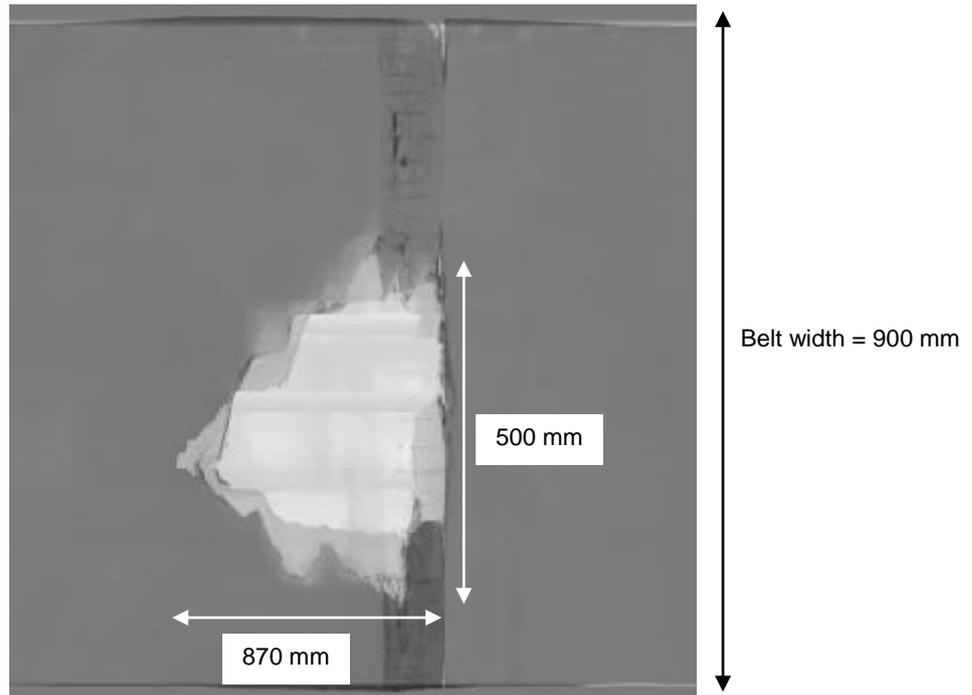
Large hole

Figure 5: X-ray images of various damages found during the test surveys.

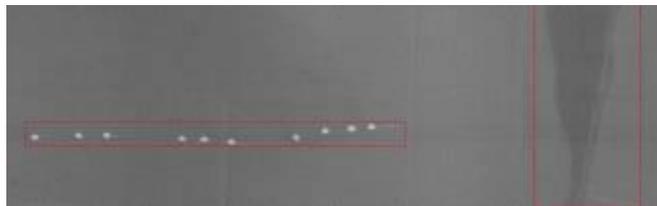
Small holes

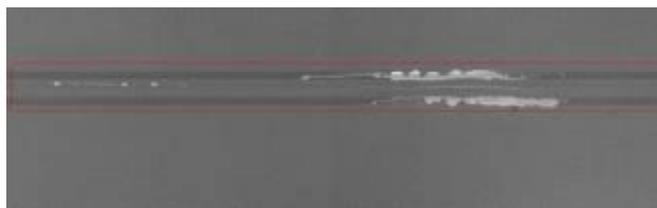
Folds in the rubber

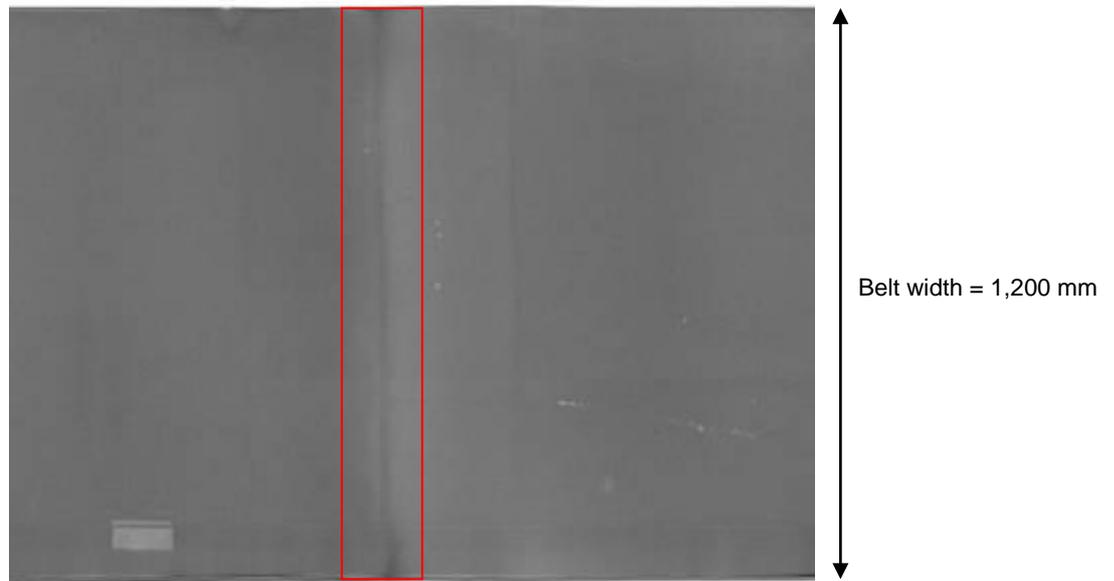
Figure 6: (a) An X-ray image of a press mark, that is imprinted during the belt manufacturing process, contained within the red rectangle. (b) Positions are shown of the press marks and splices for the entire length of belt using a damage detection algorithm. The press marks are indicated by the periodic short peaks, and the two splices of the belt by the tall peaks. The press marks occur every 9 metres.
