# **TECHNICAL EVALUATION OF THE MAJUBA POWER STATION 10 000 TONNE COAL SILO 20 FAILURE MECHANISMS/FACTORS**

A.P.Wiid and B.Marrai

Eskom

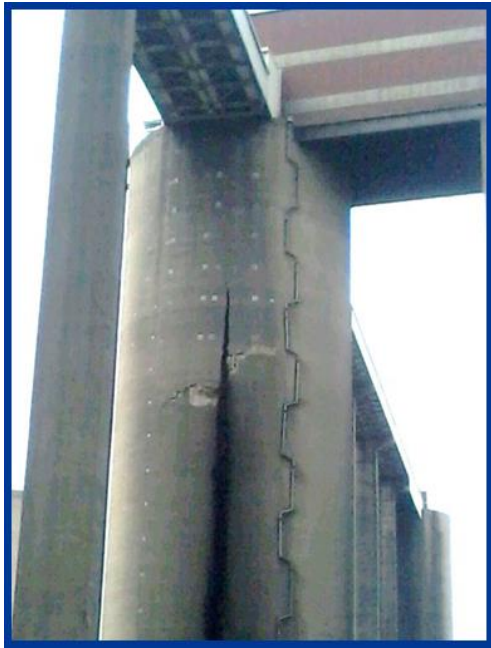
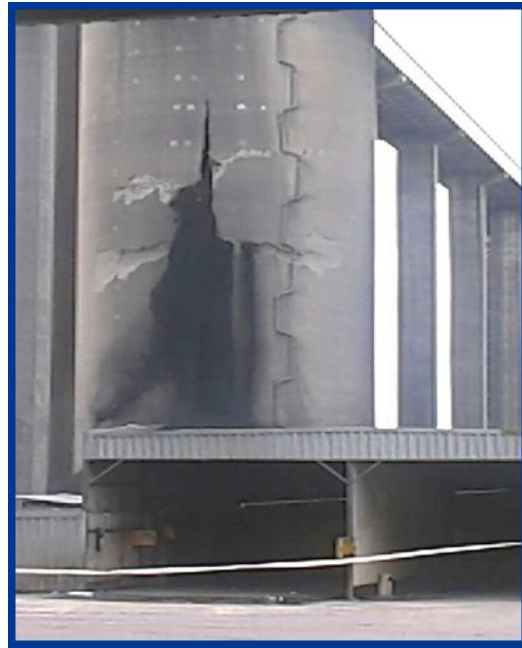
On the 1<sup>st</sup> November 2014, a vertical fracture developed on the south eastern face of silo 20, approximately two metres above the intersection of the internal hopper and the vertical wall. The vertical crack in the silo wall extended upward for approximately 10 m in height. This vertical fracture was followed by two horizontal fractures which then resulted in the sudden collapse of the cylinder section.

Figure 2. The vertical crack in the silo with coal running from the crack, followed by the horizontal cracks.

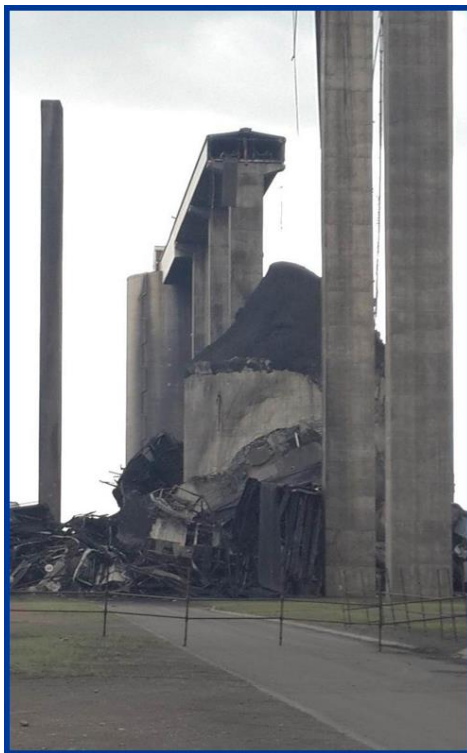
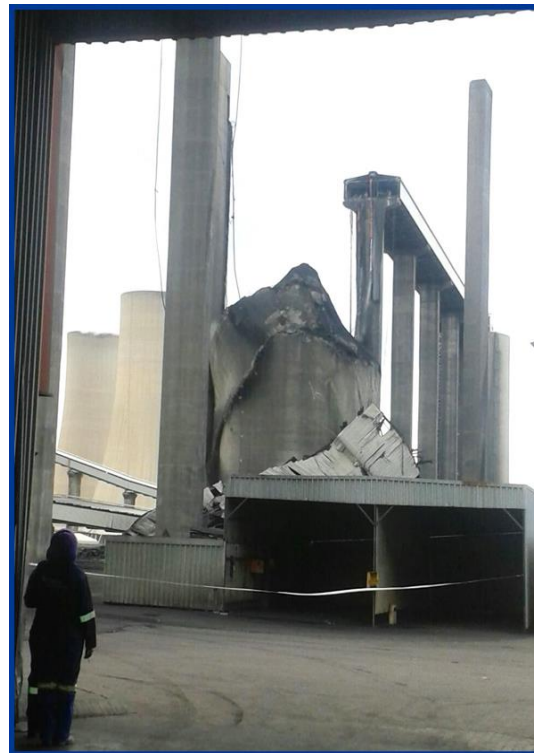
Figure 3. The collapsed silo with the bottom part below the 28 m level remaining in situ.

The collapse of silo 20 resulted in the collapse of other structures that were connected to it, including portions of the overland conveyor and over-silo link conveyor gantries.

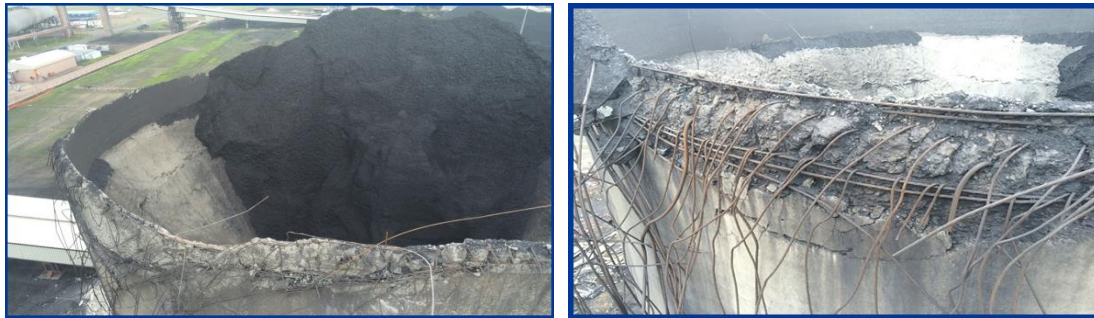
The section of silo that failed is the section above the 25.5 m level. This is approximately 1.5 m above the intersection between the internal mass concrete hopper and the cylindrical wall section. The bottom part of the silo below the 25.5 m level remains in situ.

Figure 4. The part of the silo below the 25.5 m level remained in situ.

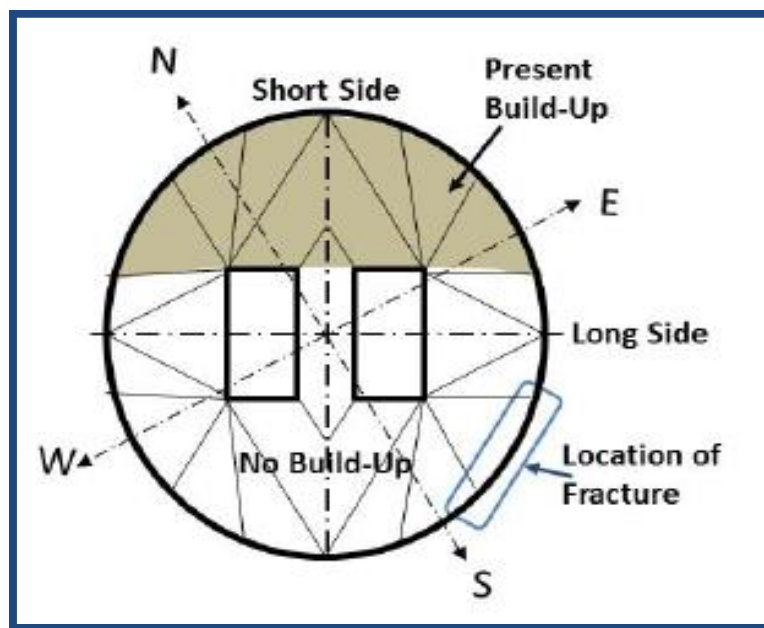
A large coal build-up, solid as rock, was present inside the standing section of the hopper. The build-up was on the short end of the silo hopper opening which has the shallow hopper angle.

Figure 5. Plan view on silo 20 indicating the location of the coal build-up as well as the location of the origin of the fracture that resulted in the failure of the silo.

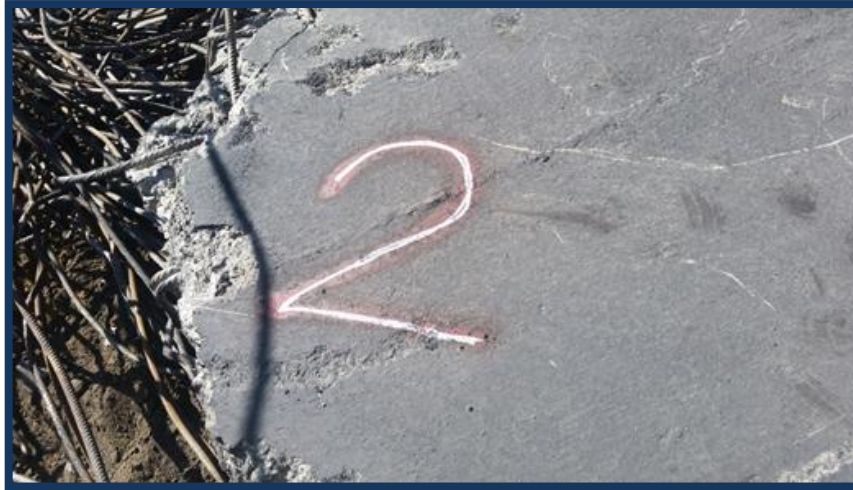
The inspected sections of the collapsed cylinder wall lying on the ground showed smooth concrete without any sign of corrosion or erosion. The reinforcement inspected on site was not corroded, eroded or rusted.

Figure 6. Part of the cylinder wall.

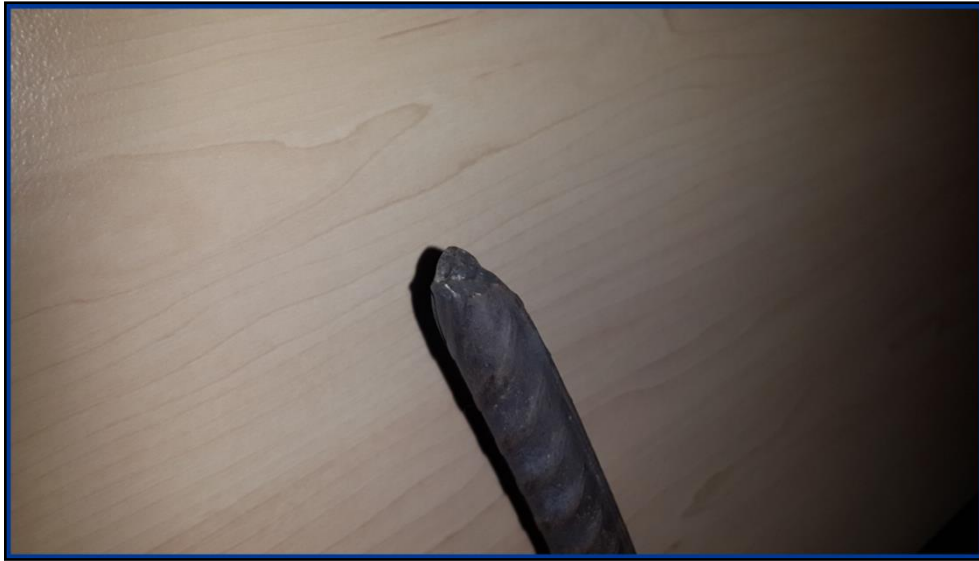
The test performed confirmed that the steel reinforcement was indeed 450 MPa high tensile steel and the concrete strength exceeded 30 MPa. By inspecting the reinforcement closely, it showed the classical neck fracture typical of a tensile failure.

Figure 8. Typical tensile failure of rebar.

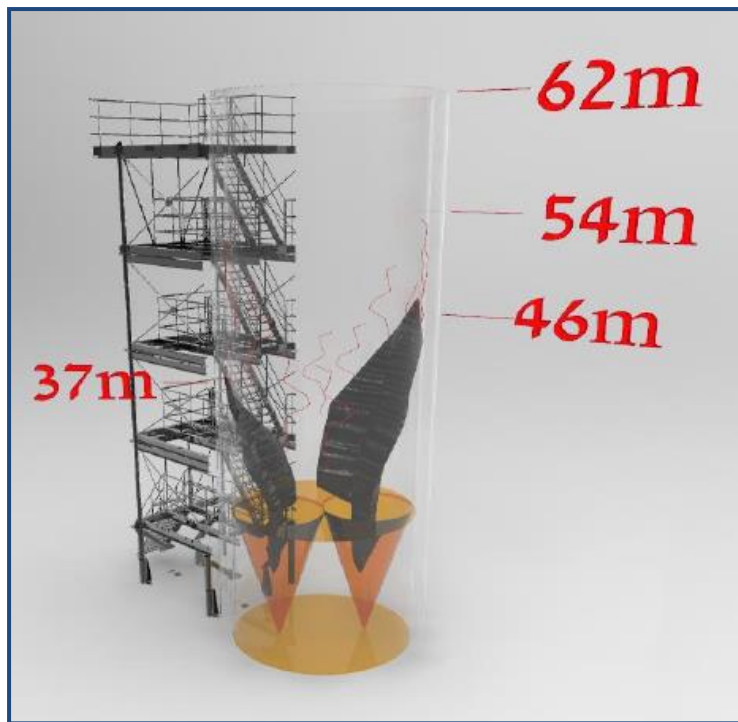
| SILO No. | SURFACE | BY MEANS | RESULTS |
|---|---|---|---|
| 30 | Internal | Skyriders – abseiling from roof slab. | Extensive cracks visible, large and small, and coal build-up present. |

Figure 9. Coal build-up inside silo 30.

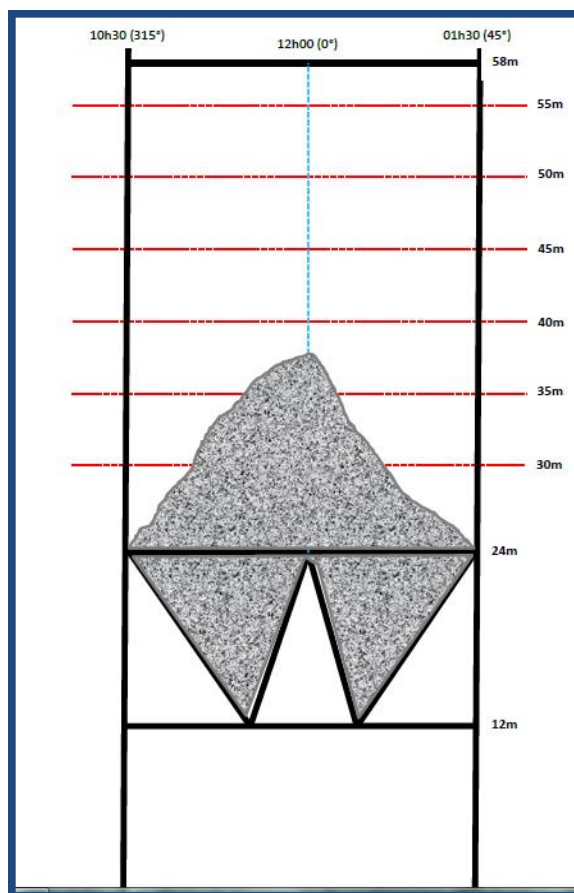
| SILO No. | SURFACE | BY MEANS | RESULTS |
|---|---|---|---|
| 10 | Internal | By naked-eye from the silo roof with flood lights. | Some larger cracks visible; smaller ones not visible due to poor visibility. Coal build-up present and visible. |

Figure 10. Coal build-up on silo 10.

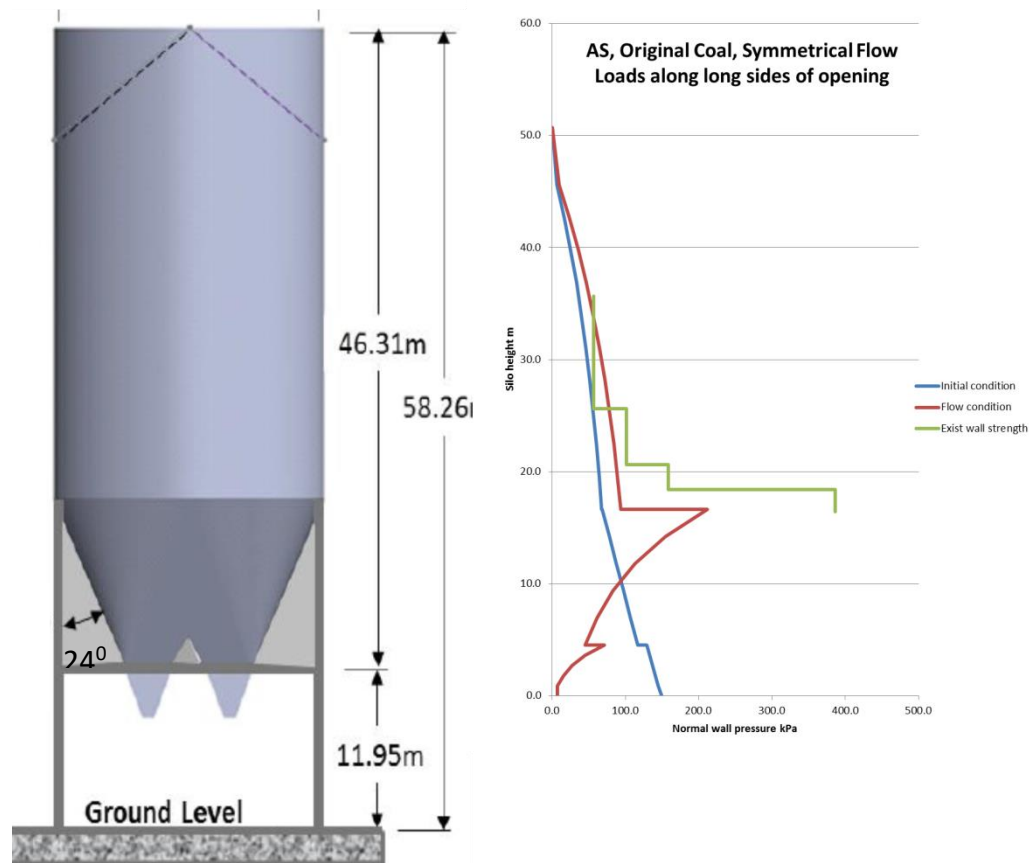
Figure 21. Wall load for the original coal based on AS 3774-1996.

Figure 21 shows that the amount of reinforcement between elevation 25 m and 35 m is not sufficient when checked with original coal and the AS 3774-1996. The wall strength at the 25 m level is in the order of 57 kPa compared with the calculated applied wall loads in the order of 60 kPa and 84 kPa for the initial and flow condition respectively.

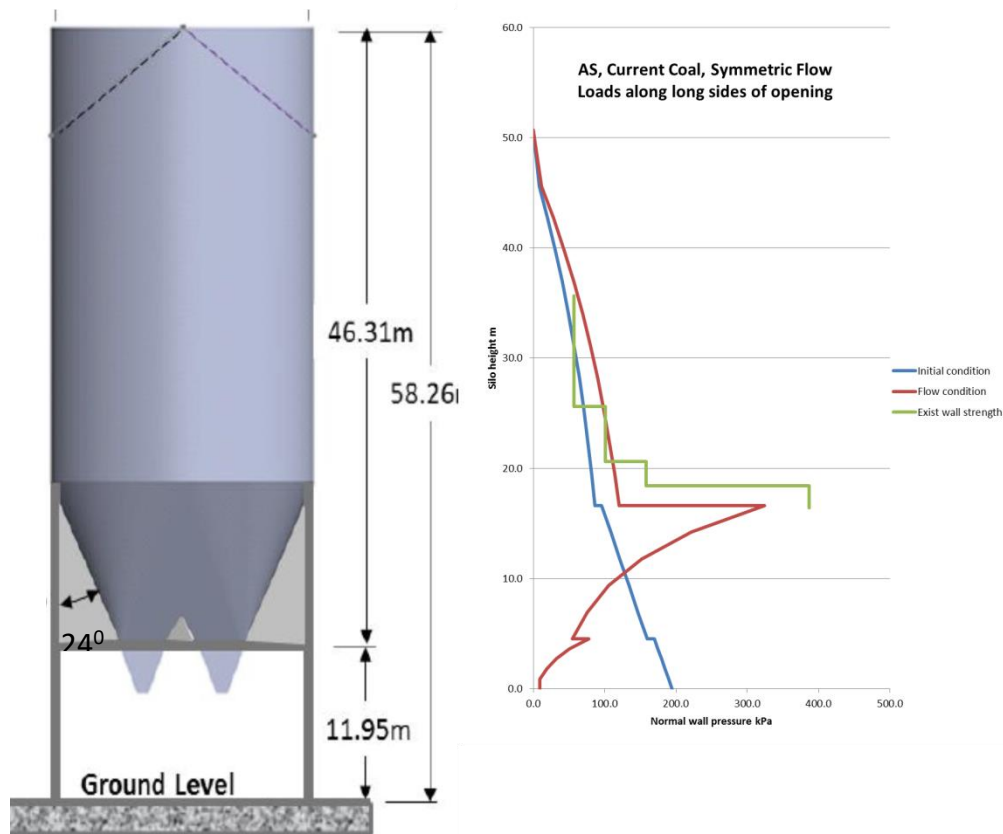
Figure 22. Wall load for the current coal based on the AS3774-1996 – excluding eccentricity.

Figure 22 shows that the amount of reinforcement between elevation 21 m and 35 m is not sufficient when checked with current coal and the AS 3774-1996. The wall strength at the 25 m level is in the order of 101 kPa compared with the calculated applied initial wall loads in the order of 107 kPa.

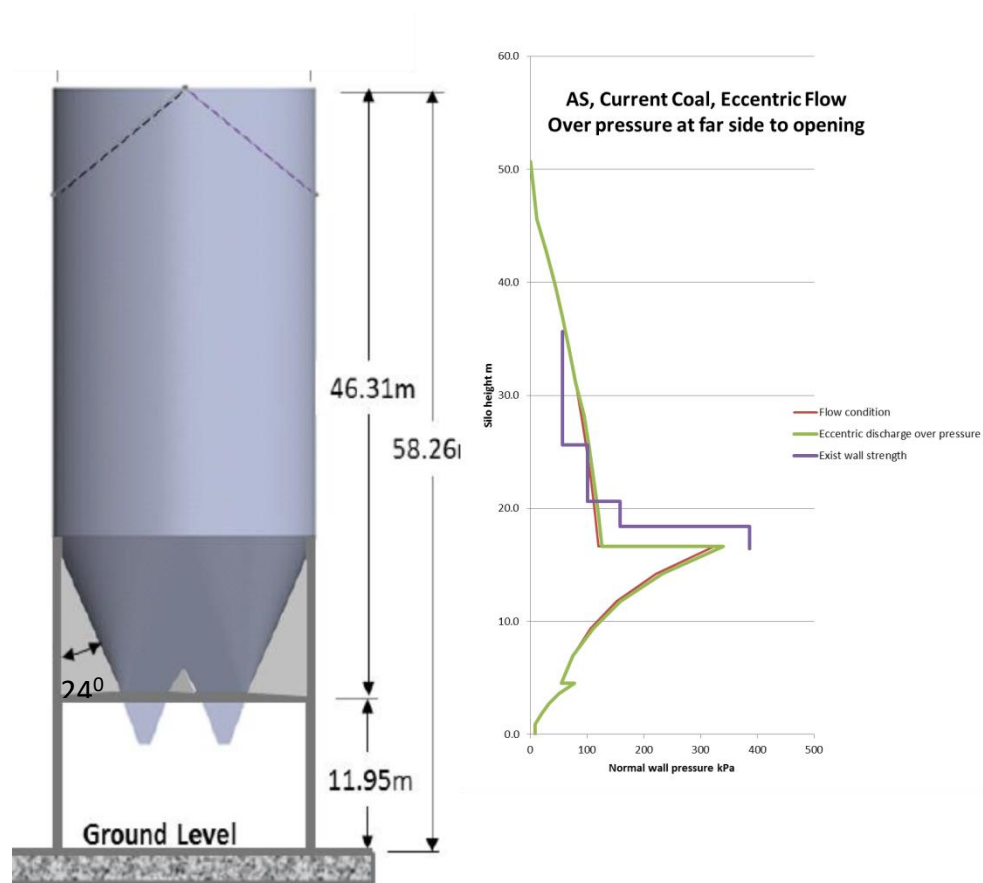
Figure 23. Wall load for the current coal based on the AS 3774-1996 – eccentricity included.

Figure 23 shows that the amount of reinforcement between elevation 21 m and 35 m is not sufficient when checked with current coal and the AS 3774-1996 including the eccentricity. The wall strength at the 25 m level is in the order of 101 kPa compared with the calculated applied wall overpressure load in the order of 120 kPa.

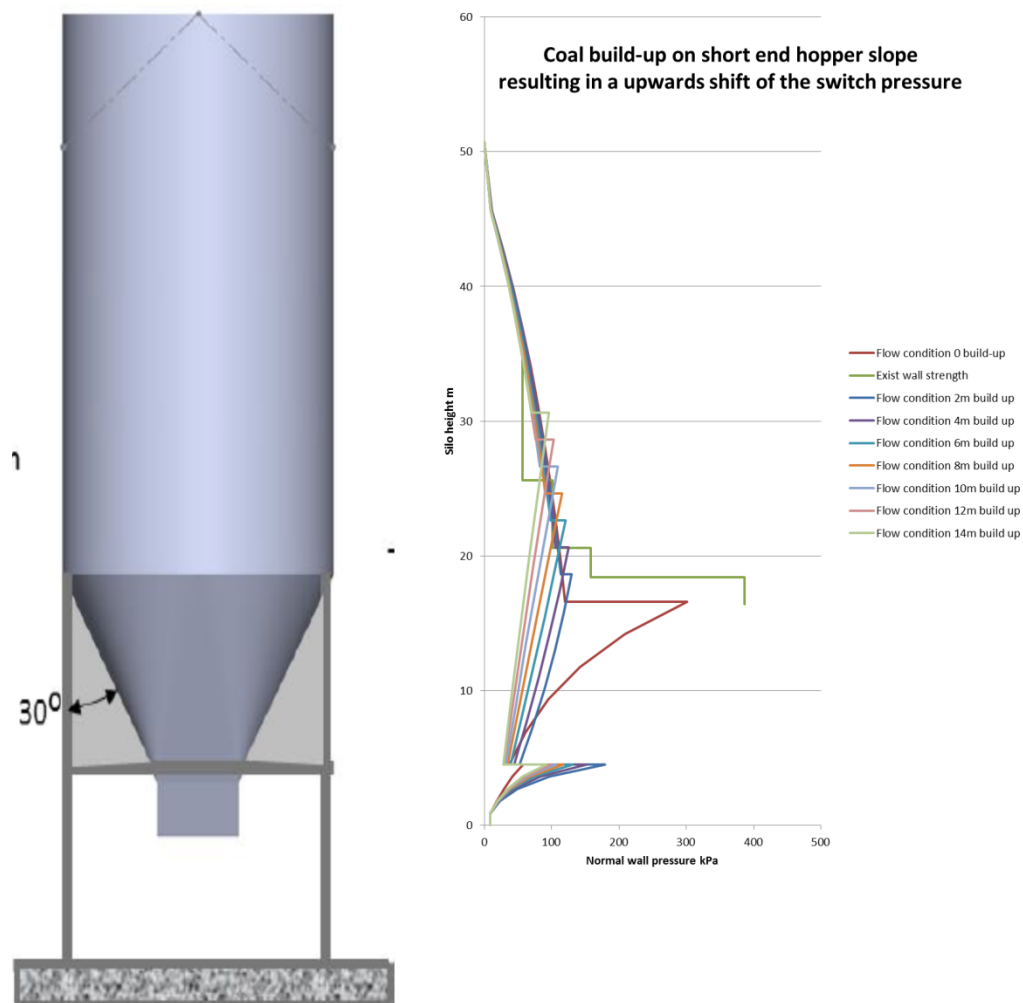
Figure 24. Switch pressure along build-up development based on the AS 3774-1996.

Figure 24 shows the development of the build-up together with the shift of the switch pressure checked with current coal and the AS 3774-1996 including the eccentricity. In this case the calculated applied wall pressure exceeds the wall strength ability for the silo vertical wall for the height range between approximately 2 m and 12 m above the hopper to vertical wall intersection.

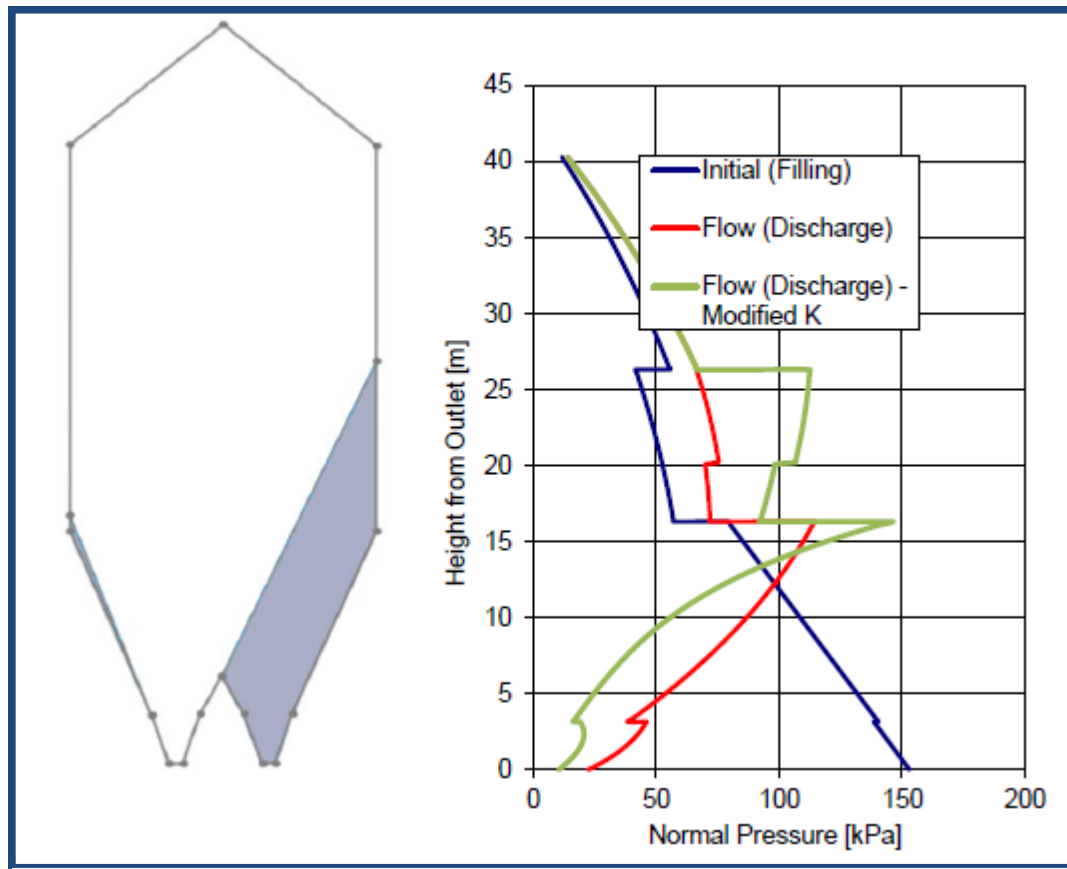
Figure 28. As a result of the stagnant coal in the silo, a switch pressure develops at the convergence point of the flow channel to the vertical wall.

Professor Roberts concluded that the silo experienced a very high eccentric pressure load caused by the presence of the build-up and the modus operandi of the silo. These high eccentric pressure loads contributed to the failure of the silo.

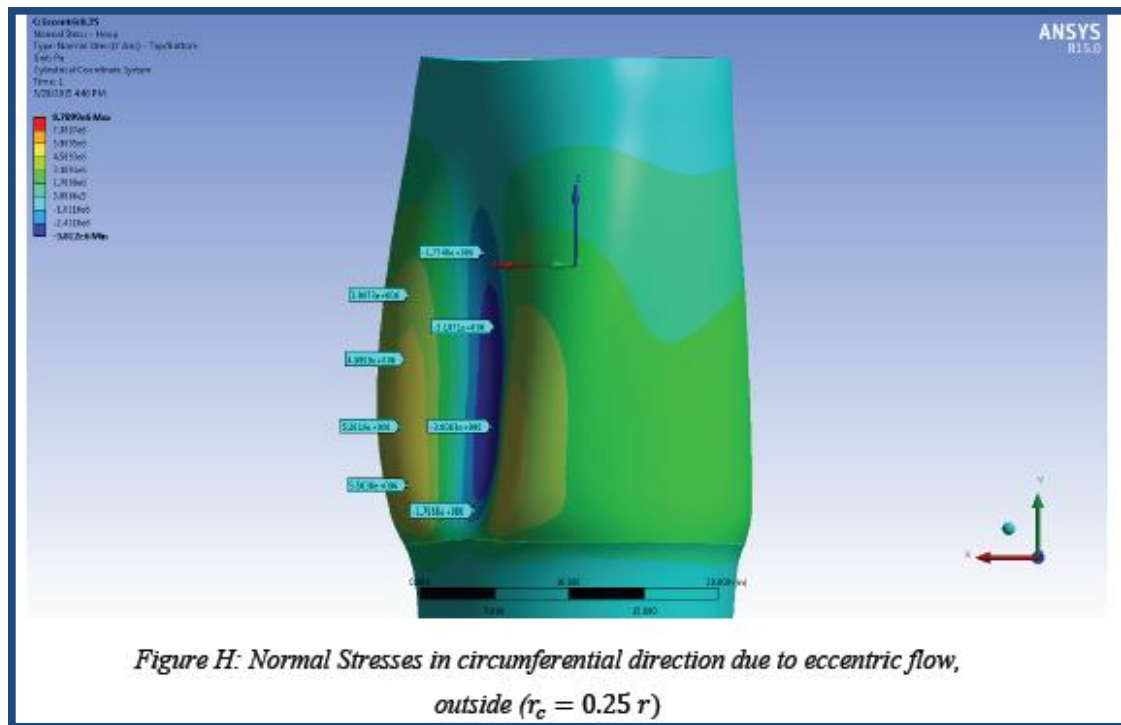
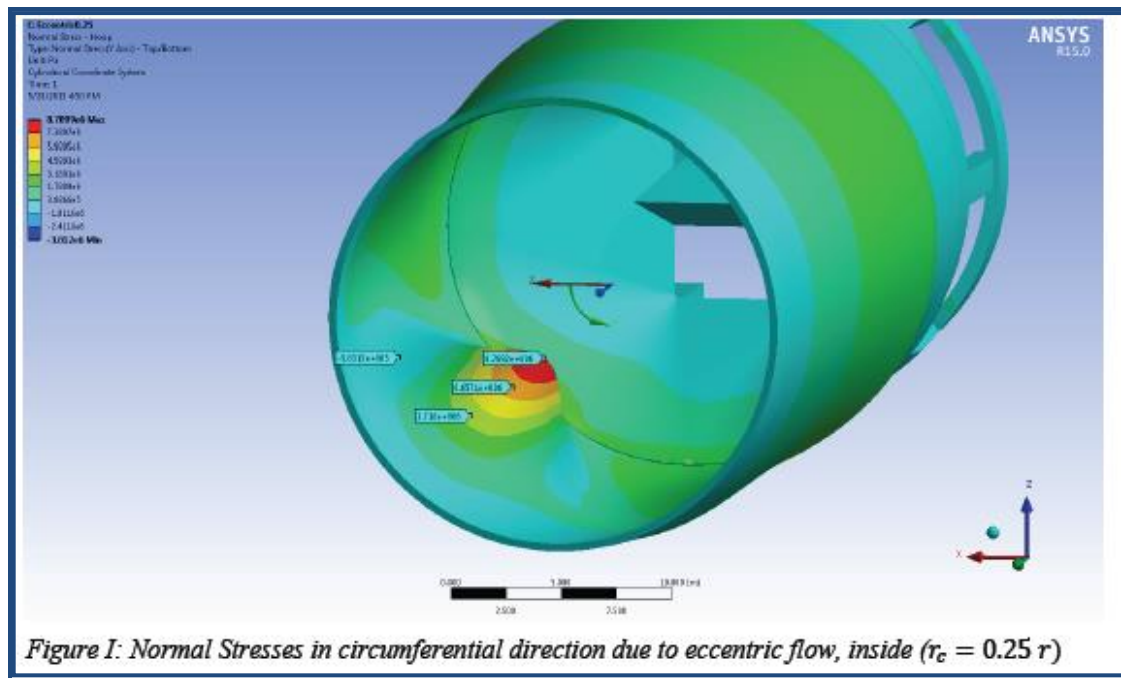
Based on analyses, it is concluded that the cylinder wall of silo 20 was in a compromised condition to carry the combined solids-induced loads per BS EN 1991-4:2006 and roof loads.

Figures 29 and 30 show the normal stress distribution in the circumferential direction (hoop stress) for eccentric load Case 1 for a flow channel radius  $r_c = 0.25 r$ . Stress values are shown along the height of the cylinder in the flow channel (blue colour region along the height) and at the edges of flow channel (yellow colour region along the height). For example, in the flow channel (circumference width about 3.5 m) at approximately 8 m from the bottom of the cylinder, the circumferential stress on the outside face is -3.8083 MPa (compression), and at the same elevation the circumferential stress on the inside face is 8.7692 MPa (tension). From this the uniform tension stress due to hoop tension is  $f_t = 2.4805$  MPa and the bending stress is  $f_b = 6.2888$  MPa.
