IMPROVEMENTS IN CONVEYOR AVAILABILITY - DOUGLAS COLLIERY OVERLAND SYSTEM

**HENDRIK PIETERSE, PLANT ENGINEER,
DOUGLAS COLLIERY, VANDYKSDRIFT.**

**JIM PIERCE, VICE PRESIDENT,
BELTSCAN, INC**

**PAPER PRESENTED AT BELTCON 8
SOUTH AFRICA
OCTOBER 1995**

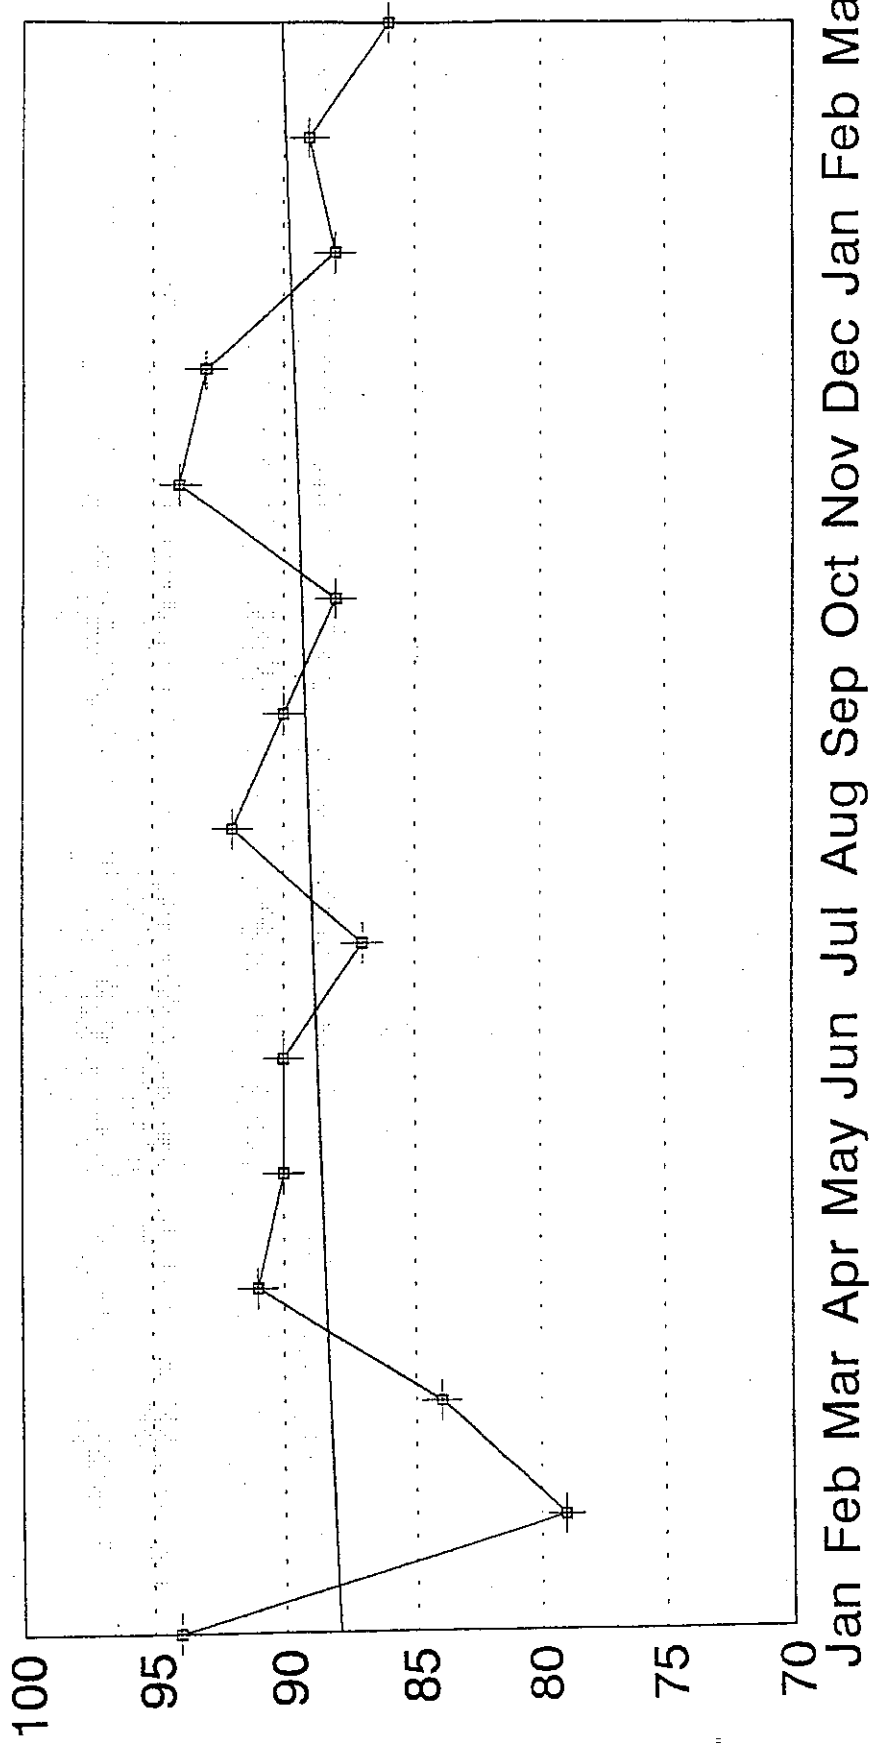
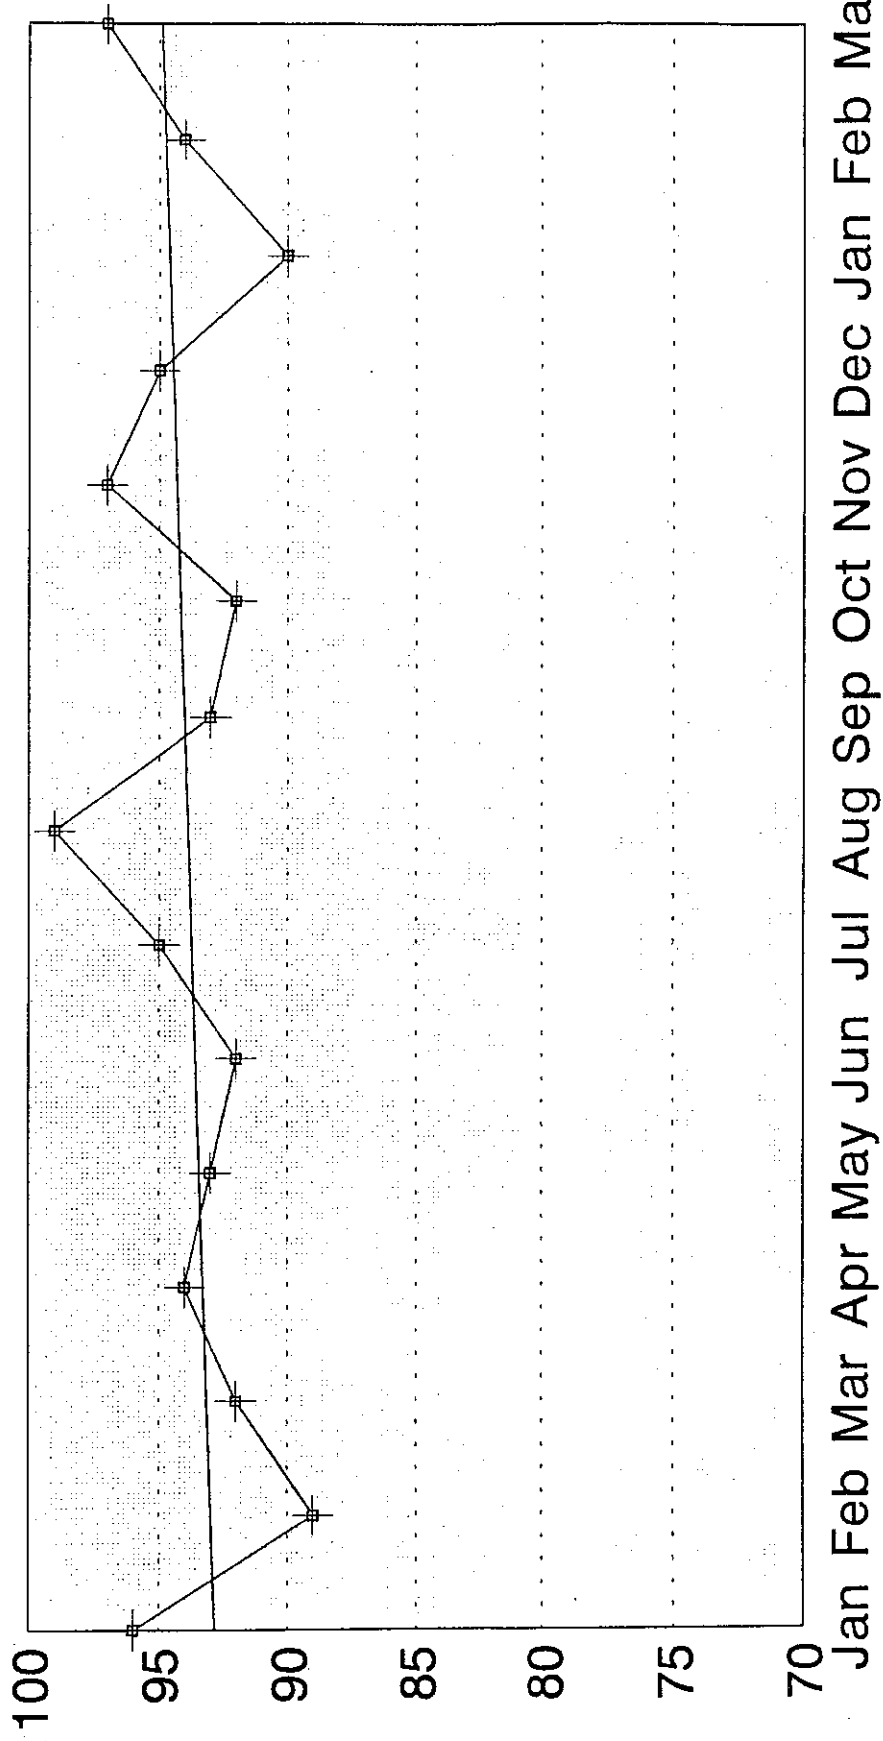
Conveyor belt availabilities as can be seen from the graphs were as low as 86%. Even if the other belts are 90% available, the overall availability is still 86%, as the conveyors are in series.

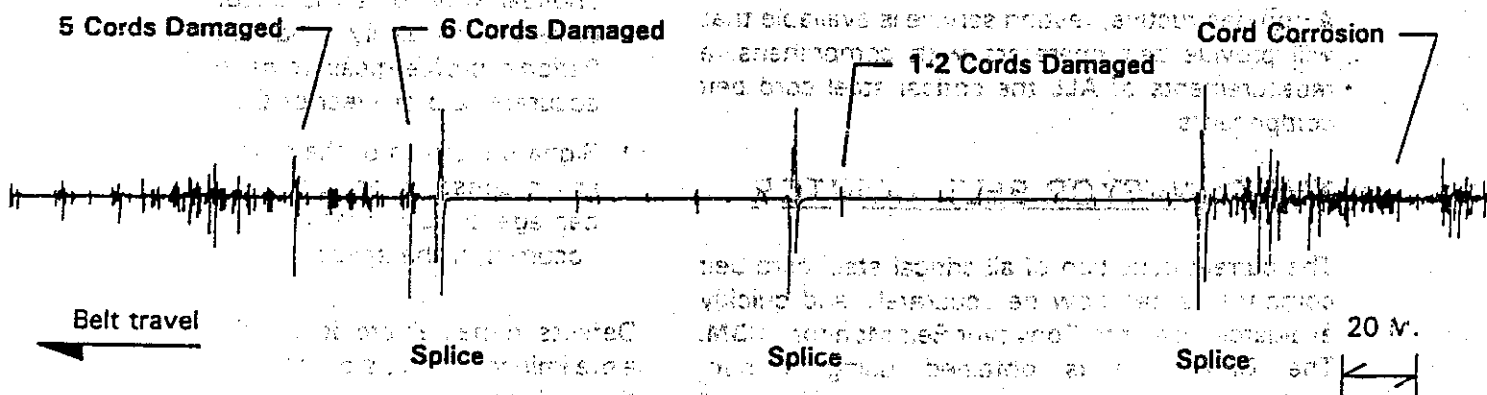
Example of CBM Data - Steel Cord Damage Trace
