BELTCON 3

Practical and Operating Aspects
of the Richards Bay Coal Terminal

R Taylor

***9, 10 & 11 September, 1985
Landdrost Hotel
Johannesburg***

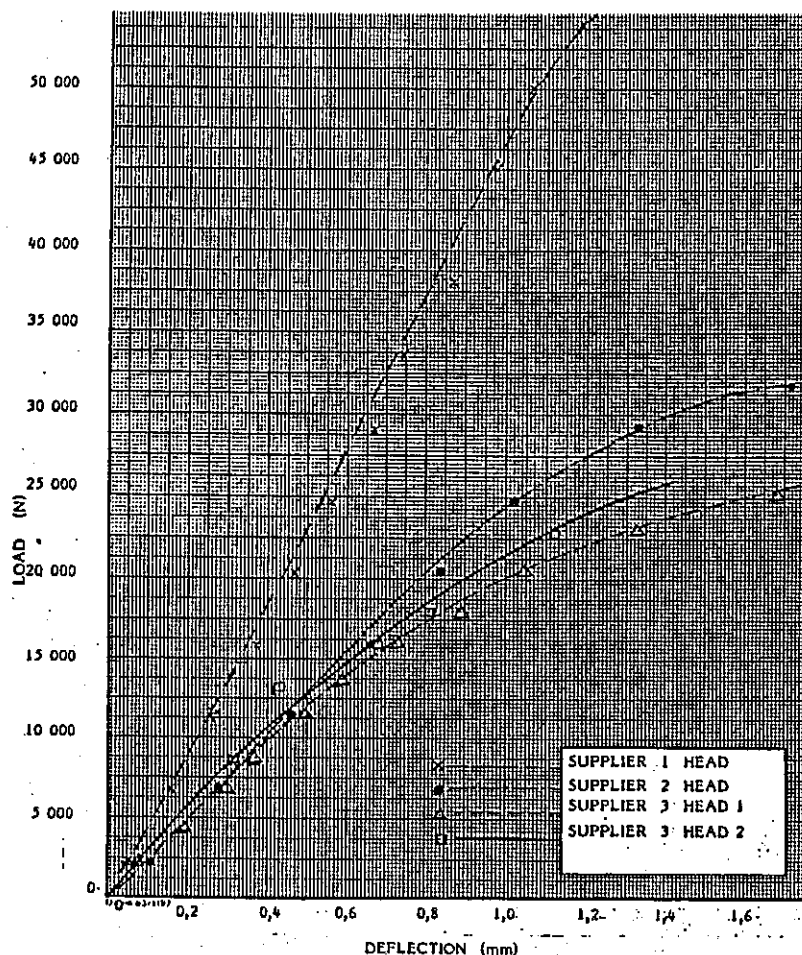
The Coal Terminal's access conditions are often such to necessitate a fair measure of rehandling and ultimate hand transportation. Unfortunately the Coal Terminal rolls are relatively heavy and awkward. These two factors tend to result in the idler rolls being dropped or receiving blows to the end cap or exposed shafting.

The following graph Figure 1 shows the rigidity of some commercially available idler roll end caps. As can be seen considerable variation in idler end cap rigidity exists between manufacturers.

FIG. 1 - Load deflection curves for idler roll end caps.

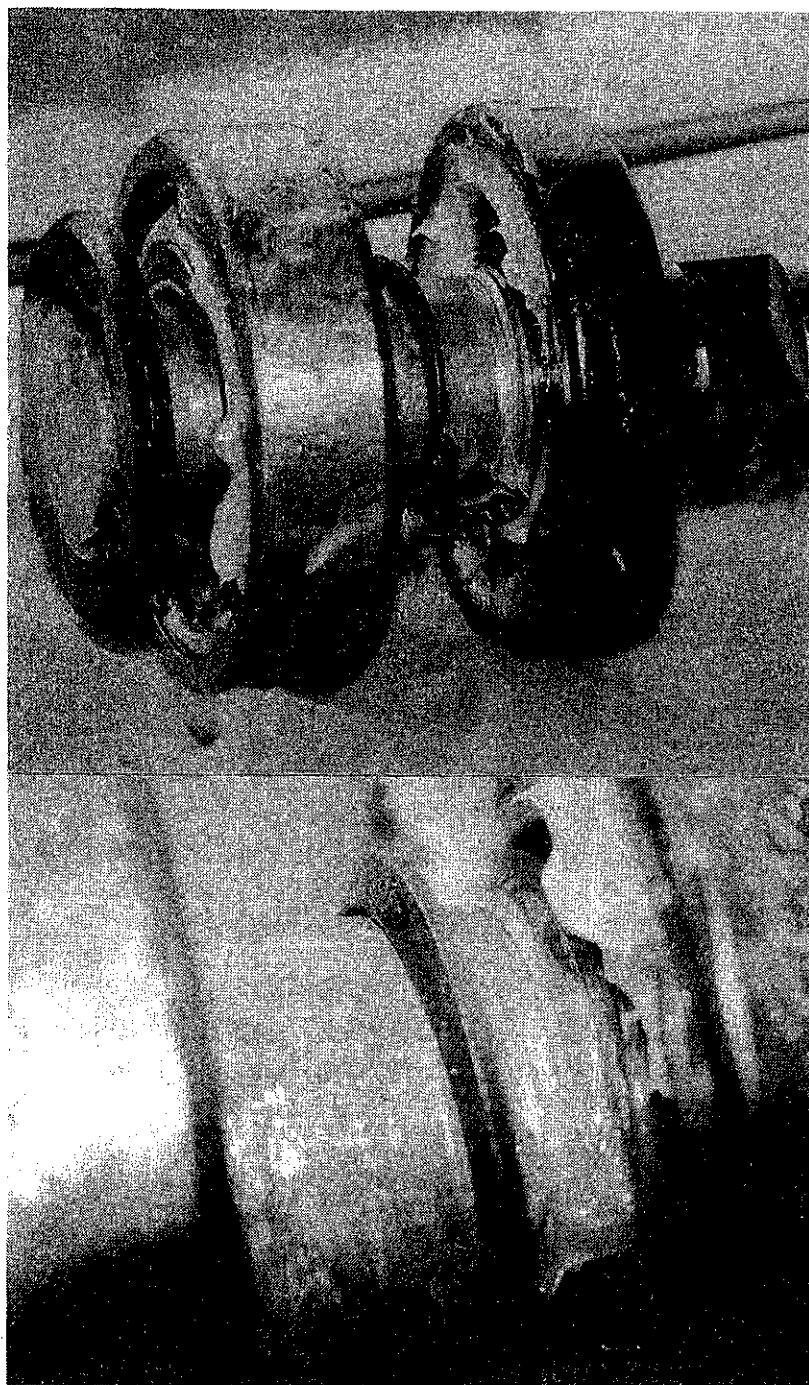
Whilst the effect of lack of rigidity may be most critical to idler rolls using taper roller bearings, where careless handling may result in loss of preload to the bearing, there is equal evidence of its significance for other 'bearinged' idler rolls. Figure Fig. 2 shows displaced retaining circlip and damaged circlip groove from an idler roll using a deep groove ball bearing.

FIG. 2 - Photograph of deep groove ball bearing idler showing displaced retaining circlip and damaged circlip groove.

- limitation of tubing to South African Bureau of Standards specification 657 for idler rolls for use under the Coal Terminal conditions. This will result in time in the Coal Terminal seeking idler rolls with:
 - very low order TIR,
 - very high order balance,
 - improved resistance to abrasion and corrosion.
- importance of idler roll end cap rigidity,
- improvements in package and transportation of idler rolls. This is likely to encompass:
 - idler roll end cap protection,
 - protection to corrosion protected surfaces.

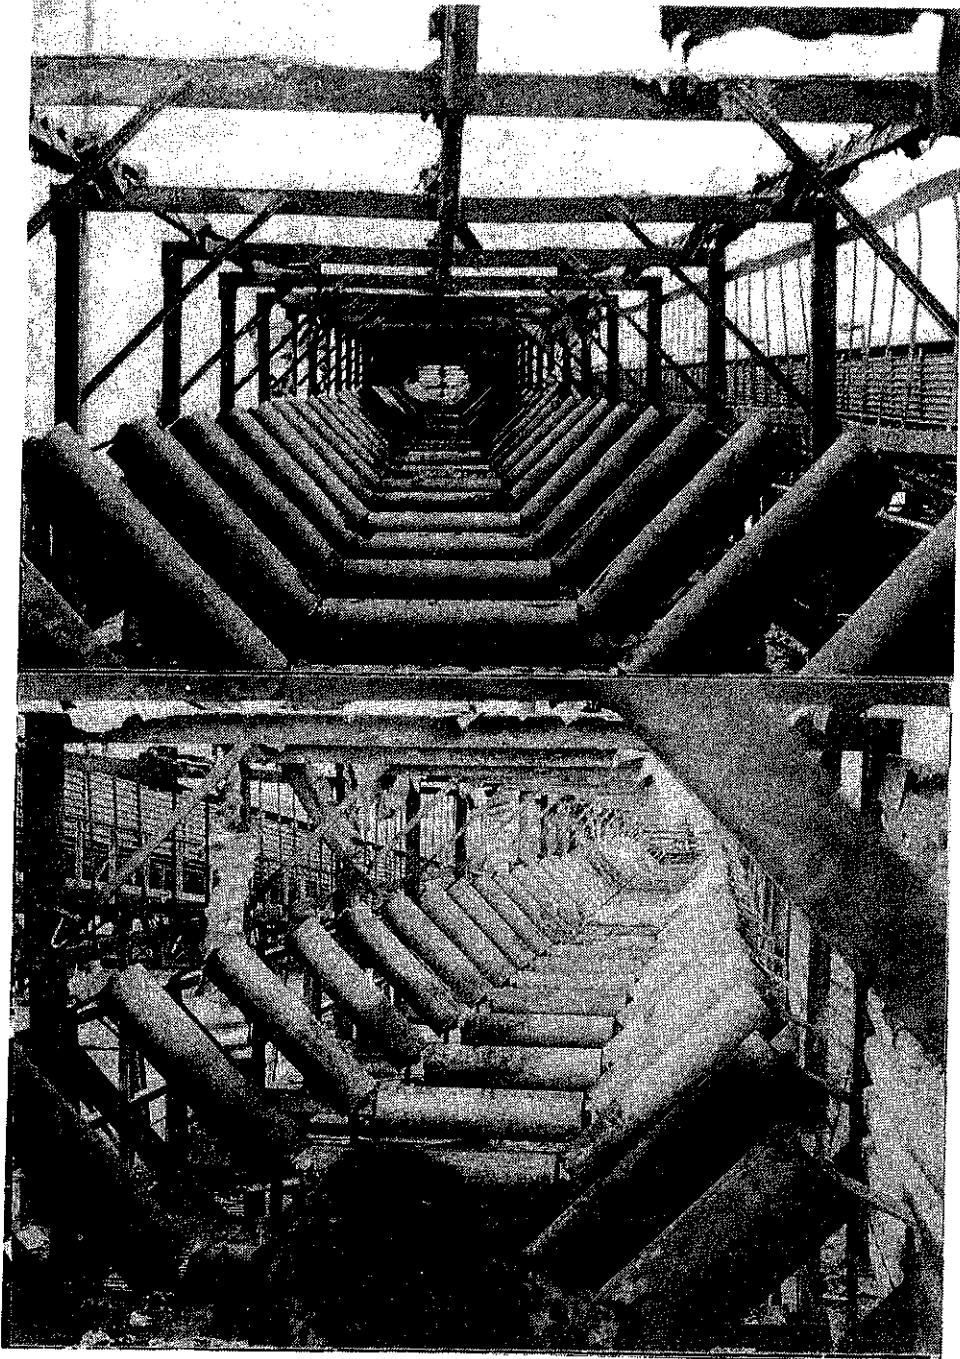
idler beds and/or fires being indiscriminately distributed between types. The typical scenario for a belt fire is that fire has occurred shortly after a running belt conveyor has been stopped : the fire is associated with a siezed impact idler with/or without the association of spillage existing in the vicinity, normally present on deck or spill plates.

FIG. 3 - Aftermath of fire on gantry section conveyor.

It is obviously difficult to undertake definitive investigations into idler rolls which have been subject to fire and in general no clear cut mode of failure could be defined. From the investigation it did appear that from a practical view point physical replacement of idler rolls was a major difficulty due to the physical configuration of the loading area, idler spacing, loading skirts, spill boards etc. It would seem reasonable that if items are difficult to replace, replacement may be tardy or neglected.

- use of heavier duty bearing, probably spherical roller type of generous proportions,
- use of readily demountable or 'collapsible' impact idlers and this may encompass
 - garland type impact idlers,
 - 'collapsible' fixed impact idlers ; in this case however, special care will be required to be exercised in design and material construction due to the Coal Terminal's difficult corrosive environment.

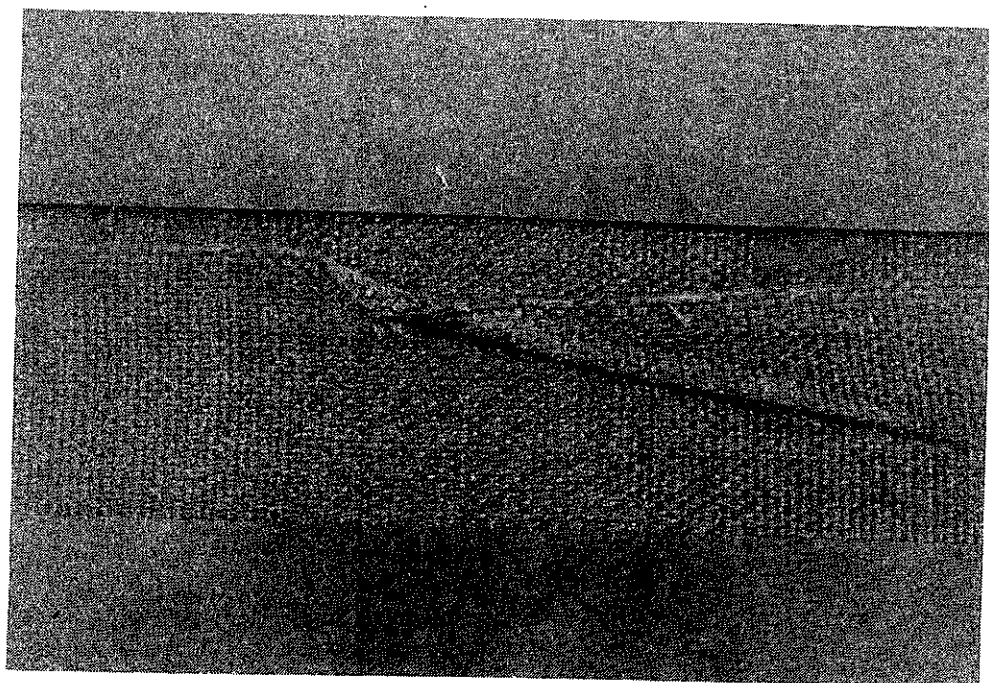
- fabric folds in warp direction,
- folds in fabric associated with one or more plies at varying angle to warp direction,
- faulty longitudinal joints where fabric ran apart, in places up to 25mm and others where there was overlap to the same extent,

Fig. 5 shows an example of a typical fault uncovered.

FIG.5 - Cover stripped to show a fold and overlap in carcass.

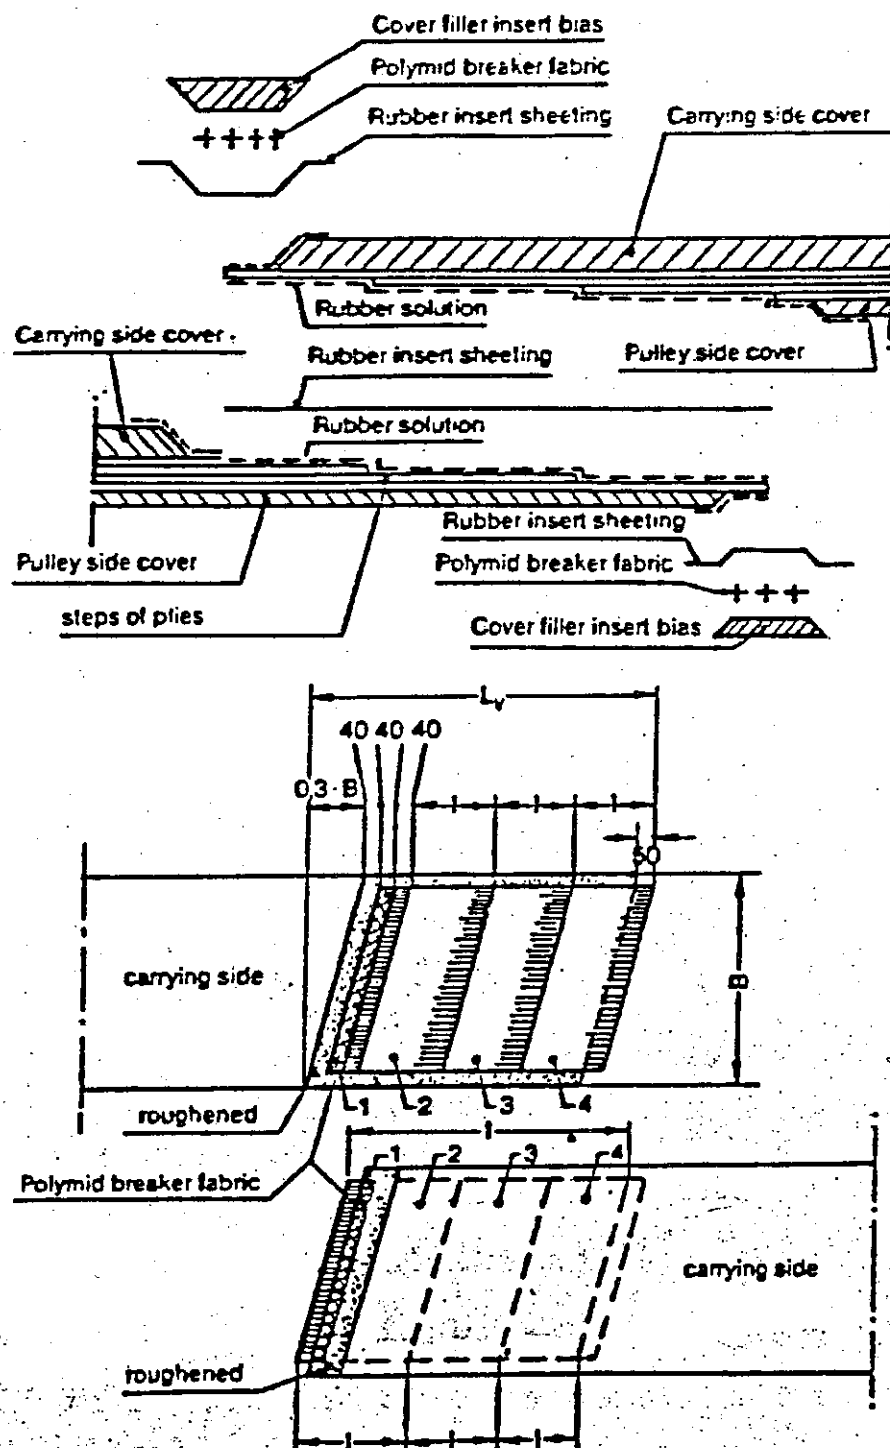
All of the Coal Terminal's splices however performed, are of the butt type. A typical poly-ply belt splice is shown following in Fig.6

FIG. 6.- Typical splice of a poly-ply belt.
