# **EXPECT THE UNEXPECTED**

## **CASE STUDY: HIGH POTENTIAL CONVEYOR INCIDENT**

S R Marais

Exxaro

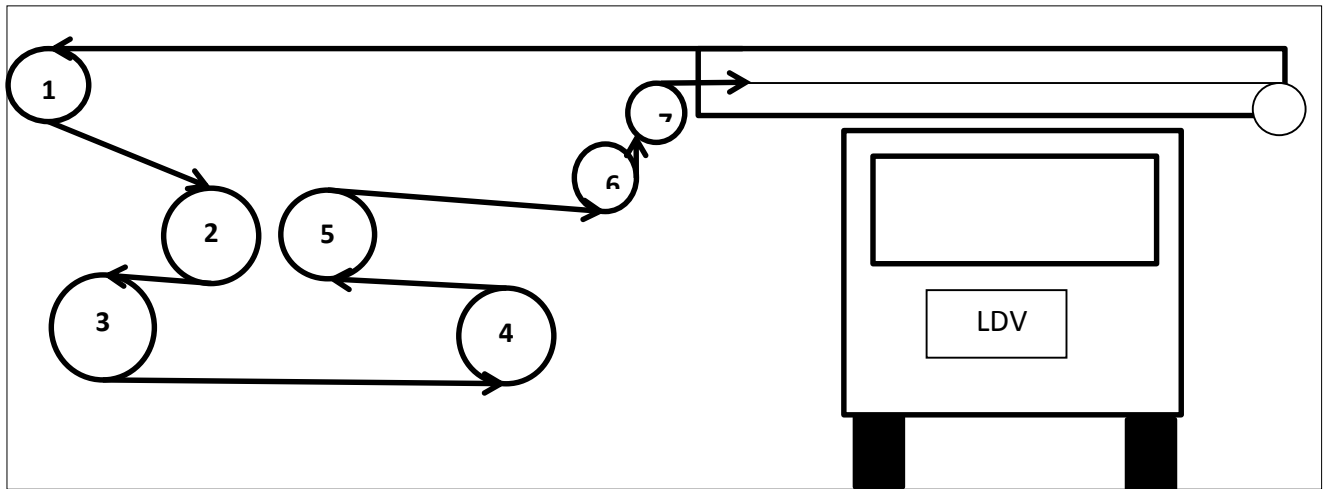
Figure 2. Schematic for the pulley configuration on conveyor L403 Drive with LDV crossing underneath the conveyor

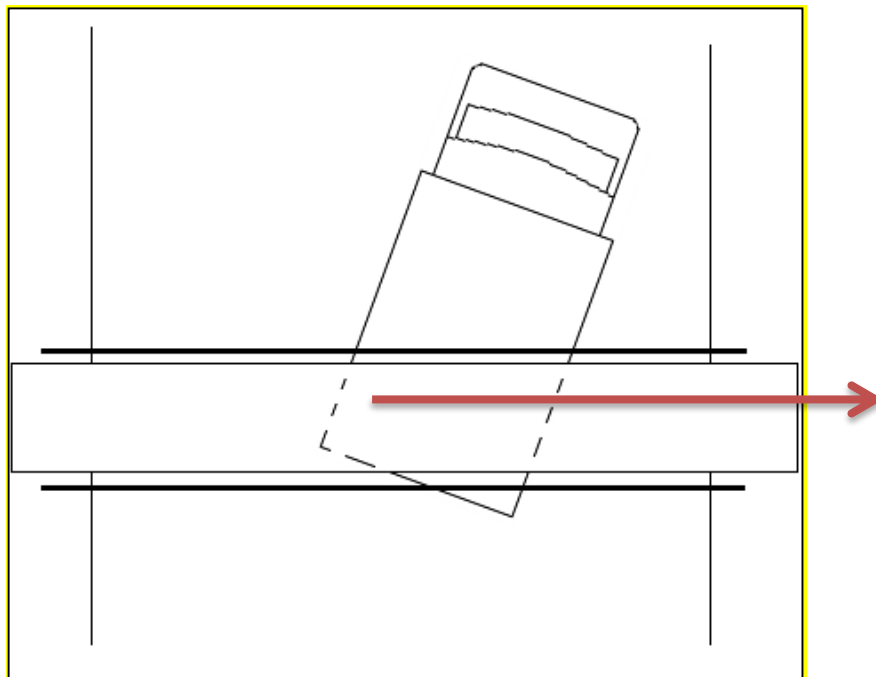
On 29 August 2013, an unfortunate incident occurred. Whilst the LDV was driving under the L403 Bridge above which the conveyor passes over the road, the conveyor belt started up. With the starting of the conveyor, the belt sagged to the extent that it was able to touch the top and side of the LDV canopy. The rubber covered conveyor belt coming into contact with the corner of the canopy enabled the conveyor to grip the LDV and consequently flip the LDV onto its side. Fortunately none of the three occupants inside the LDV were injured. However the incident is classified as an HPI as there was a high possibility that one of the occupants of the vehicle could have been seriously injured or even worse.

Figure 3. Sketch illustrating the vehicle going under the L403 Bridge

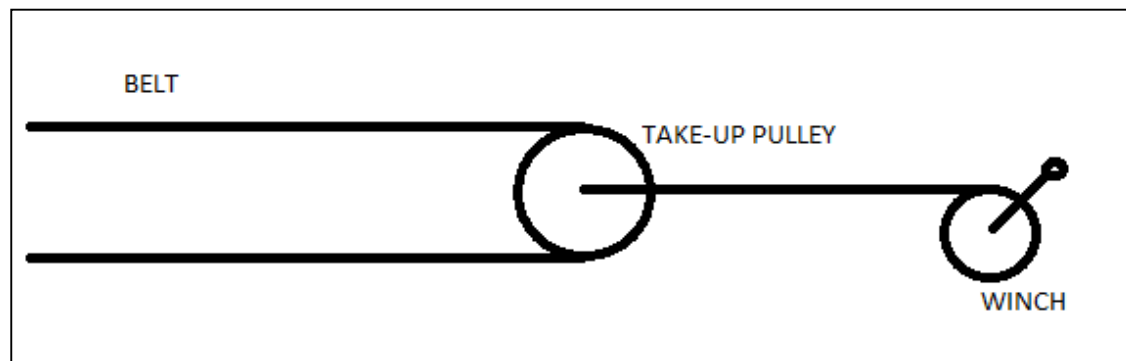
In the case of the L403 belt, the electric winch had not yet been installed. This resulted in the belt starting up without the correct tension and subsequently causing belt slack at the bridge resulting in the HPI.

Figure 4. Typical set up of a winch style take-up

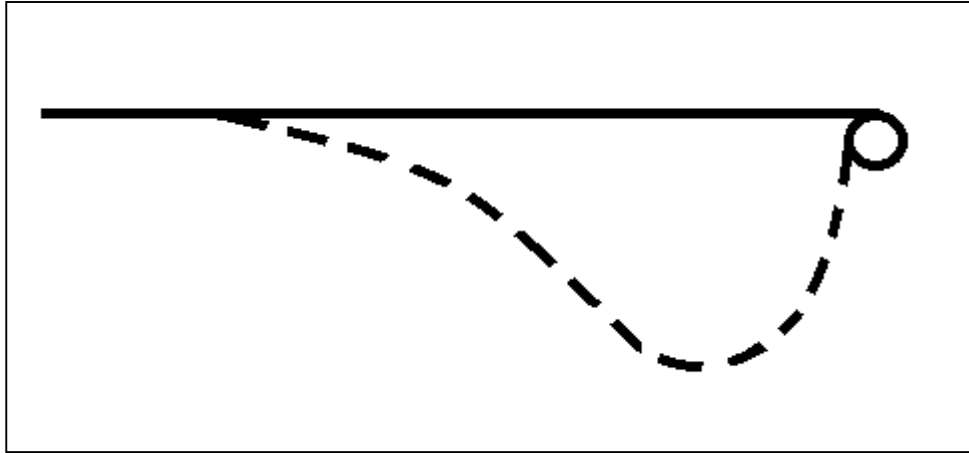
After the inspection of the bridge where the HPI took place, it was noted that the return idler was not running perpendicular to the belt but was slightly skewed. This resulted in an increase in the frictional forces that were imparted to the belt and the belt could not run over the idler with as little effort as it should have, thus forcing the belt to sag at the bridge area.

Figure 5. Schematic illustration of how the return belt sagged as it rolled over the skewed idler causing contact with the LDV

This sag or slack in the belt was sufficient to enable contact with the canopy of the LDV, consequently turning the LDV on its side.

| <b>Skewed Idler</b> | Idler was not installed correctly. | Because the idler was installed incorrectly, this imparted too much friction into the system. Therefore when slack was created behind the drive, the first place where the conveyor was able to throw this slack was at the first 'high friction' point, in this case the idler. Hence the reason why the dip occurred at the bridge. |

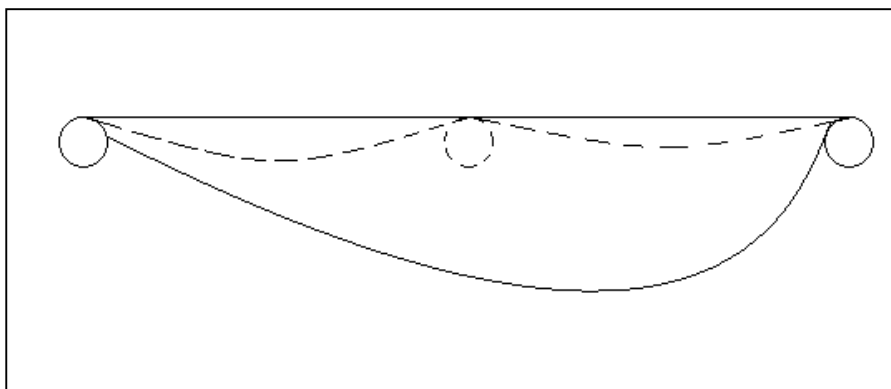
After the inspection on the structure was completed, it was noticed that an idler was missing in the middle of the bridge. This idler had been removed because LHDs were coming into contact with the idler. The easiest solution was to remove the idler.

This contributed to the incident as the distance spanning the bridge had now been increased drastically. It allowed for the belt to hang lower than usual when it slacked and made it possible for the belt to come into contact with the LDV and overturn it.

Figure 6. Illustration showing the difference between having the idler in position and having it removed

| <b>Removed Idler</b> | Idler had been removed. | With the idler in the centre of the bridge being removed, it allowed a great span for the conveyor to traverse unsupported. This caused the belt to sag much further than if there were a supporting idler in between. When the belt slacked, the increase in unsupported weight assisted in pulling the conveyor belt downwards until it came into |

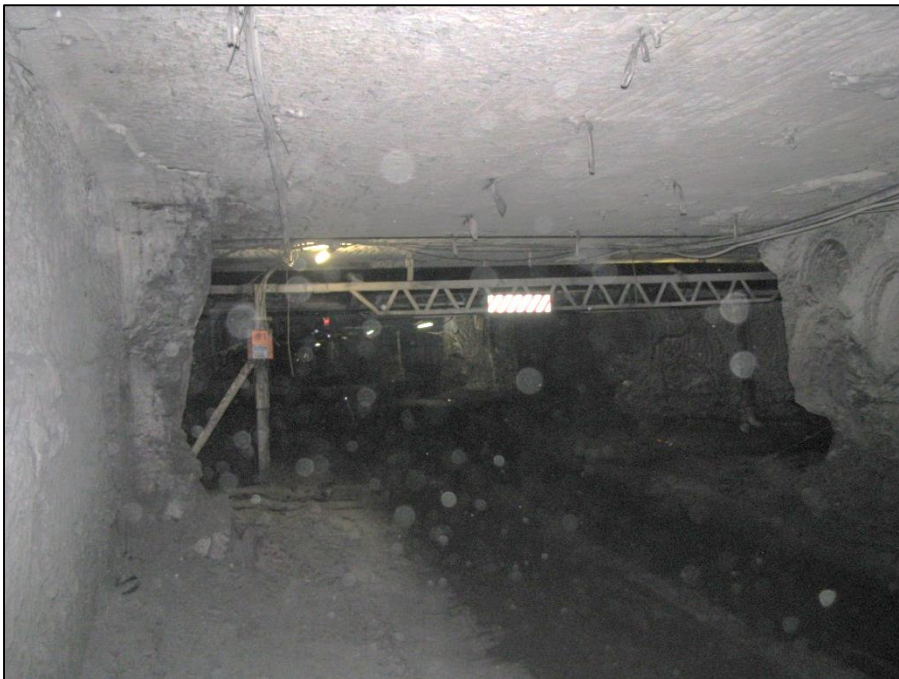
Looking at the images of the bridge below, the height, due to this being a low seam section, is well below 3.5 metres. In this case the underside of the bridge should be guarded to prevent contact with the belt by either personnel or equipment. This guarding was not installed.

Figure 7. Image showing the bridge where the HPI took place

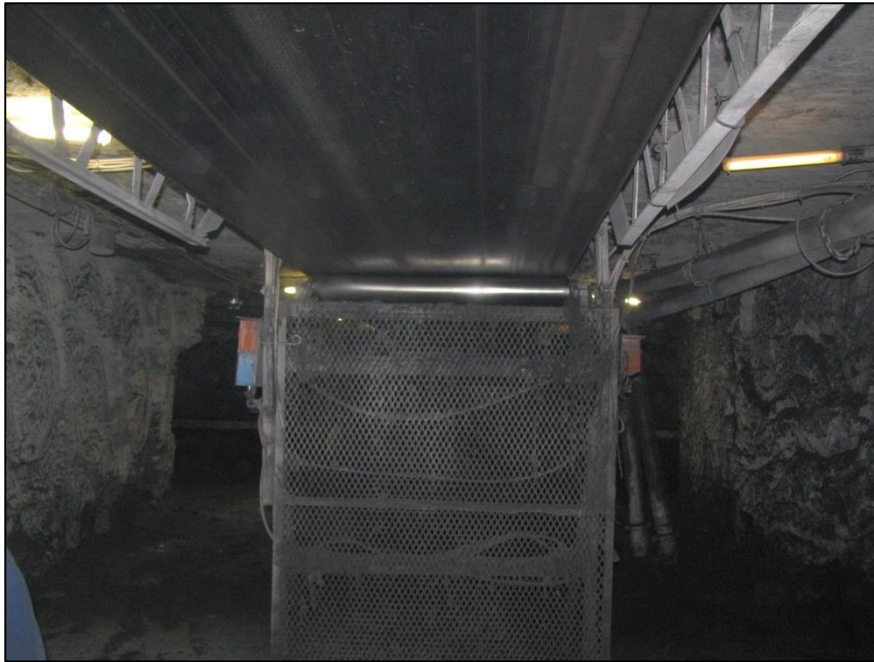
Figure 8. Image showing the lack of guarding at the belt bridge.

Although having this guarding in place would have prevented the incident from occurring as the belt would not have been able to come into contact with the vehicle, it would not have prevented the belt from producing slack. However, this cannot be seen as an ultimate resolution to the issue at hand. The belt would still be able to slack and could potentially injure someone at another point downstream of the belt or result in damage to the bridge and/or the belt structure.

| <b>Guarding</b> | The bridge was insufficiently guarded. | Adequate guarding would have prevented the belt from coming into contact with the LDV, but it would not have prevented the slack in the belt. |

- When it comes to the guarding of the belt, traditionally only guarding of belting to protect personnel has been considered. The Conveyor Codes of Practice should be revisited to include the guarding of a belt bridge to prevent contact between mobile equipment and the moving conveyor.
- Change management is an important part of any mine, and measurements should be taken to ensure that employees follow the correct procedures when changing equipment as it could have drastic effects on the production of the mine and safety of its employees.
- When doing belt inspections, care should be taken to observe any changes that have occurred and report these to the relevant parties.
- Risk assessments should be completed by trained, experience personnel.
- Risk assessments should include risks associated with various seam heights.
