## **Replacing C-6 Conveyor Belt at Kennecott Copper, Bingham Canyon Copper Mine**

Dr. Robin B. Steven

The Goodyear Tire & Rubber Company

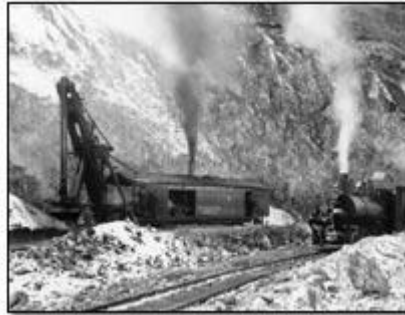
Fig.2 Early Steam Shovel and Rail-car

Before the turn of the century, the mine was developed for it's silver and gold deposits which were extracted using underground mining methods of the day. Copper was not mined until after 1898 when surface mining methods involving the mass production of low-grade copper ore were shown to be profitable [1]. In 1906 the Utah Copper Company and the Boston Consolidated Mining Company made the first cuts into the mountain to remove the copper ore using steam driven shovels The ore was transported from the mine by rail-car. The Utah

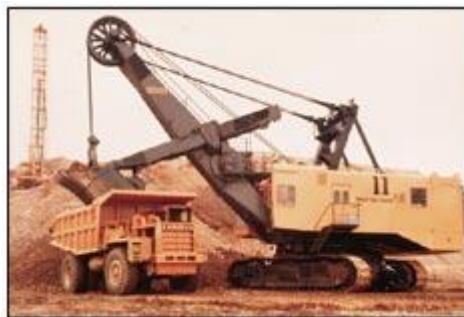
Fig.3 Electric Shovel and Trucks

In the 1960's they implemented a \$100 million expansion and modernization adding haulage trucks, large drills, and electric shovels.

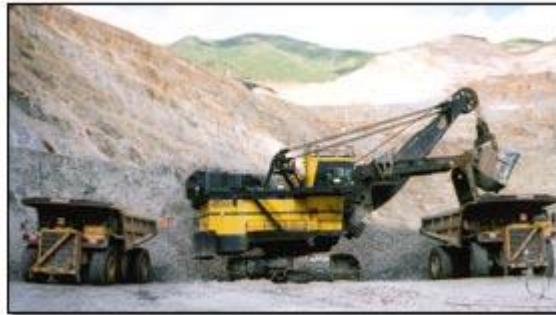
Fig.4 Today's Trucks and Shovel

Today, using current technologies, mining is still executed by a sequence of drilling, blasting, loading, hauling crushing, conveying, concentrating, smelting and refining and is carried out 24 hours a day, 365 days a year with 12 hours maintenance every 2 weeks. Additional time is allowed for crusher lining maintenance. The mine removes on average around 450,000 tons of material (ore and waste) a day and produces copper, gold, silver, molybdenum and sulfuric acid. The Kennecott currently employs around 1700 workers with around 800 at the minesite.

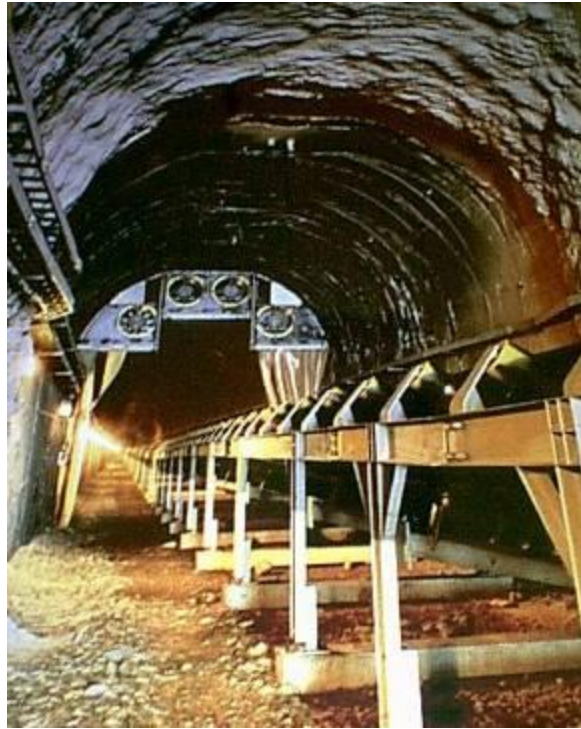
Fig. 6 C-6 Conveyor in the tunnel

C-6 was 5,288m (17,352 ft) center to center length with a 4m (13 ft) drop. It was driven by a 1,120 kW ( 1500 HP) primary and secondary drive at the head with one additional 1,120 kW (1500 HP) drive at the tail. The great majority of the conveyor length was inside a tunnel where the rail line had previously been, see Figure 6. A conventional rock box loading chute was used.

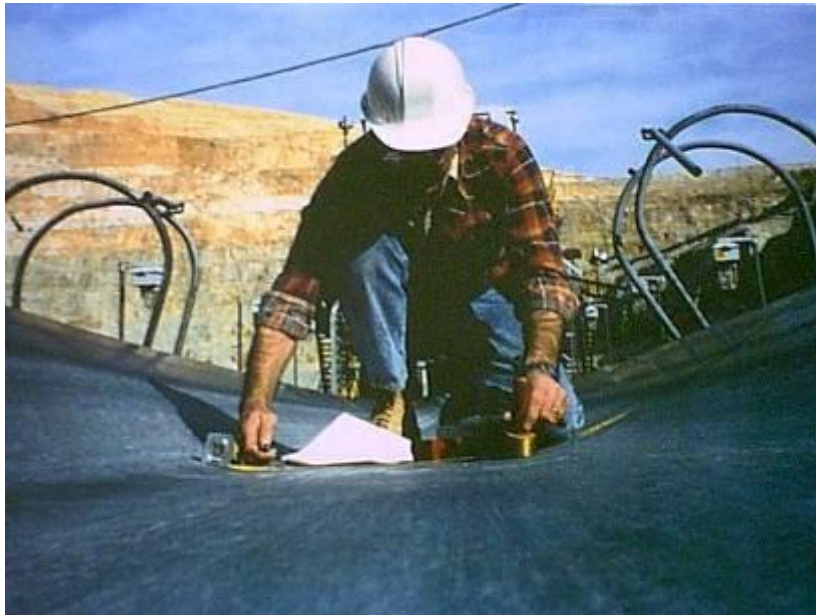
Fig. 8 Measuring belt cover gauge

Cover gauge measurements on the top cover were made periodically on the belts using special gauging equipment, Fig.8. The equipment determines the belt gauge from a probe that is placed on the belt surface. The technique is based on the principal that there is a known relationship between the strength of an electromagnetic field induced by the probe in the steel cords and the gauge of the rubber between the probe surface and the cords. After being calibrated for the belt to be measured the correct belt cover gauge is displayed directly on the hand held meter attached to the probe. Typically, measurements were taken every 152mm (6") across the belt width. In this way a gauge profile could be generated for each belt. Ideally, the same position on the belt should be used for subsequent gauge measurements. However, previous studies have indicated that there is little variation in gauge profile along the belt.

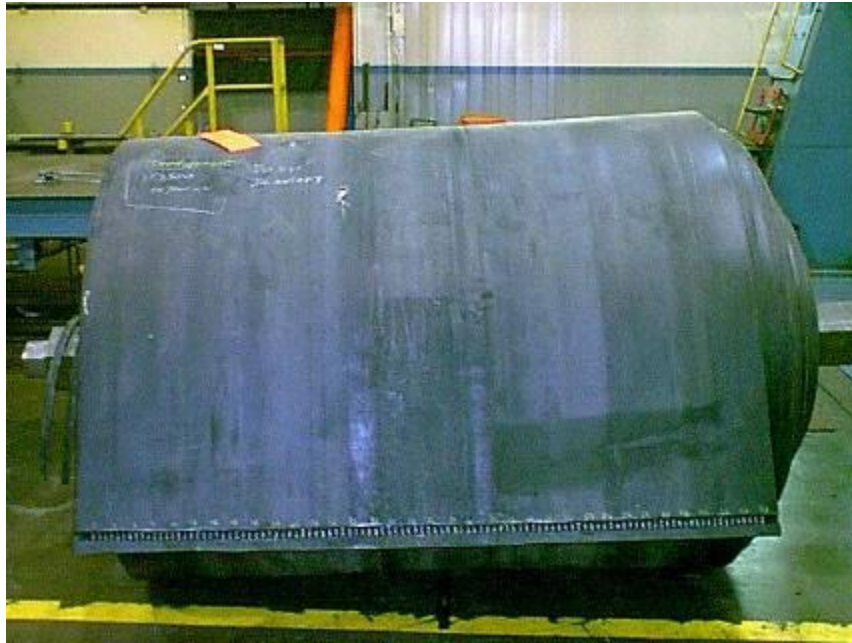
Fig. 10 Belt sample returned to Conveyor Belt Technical Center

The final top cover wear pattern shows irregularities in the region of the idler roll junctions. Peak wear points occurred approximately 100mm (4") in-board of the center idler roll ends. It is apparent that this is related to the material loading pattern, lump size and the configuration of the belt in the idler junction zones. The center wear pattern can be seen on the belt surface of the returned sample, see Figure 10. However, in general the belt shows very little top cover wear considering its age and the volume of material it has conveyed.

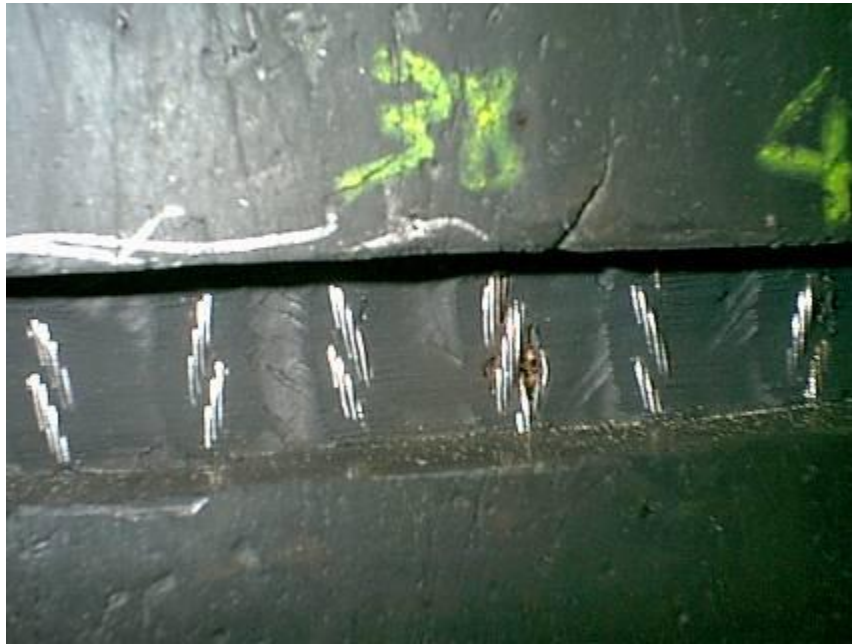
Fig. 16 Example of cord corrosion initiated from impact damage

With regard to the cord breaks, Fig. 16 shows how local impact damage initiates corrosion which leads to cord breaks and Fig. 17 shows the incidence of cord breaks plotted against time.

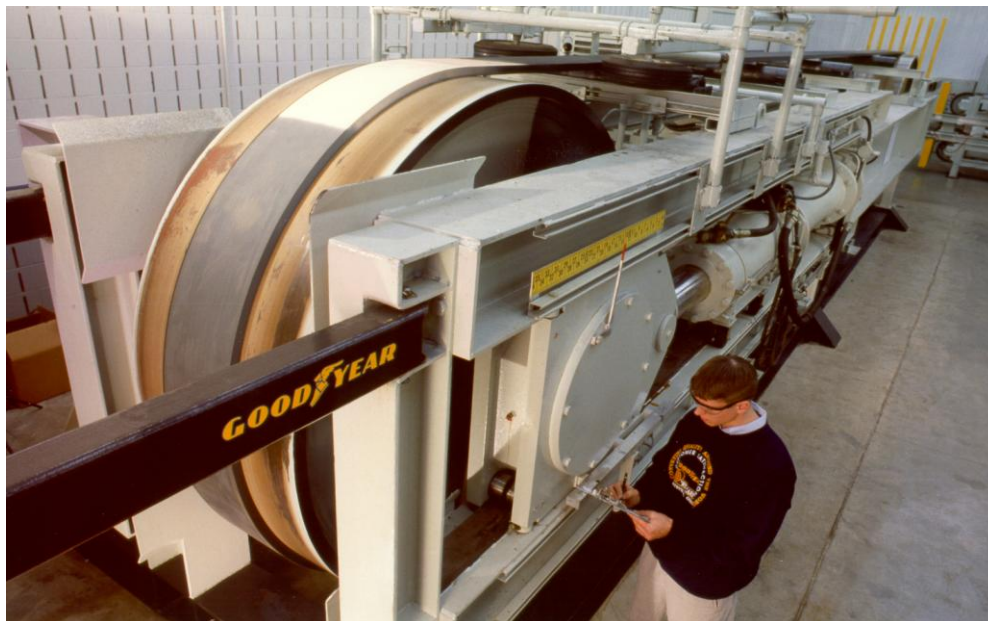
The original splice design was never dynamically tested. However, from test experience it was determined that the original splice would probably meet the new dynamic splice requirement of 60% dynamic splice efficiency with few changes. The manufacturer was able to test the dynamic splice efficiency on their 2-pulley Dynamic Splice Test Machine in the belt manufacturer's Technical Center in Marysville Ohio. Fig 23

Fig.23 2-Pulley Dynamic Splice Test Machine, in the manufacturer's Technical Center

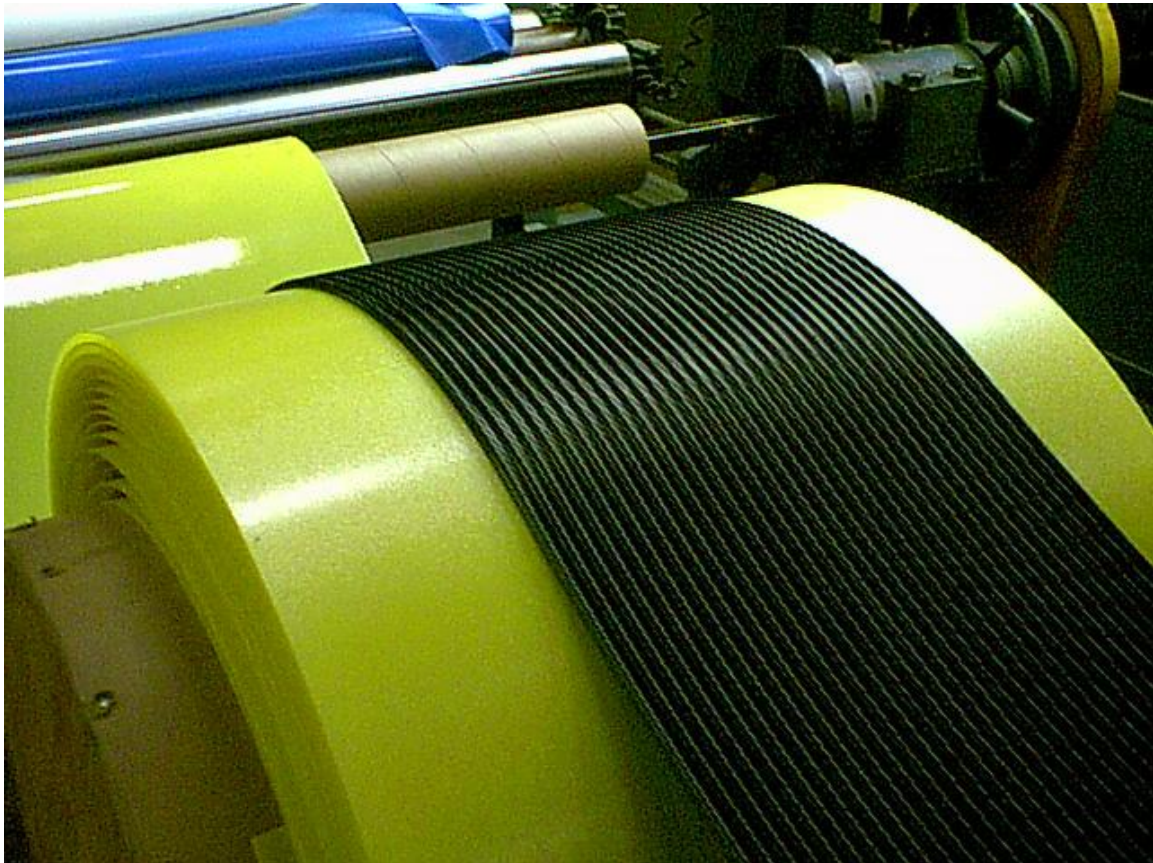
Five of the twenty-four splices were made using a patented Splice Preform instead of the conventional insulation gum noodles. The insulation gum preforms reduce splice time by reducing cord lay-up time and cement drying time. They also provide improvements in cord spacing and alignment and this has shown to improve dynamic splice life. Fig. 30 shows preform material as supplied to Kennecott. The final splice was also made using preforms as the preform splice is made without the use of cements and there was a concern about dust sticking to wet cement because the final splice was made on the conveyor instead of the splice shed.

Fig. 30 Patented splice preform material for C-6

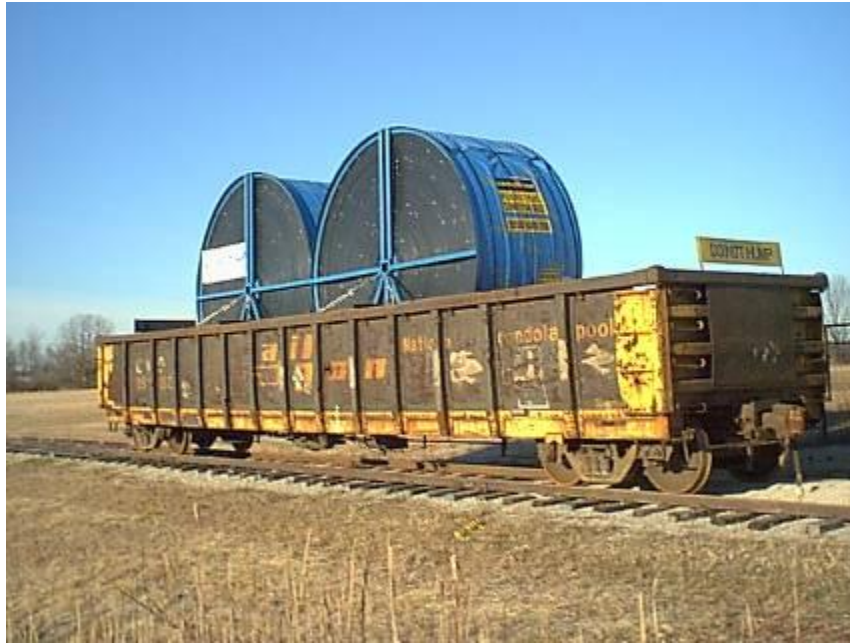
Fig. 31 shows two of the twenty-four belt rolls of the replacement belt on a rail-car ready to ship to the mine site. The steel shipping reel's design provides good support and protection for the belt during shipping and storage. The same reel design had successfully protected a similar diameter but narrower belt from damage after it fell from a truck on a curve during transportation.

Fig.31 Two rolls of replacement belt ready to ship to Kennecott February 2002
