**KD01 CONVEYOR - KYUGA COAL  
ANGLO-AMERICAN, HUNTER VALLEY, AUSTRALIA**

PETER R. GILBERT  
NEPEAN CONVEYORS INTERNATIONAL PTY. LTD

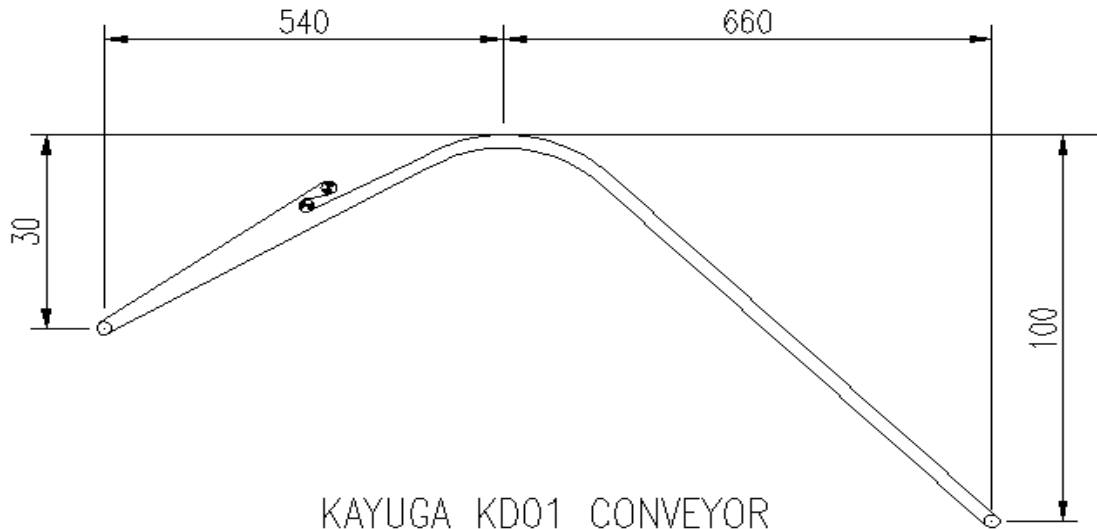
Sketch # 2

Conceptual design of the conveyor (Sketch # 2) evolved somewhat likened to an inverted "Boomerang" with one leg longer than the other, that being the decline component of the conveyor.

Further calculations concluded that were the conveyor to be loaded in the "uphill only" a power demand of 650kW would be required of the drive system, however, were the conveyor to be loaded in the decline portion only, the conveyor system would regenerate some 800kW of power.

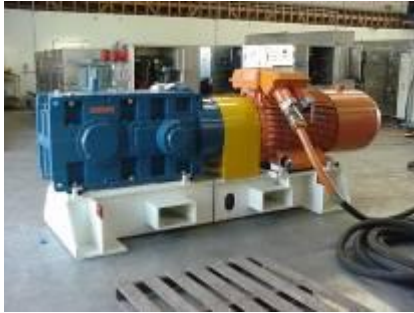
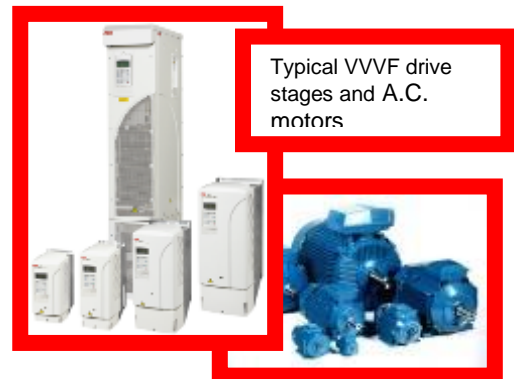
Typical VVVF drive stages and A.C. motors

A typical 500kW VVVF power module

2... The key to VVVF control is the drive stage. Essentially, it's a box of electronics with replaceable cards (two units about the size of a suitcase would drive a 500kW motor) that converts the A.C. current to D.C. current, "chops" and appropriates the required motor voltage & frequency, then converts back to A.C. current prior to charging the A.C. motor with the desired "flux" to rotate the motor at the speed and torque required.

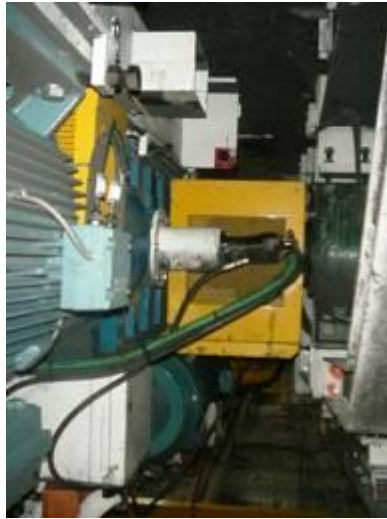
***Secondary gearbox overspeed pump.***

Given a known belt 100% belt speed of 4 m/sec and a design capacity of 4,200 t/p/hr, Nepean fitted a hydraulic pump to the first motion cross-shaft of the secondary gearbox and provided a fail to safe measurable hydraulic flow system that measured belt speed driven by the gearbox pump. I.E.: Belt speed 4m/sec = 1201 r/p/m @ 24 l/min

First overspeed = 1441 r/p/m @ 28.8 l/min or 120%

Second overspeed = 1681 r/p/m @ 33.6 l/min or 140%.

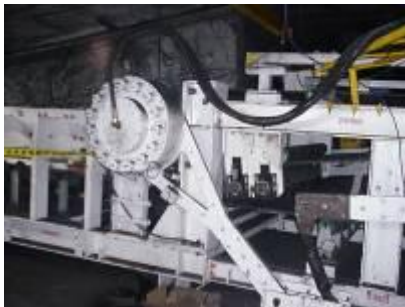
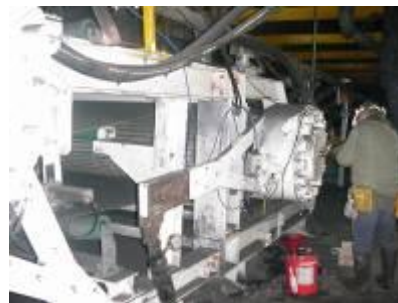
***The secondary brake with the primary brake torque-arm saddled for hydraulic pressure.***

The secondary brake control hydraulic circuitry however is prioritized over by way of a hydraulic pressure lock generated mechanically by the primary brake's torque arm rotational force.

In short, while ever in an emergency situation, the primary brake is operating (to stop the conveyor), its torque arm generates hydraulic lock pressure to dis-allow the secondary brake to clamp on & complicate the matter.

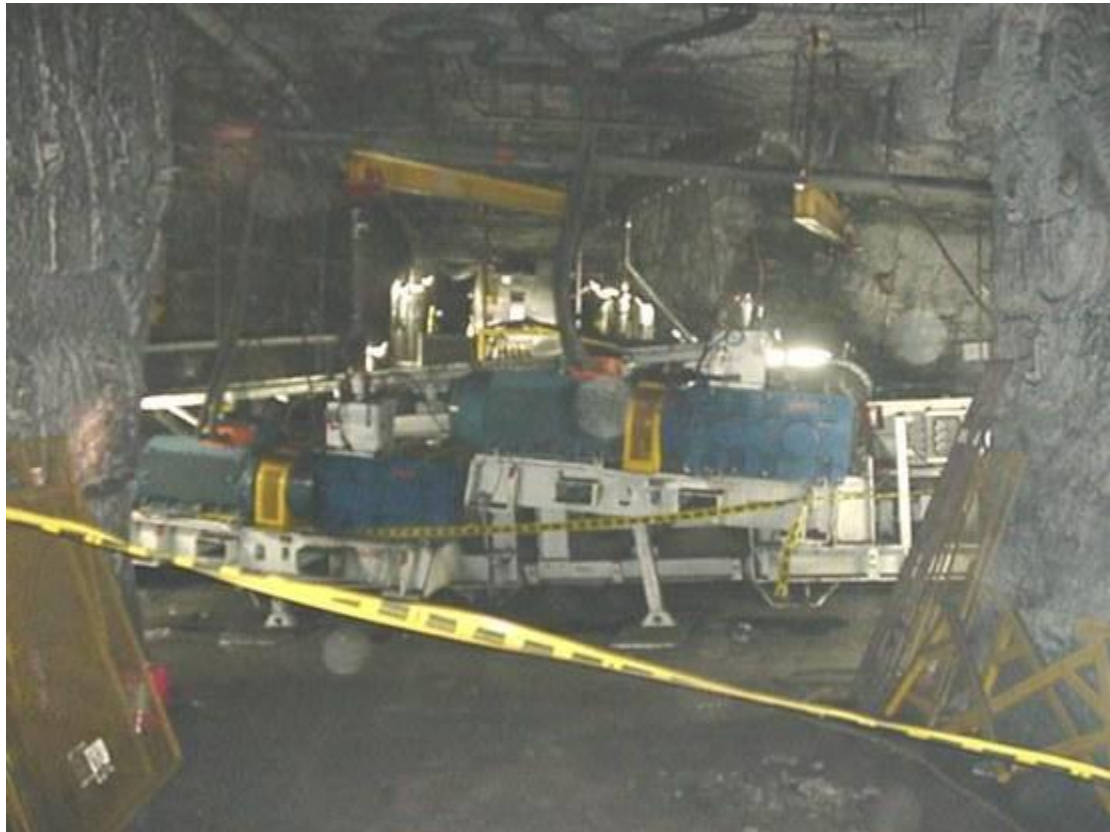
***The Tripper Drivehead, VVVF power modules and Brakes***

The Tripper Drivehead, VVVF 1mW sub-station and twin 160k/Nm brakes were all installed at a location two hundred meters inbye from the conveyors "peak" at a cut-through accessible from both sides of the KD01 conveyor heading.
