# CONVEYOR SYSTEM DESIGN AUDITING, DYNAMIC TESTING AND CONDITION MONITORING OF STEEL CORD BELTS.

Athol Surtees

### PART 1: CONVEYOR SYSTEM DESIGN AUDITING AND DYNAMIC TESTING.

### PART 2: CONDITION MONITORING OF STEEL CORD BELTS.

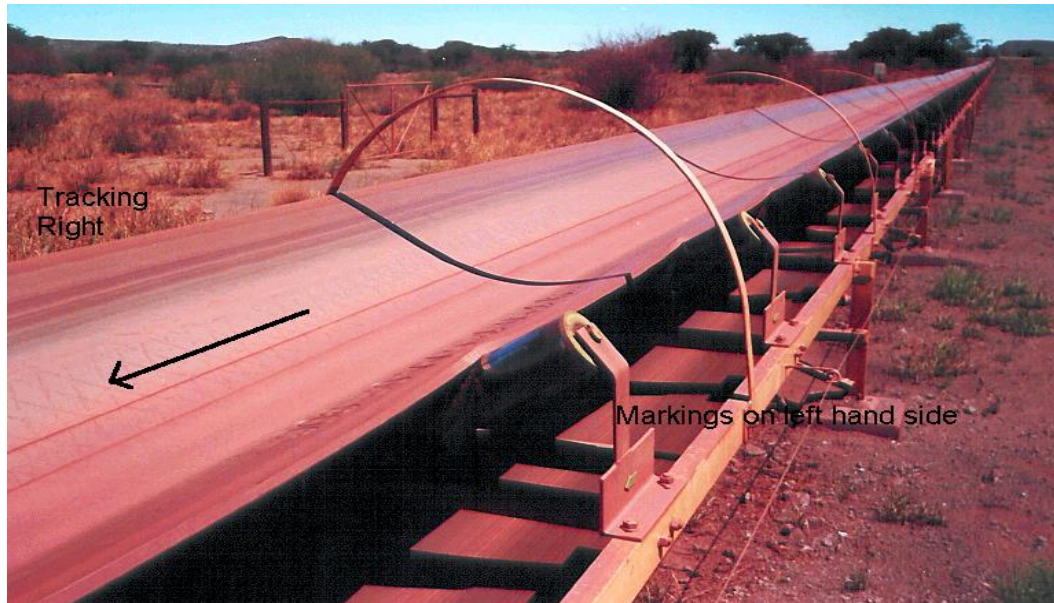
#### EXAMPLE 12: BELT MISTRACKING.

Y-axis: Mistracking in mm.

The positive tracking values indicate belt tracking towards the left hand side of the conveyor centre, viewed in direction of product travel, on the carry cover.

The negative tracking values indicate belt tracking towards the right hand side of the conveyor centre, viewed in direction of product travel, on the carry cover.

X-axis: Time in seconds.

The tracking cycle with each revolution of the belt is repeatable.

The maximum amplitude of mistracking measured, from belt tracking right to belt tracking left exceeds 160 mm.

The belt always tracks left when the markings on the carry cover are on the right hand side of the belt.

Inversely, the belt always tracks right when the markings on the carry cover are on the left hand side of the belt. For example:

The tracking swings from one side to the other at those splices where the markings on the belt change from one edge to the other.

The poor belt tracking is directly related to the occurrence of those splices that have been made between one belt roll end and another belt roll end, or at those splices that have been made between one belt roll beginning and another belt roll beginning.

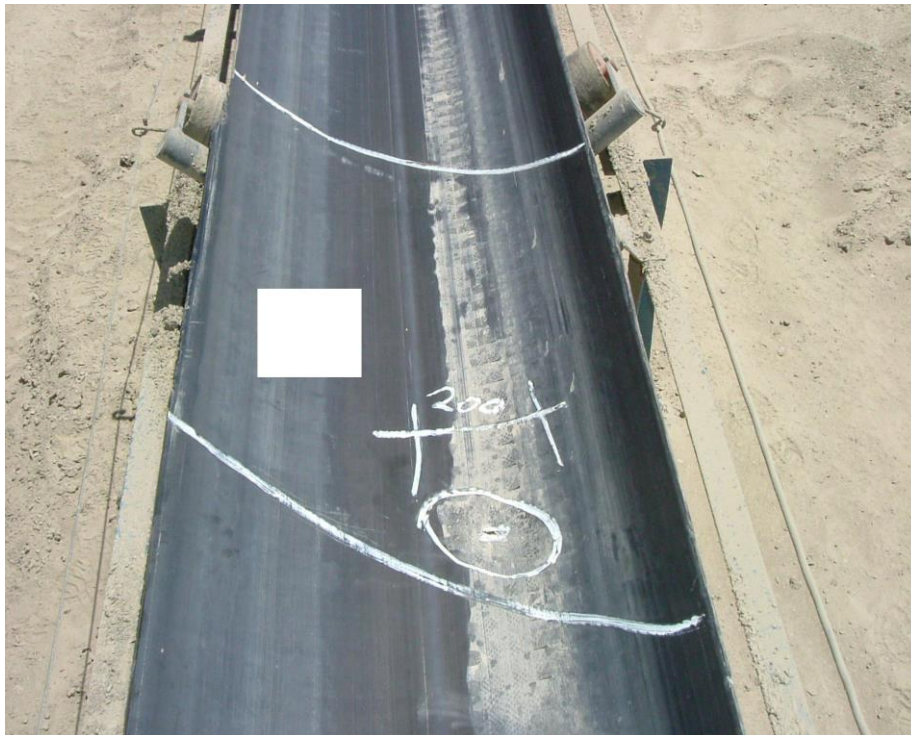
Example of visual inspection of damage in splice with suspect magnetic signature.

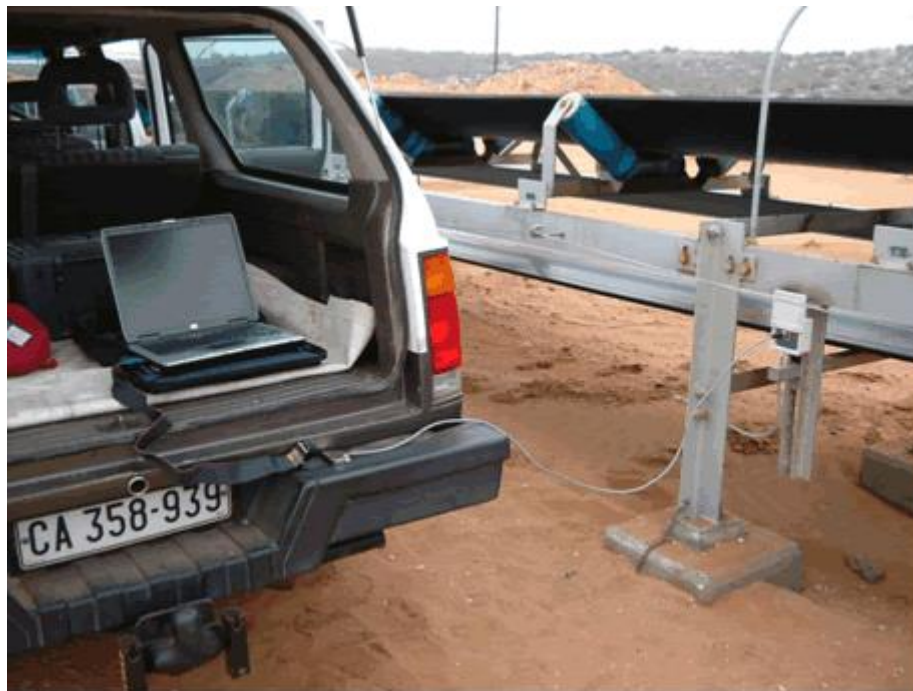
Example of a permanent installation.

Equipment is installed under the return belt, on either side of a flat idler.  
A laptop computer is connected to the terminal box for data collection.  
An on-site briefing is given, outlining any major damage needing immediate repair plus a thumbnail condition assessment.
