CONVEYOR BELT BOTTOM COVER FAILURE FROM IDLERS AND PULLEYS

Yijun Zhang

Conveyor Dynamics Inc.

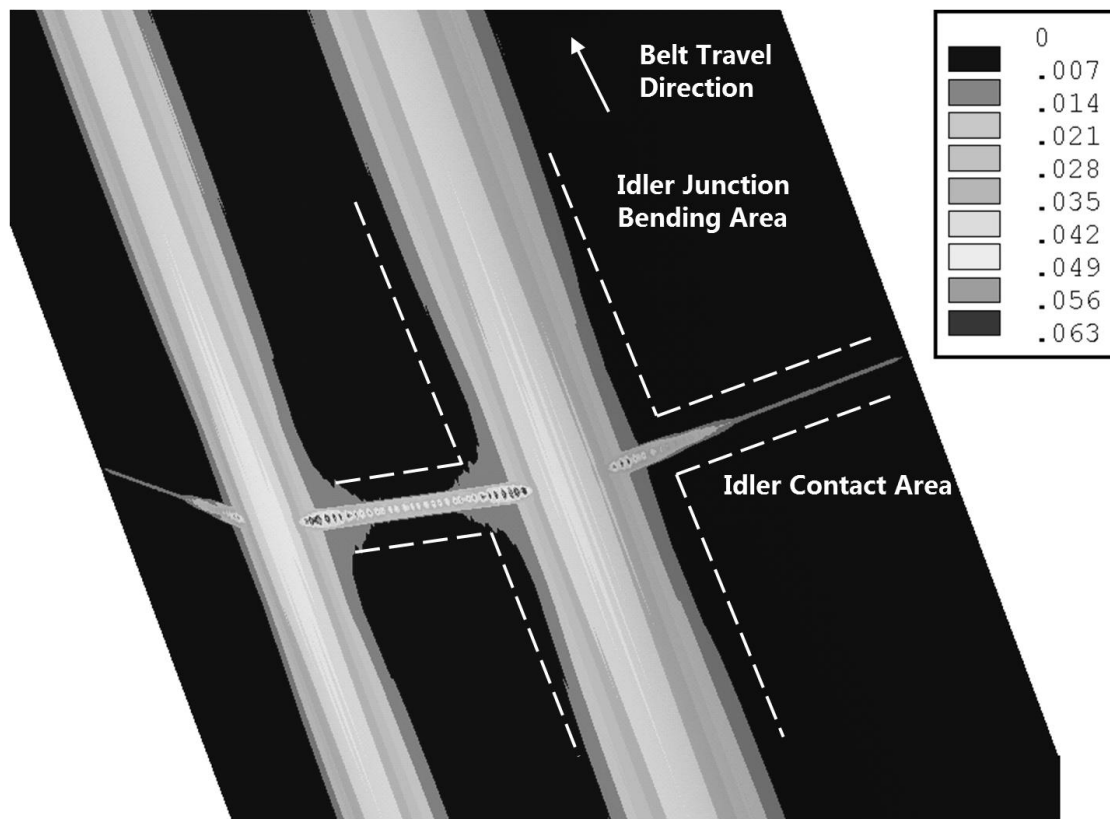
The conveyor belt bends at the junction between idler rolls. The bending creates compression in the belt's top cover and tension in the bottom cover. The extent of this deformation depends on the idler arrangement, belt properties and belt loading. Figure 1 shows a finite element analysis (FEA) of the deformation in a steel cord belt on three-roll trough (idler set not shown in the figure). The idler junction bending area is along the belt travel direction, symmetric along the belt centre line, and separates the belt's contact between the centre roll and wing roll.

Deformation in the idler junction area is mainly due to bending. Deformation in the idler contact area is mainly compression from the material and belt load and shear from rolling resistance. The circles in the idler contact area are high pressure points directly under individual steel cords, which relate to a different type of bottom cover failure.

Figure 1. Equivalent (von Mises) strain in the belt bottom cover of a steel cord belt from finite element modeling

In Figure 1, the idler contact area shows high deformation areas (circles) lying under individual steel cords. The contact pressure is relaxed under the rubber gap between adjacent steel cords. Also, the contact pressure near the edge of the wing roll and centre roll is higher than the rest. Combining the two effects, the localized contact stress can be significantly higher than the average contact stress over the entire contact area.

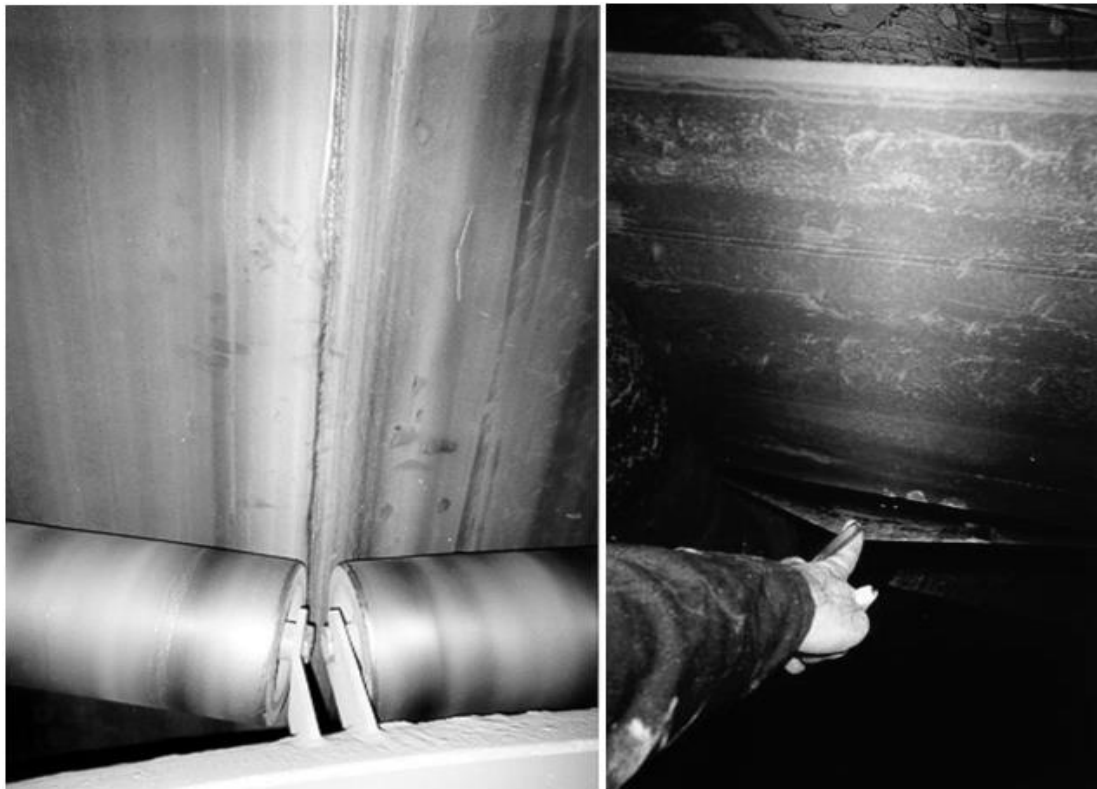
High tensile strain in the bottom cover, due to severe bending at the idler junction, can facilitate surface cracks. The surface cracks may develop from short lengths to long stretches and further coalesce to cause deep cover failure. An example of this idler junction failure is illustrated in Figure 2. Some belt manufacturers' manuals mention this type of failure, but without detailed analysis².

Figure 2 . Idler junction cover failure

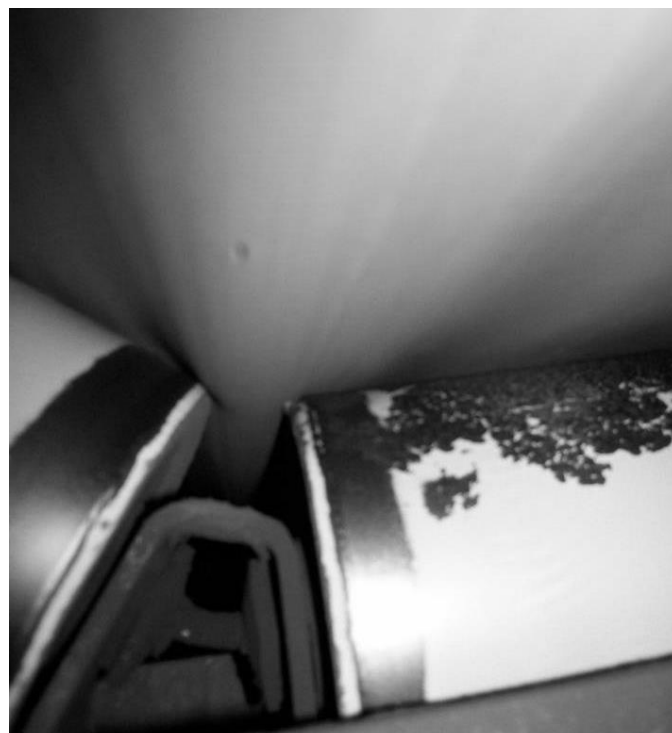
In an inline idler arrangement, where all rolls are on the same plane, there is a gap between adjacent idler rolls. If the gap is wide enough and the belt's idler junction bending is severe enough, the belt may contact the idler edge. Figure 3 shows an example of a belt contacting the idler edge. When this scenario occurs, the idler edge acts like a knife edge, where the contact stress between belt and idler edge is very high. This leads to an excessive rate of cover wear. Well designed and manufactured inline idler sets should have an idler gap of less than 10 mm to avoid potential contact with the belt.

Figure 3. Belt contacting idler edge

An improved design is the offset idler arrangement, where the rolls are staggered to create an overlap at the idler junction. This eliminates any potential contact between belt and idler edge. A large diameter idler roll reduces the contact stress between belt and idler, and the idler junction bending is reduced. For the same belt width, a five-roll trough arrangement reduces the idler junction bending, compared to a deep trough three-roll arrangement, as there are additional idler junctions that reduce the bending angle at each idler junction.

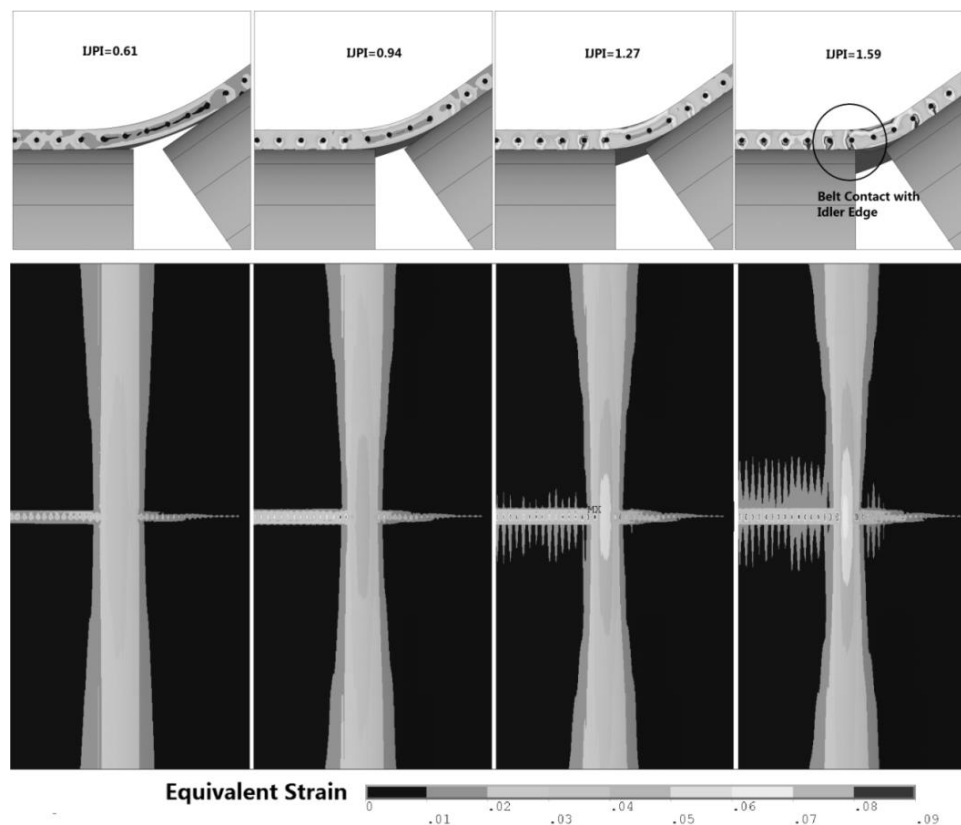
Conveyor Dynamics Inc. (CDI) developed the Idler Junction Pressure Index (IJPI) as a quantitative tool to measure the idler junction bending stress. The IJPI allows the designer to explore various conveyor and belt parameters like idler spacing; diameter; roll lengths; belt speed; belt thickness etc., to reach an optimal design while maintaining allowable idler junction bending. Higher IJPI values mean more bending deformation. As a general design criterion, the IJPI should not exceed 1.0~1.2 range. Figure 4 shows a finite element model of the idler junction bending in a 1200 mm wide, 13.5 mm thick belt on a 35° degree trough. The material loading can be adjusted to achieve four different IJPI values, from low to high. It is obvious that the strain and idler junction bending increases with a higher IJPI value from 0.61–1.59. IJPI = 1 can be viewed as a relatively conservative limit. When a IJPI exceeds 1.2, the belt bending becomes severe. At IJPI = 1.59, the belt starts to contact the idler edge.

Figure 4. Finite element modeling of belt deformation with Idler Junction Pressure Index (IJPI). Top graphs: cut plane of a belt near the idler junction area. Bottom graphs: the belt bottom cover (looking from beneath the belt bottom cover)

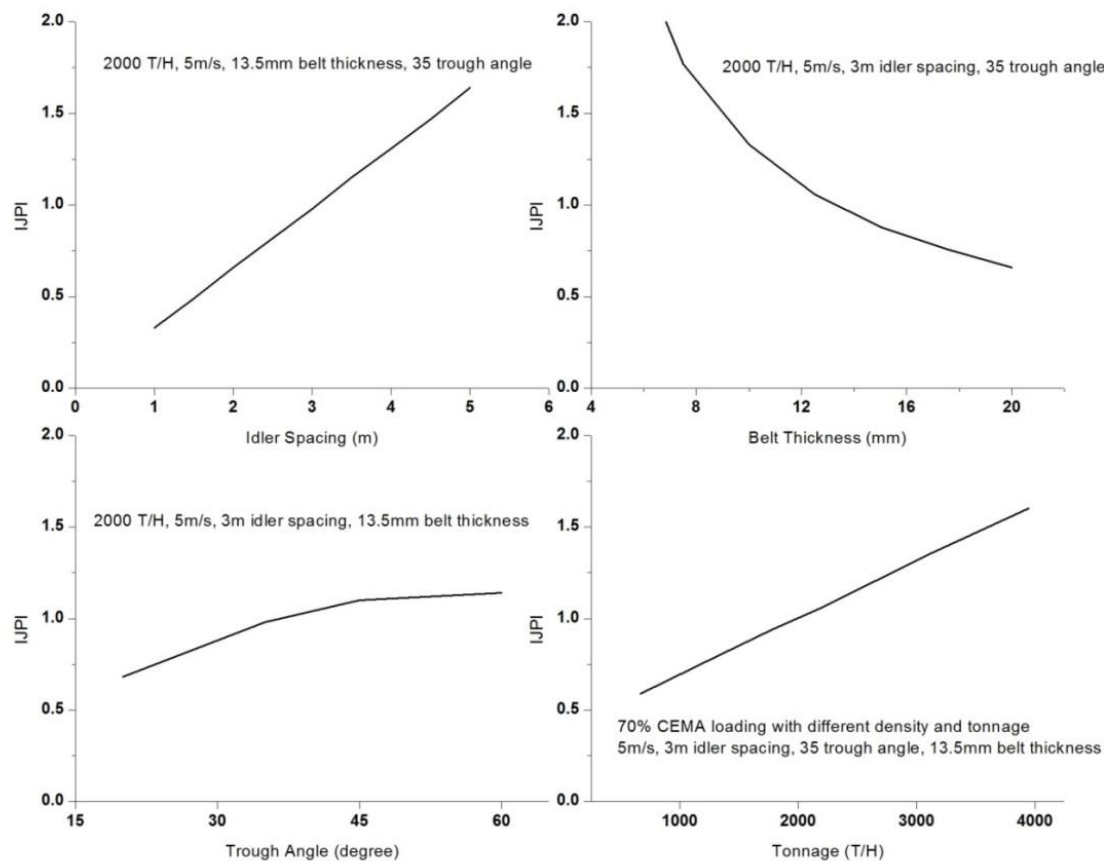
To illustrate the relationship of a IJPI to conveyor and belt parameters, Figure 5 shows a different IJPI on the same 1200 mm wide belt, at 70% CEMA loading and 5 m/s belt speed, but with varying idler spacing, belt thickness, trough angle and tonnage. Some weight related factors, like idler spacing and tonnage, show a linear relation to the IJPI. Some bending related factors, like belt thickness and trough angle, show a non- linear relation to the IJPI. For example, the IJPI increases beyond a linear relationship with reduced belt thickness.

Figure 5. Idler Junction Pressure Index (IJPI) vs idler spacing, belt thickness, trough angle and tonnage. Belt width is 1200 mm in all cases ^{13,14}

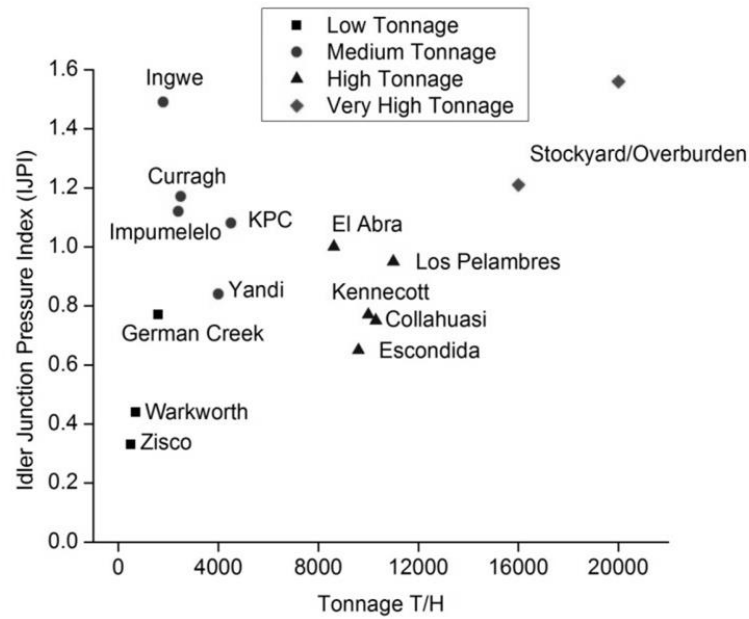
The design limit on a IJPI is derived from studying belt behaviour and service life on running conveyors. A high IJPI should be mitigated by design changes like reducing idler spacing, increasing belt thickness or increasing belt speed. Figure 6 displays the IJPI of selected overland conveyor projects that CDI has worked on. Major system details of these conveyors are listed in Table 1.

Figure 6. Project examples of Idler Junction Pressure Index

Some conveyors may have undergone modifications or upgrades, thus the parameters may not be current. There are four categories of conveyors: first is low tonnage conveyors (<1000 t/h). Because the tonnage is low, the IJPI is low as well, even with a thin belt and extended idler spacing at 5 m.

The second category is medium tonnage conveyors between 1500 t/h and 4000 t/h. Conveyors in this category can have a wide range of IJPIs. This is due to the wide variations in system parameters like belt rating, idler spacing, belt speed, etc. For conventional conveyor design using short idler spacing, the IJPI is expected to be low. Conveyor design can also be optimised to reduce capital and operating cost, including reducing belt thickness and width, increasing belt speed and idler spacing, and utilizing a low rolling resistance belt to reduce power consumption. The IJPI is typically increased in an optimised conveyor design, compared to the conventional design with reduced idler spacing. It is the conveyor designer's responsibility to make sure the IJPI is within the allowable limit.

The third category is high tonnage overland conveyors which are operating in some South American copper mines. Although the tonnage is high, over 8000 t/h, the belt thickness is also normally increased by having large diameter steel cords and thicker belt cover to compensate for high belt rating and hard rock handling. Short idler spacing is usually specified to limit idler load and bearing size. For these conveyors, the IJPI is generally expected to be within design limits, until the belt becomes thin from significant cover wear.

The fourth and final category is very high tonnage conveyors over 15 000 t/h. This type of conveyor is located in large stockyards in bulk material handling ports or surface mining operations. They do not necessarily have long lengths or a high incline/decline angle, but are characterised by wide belt and very high tonnage. The IJPI can increase very quickly with a normal three-roll trough even with reduced idler spacing. Careful consideration of idler spacing and trough arrangement should be taken to limit the idler junction bending.

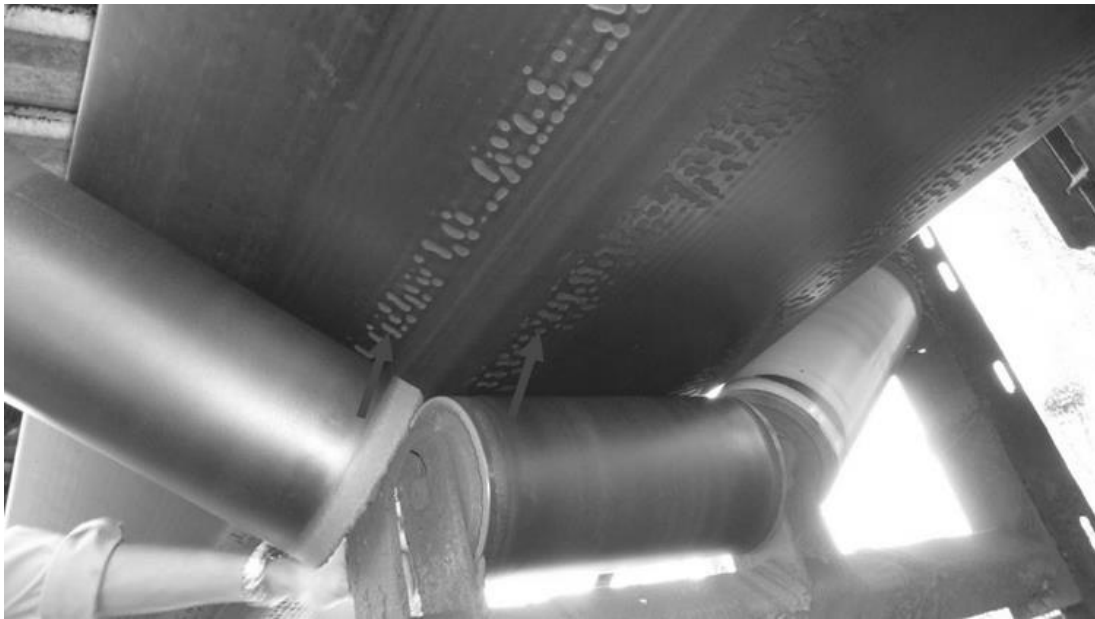
High normal and shear stress can potentially cause accelerated belt cover wear. One example is shown in Figure 7. This particular belt was travelling at high speed with a heavy material load, so both normal and shear contact stress was high. The contact stress further increased around the idler edges and directly under individual steel cords. In Figure 7, the spacing of the circular damage spots matches the spacing of steel cords in the belt, which is exactly the high stress area. If the bottom cover rubber's mechanical property is not strong enough to withstand the stress or strain level, premature bottom cover belt failure will occur.

Figure7. Bottom cover damage at high contact pressure area

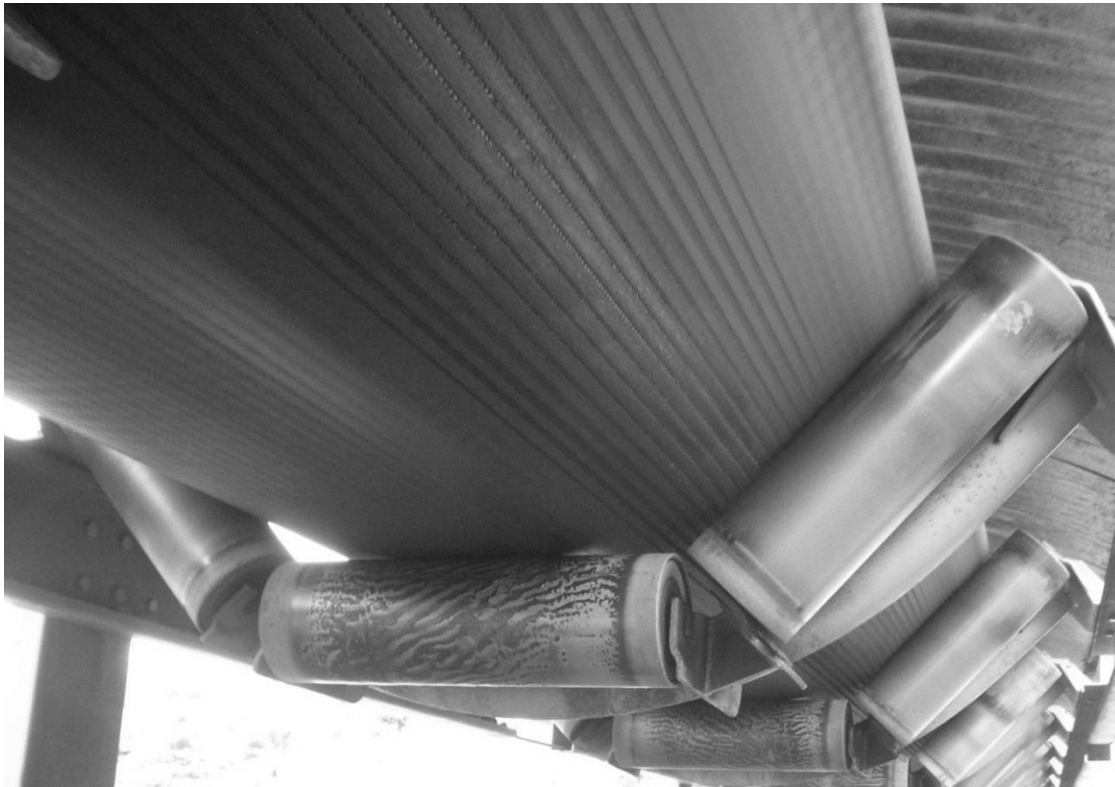
Tilting the idler arrangement forwards is adopted as a solution or precaution against belt mistracking. The rotational velocity of a tilted wing roll is at an angle (tilt angle) against the belt travel direction. The linear velocity of a wing roll can be separated into two components: one parallel to the belt travel, and the other aligned with the belt travel direction. The velocity component parallel to the belt travel is a rolling contact, which has very minimal wear on the belt. The velocity component, aligned with the belt travel direction, is a sliding contact. The sliding frictional force pushes the belt down and stabilizes it. However, the sliding friction also creates additional wear on the belt bottom cover in the wing roll contact area. By the same argument, backward tilting is not used because the direction of the frictional force is pulling the belt upward from both wing rolls, which leads to more belt mistracking. Figure 8 shows the belt cover wear caused by the forward tilting of the wing roll. The forward tilting of wing rolls can wear the belt bottom cover down to the steel cords. The high wear area also corresponds to the high contact stress area on the wing roll near the idler junction. The cover wear on the centre roll and belt edge area is much less pronounced. For short plant conveyors, belt cycle time is short and the belt top cover tends to wear very quickly. If belt mistracking creates frequent unplanned conveyor shutdowns, it is advantageous to use the forward tilting of idler wing rolls to improve belt tracking. However, such practice should be avoided for overland conveyors, when belt

Figure 8. Belt cover wear due to idler forward tilt

mistracking should be prevented by proper idler arrangement and good installation accuracy.

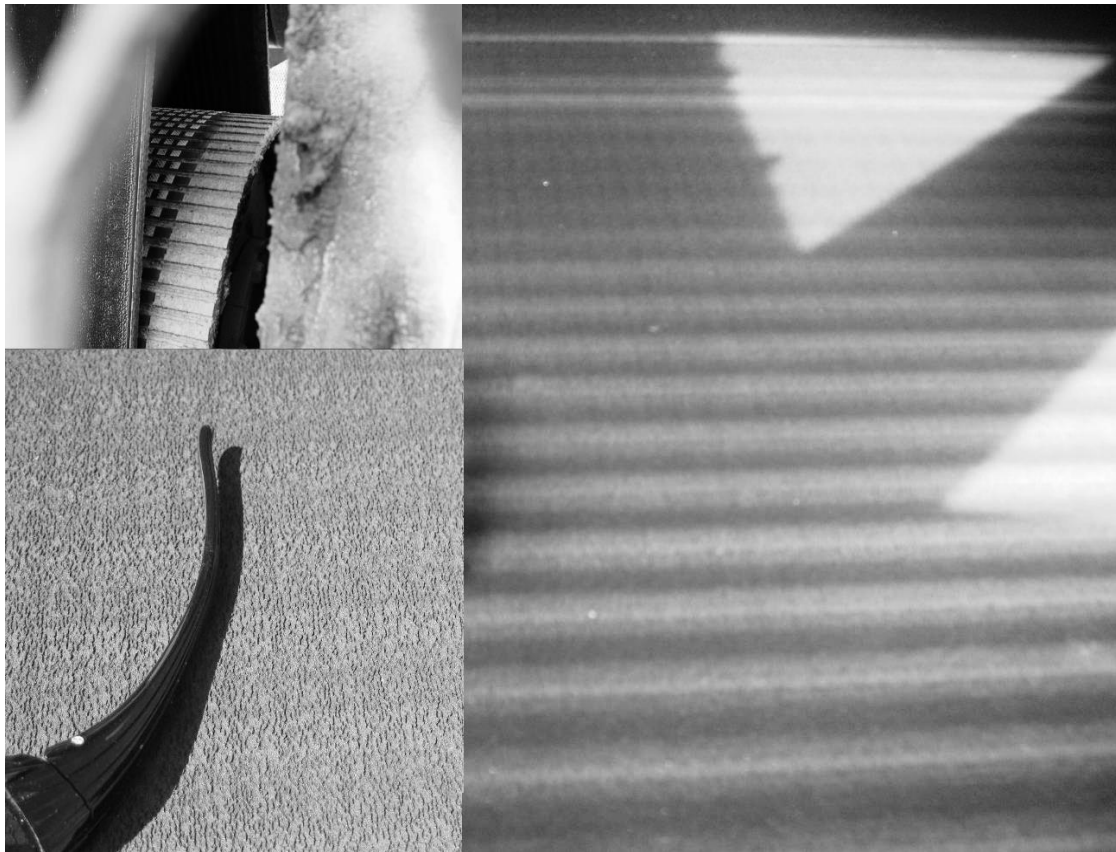
Ceramic pulley laggings are chosen over rubber pulley laggings for their superior wear resistance and higher friction coefficient. Manufacturers provide different types of ceramic lagging tile designs. Certain ceramic lagging is designed to provide a greater friction coefficient between the belt and pulley, usually by introducing small, sharp-edged protrusions on the lagging surface. The protrusions are intended to penetrate into the belt bottom cover and provide greater resistance against the slipping motion of the belt. However, from analysis of classic contact mechanics⁵, it is known that on a drive pulley, certain slipping is intrinsic to the interaction between belt and pulley. Aggressive ceramic lagging design, in combination with high tension ratio on a drive pulley, can potentially cause premature belt cover failure. Figure 9 shows the wear marks on the belt bottom cover produced from ceramic lagging tiles, where the spacing of the white stripes (wear marks) match exactly the spacing of the ceramic lagging tiles. The abrasive wear on the belt cover can be identified in the lower left image. Ceramic lagging tile design affects the contact stress. Figure 10 shows two different ceramic lagging tiles: the left lagging tile has sharp protrusions and the right lagging tile has a wavy surface. Under the same contact condition (belt tension and pulley diameter), the contact stress is more than four times higher on the lagging tiles with sharp protrusions. Indeed, the higher contact stress can provide more 'grip' between the belt and pulley, but can also add to the possibility of belt cover damage.

Figure 9. Belt cover wear from sharp ceramic lagging tile. The lagged pulley surface is shown in the upper left corner

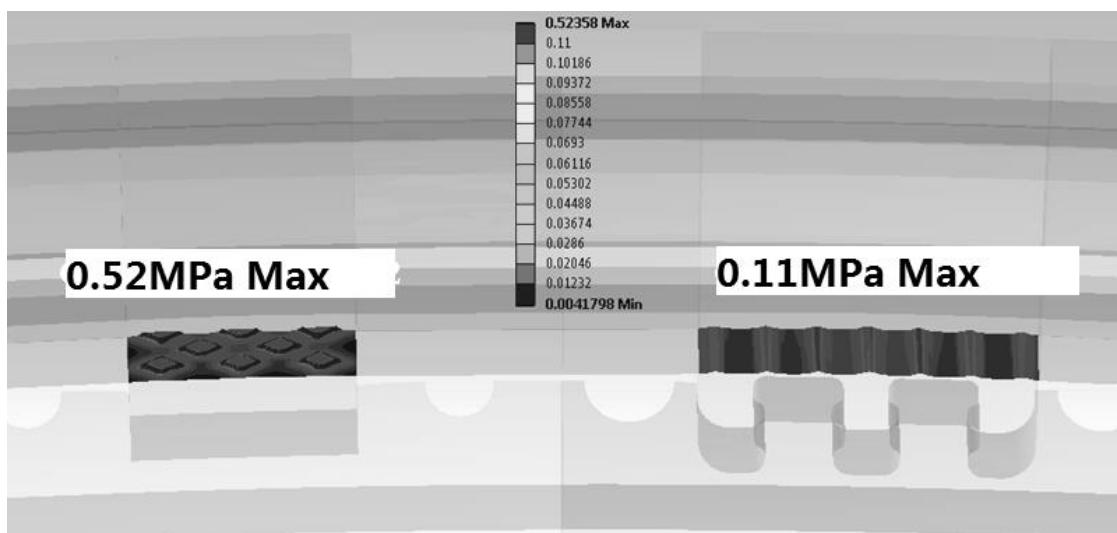
Figure 10. Comparison of contact stress between two ceramic lagging tile designs

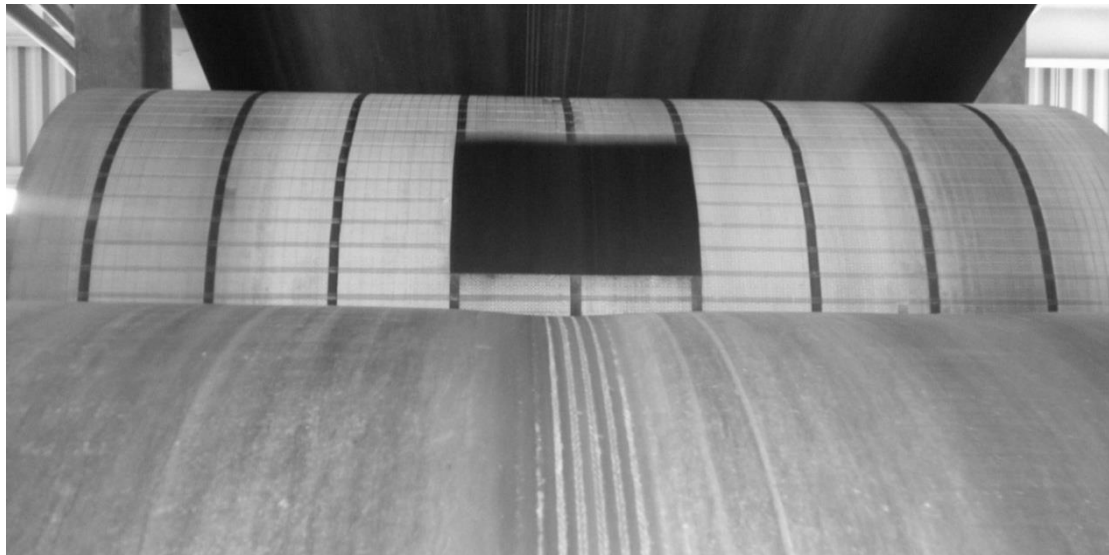
Ceramic lagging tiles may dislodge from the pulley. Missing laggings create an irregular pulley surface. Sharp corners and edges of existing lagging tiles that are adjacent to the missing pieces are exposed to contact with the belt cover and lead to accelerated wear. Figure 11 shows such an example: the belt cover has a wear zone near the centre of the belt down to the steel cords, the location of which matches that of the missing lagging tiles on the pulley surface. Although a few missing lagging tiles may seem

insignificant, the related belt damage may quickly escalate to a serious level in which the entire belt needs to be replaced. The wear is caused by localised cover rubber slip over the edges of ceramic tiles due to relaxation, between the lagged region and the region with missing tiles. Good inspection and maintenance practices are essential in preventing such belt damage.

Figure 11. Bottom cover wear from ceramic lagging
