SPLICE FAILURES RESULTING FROM RUBBER COMPOUND INCOMPATIBILITY

André van Staden

Rema Tip Top South Africa (Pty) Ltd/Dunlop Industrial Products

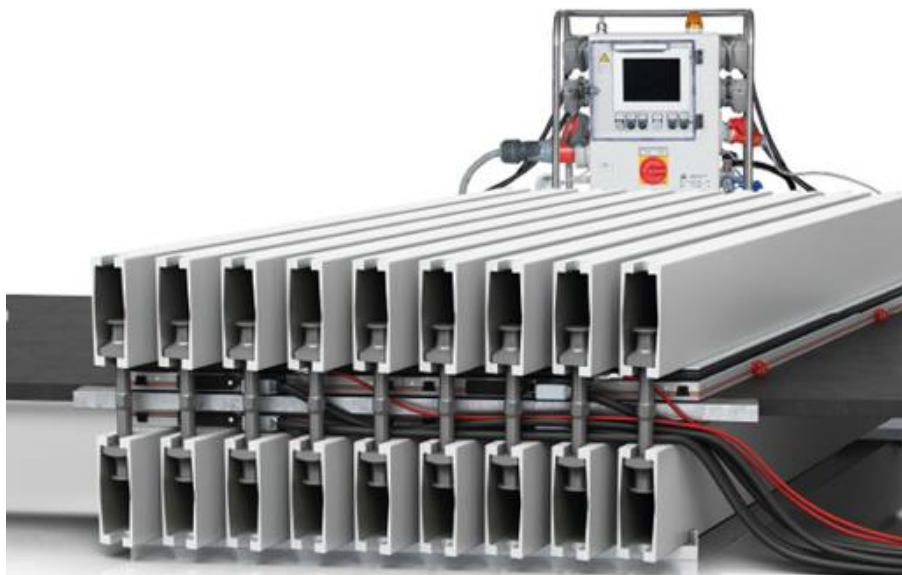
Vulcanising presses have become more efficient and advanced, offering better control over the splicing process. Heating and cooling times have been greatly reduced.

Figure 1. Hot vulcanising press.

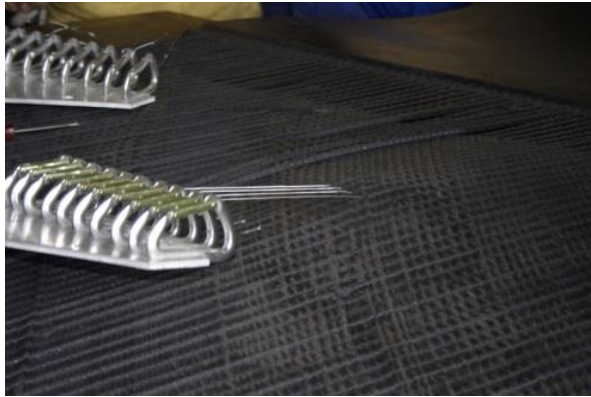
The introduction of specialised tools makes possible a reduction in the preparation time, while increasing the accuracy and quality of splices.

Figure 2. Piano wire steel cord stripper.

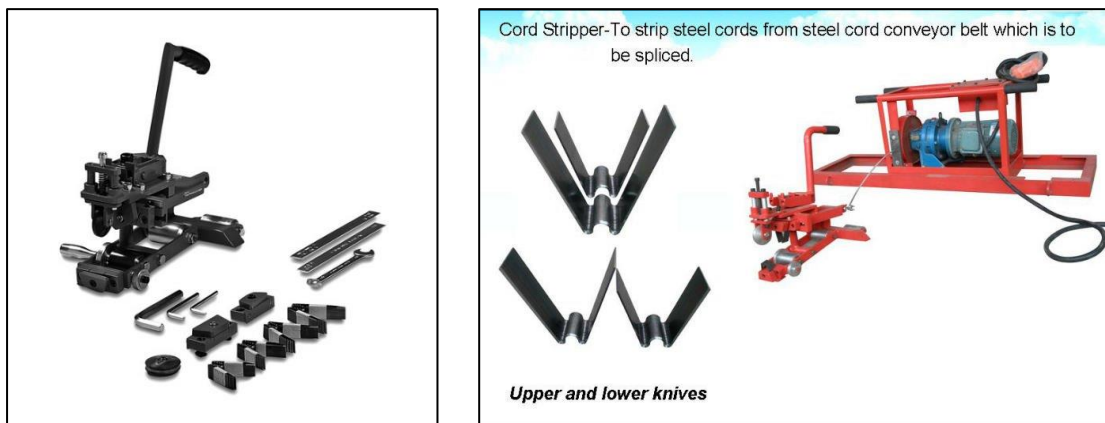
Figure 3. Knife steel cord stripper components.

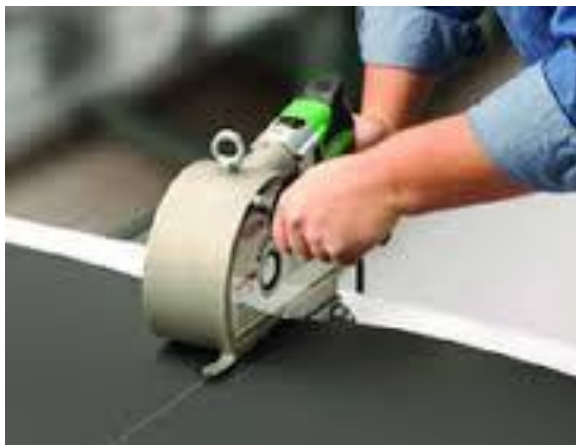
Figure 4. Knife steel cord stripper.

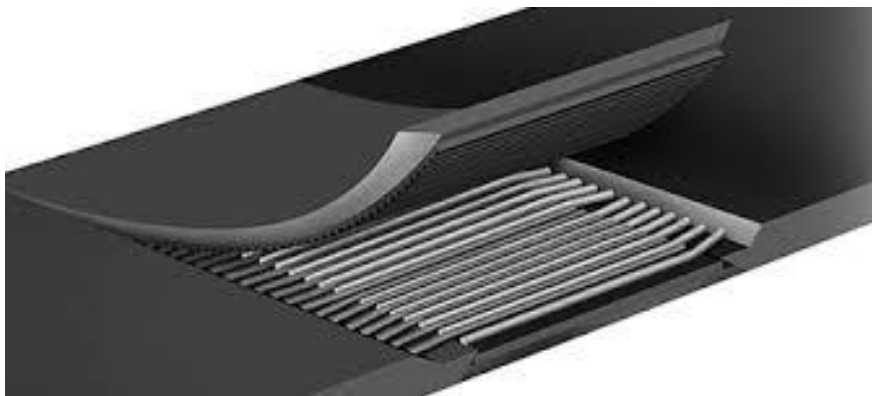
Preformed compound does away with the need for bonder rubber noodles or strips inserted between the cables of a steel cord splice. With the correct preformed bonder rubber, the cords can be laid in the correct position more accurately and faster.

Figure 5. Preformed splicing material.

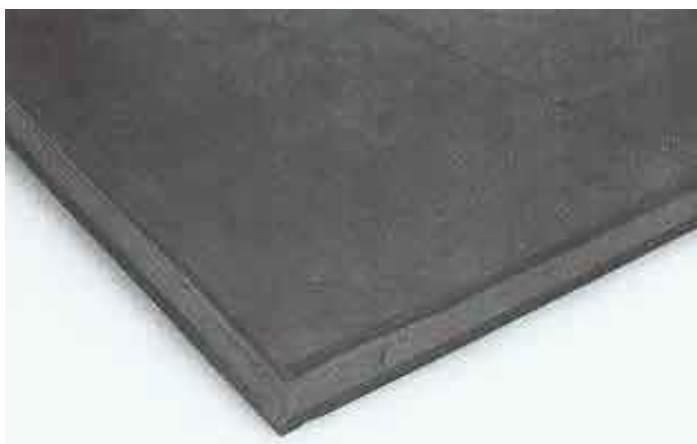
Composite splicing compound is assembled in the factory, similar to belt production. The bonder compound and the top or bottom cover compound is combined to splice specification and delivered to site in kit form. This eliminates the possibility of dust and other contaminant ingress between covers and bonder compound during assembly on site or in the workshop.

Figure 6. Composite steel cord splicing material showing cover and bonder composite.

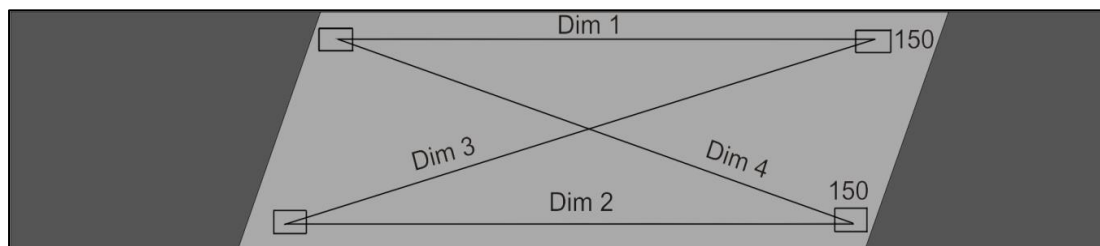
- a. Permanently embossed marks shall be placed on the inside four corners of the splice on the bottom cover (see figure below).
 $\sum^4 \text{dim}$ to remain within 1 % of original value.

Figure 7. Splice measurement matrix as per SANS.

- b. The sum of the dimensions shall not change by more than 1 %. The base line initial measurements shall be made on the low tension return side of the conveyor when the belt is under tension at a recorded datum point and always re-measured at the same datum point and under the same tensioning conditions.
- c. Initial measurement to be done by splicing constructor.
- d. Should the tensioning conditions change, a new set of base line dimensions shall be established.

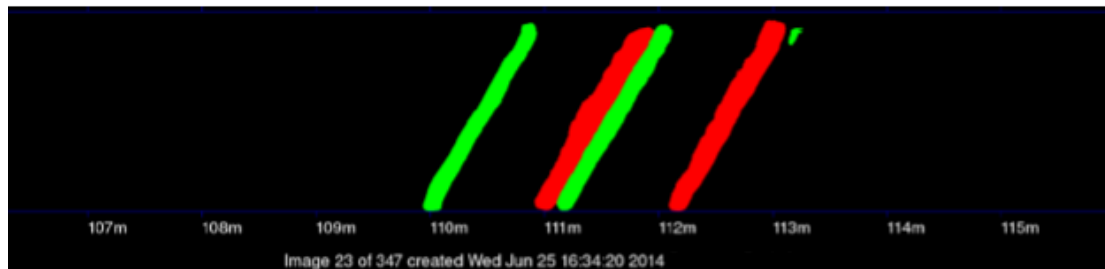
Figure 8. Typical representation of a splice on a steel cord reinforced belt, by means of magnetic flux leakage scan.

In the magnetic flux leakage scan image, the cords are magnetized and any leakage in the magnetic flux is detected by sensors mounted in a sensor array. The image in Figure 8 is of a two-stage splice showing no deformation in the splice alignment or stray and damaged cords in the splice area.

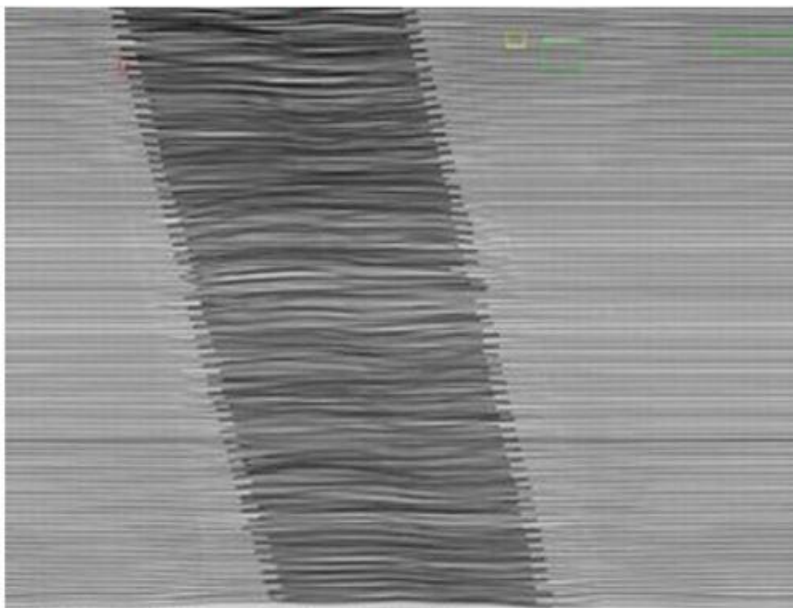
Figure 9. Typical representation of a splice on a steel cord reinforced belt, by means of a X-ray scan.

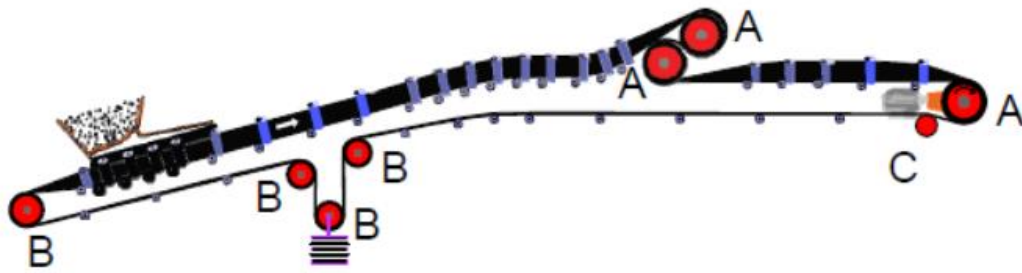
Further research is required on the effect of positive and negative bending of splices, different types of splices, including the effect of the frequency of bends on a splice, for instance at the head and snub pulley, or from a high tension snub pulley into a drive pulley. The specifying of a minimum relaxation distance between two bends in opposite directions should be investigated and documented.

Figure 10. Conveyor system indicating positive and negative bends in short succession at pulleys A-C and at A-A.

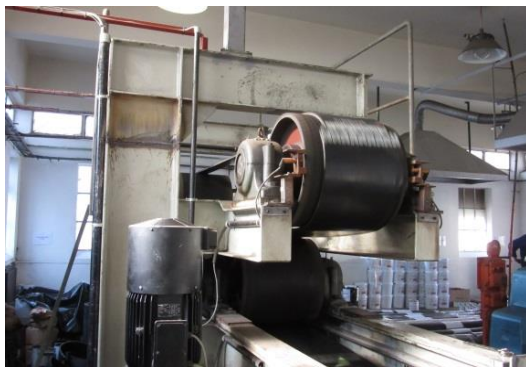
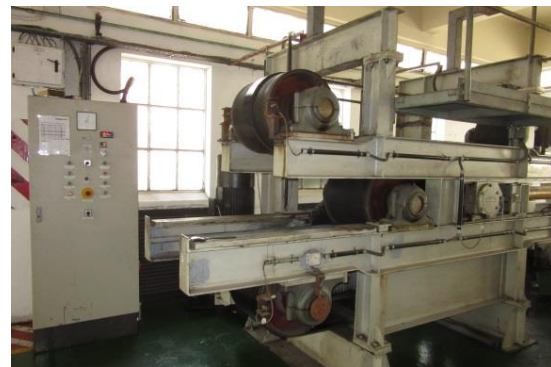
Figure 11. Din dynamic splice testing equipment.

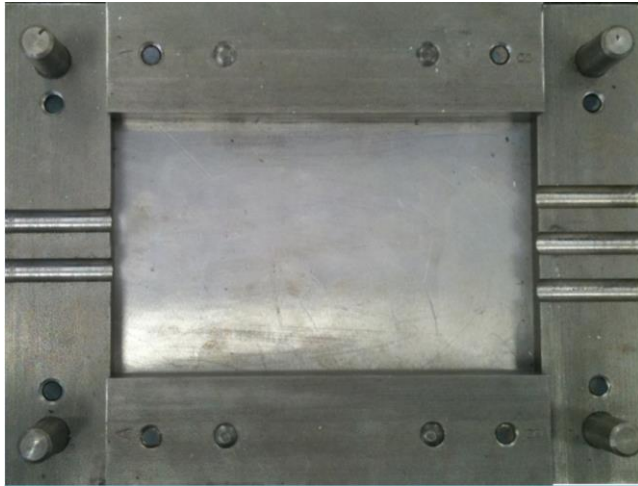
Figure 12. H-block mould.

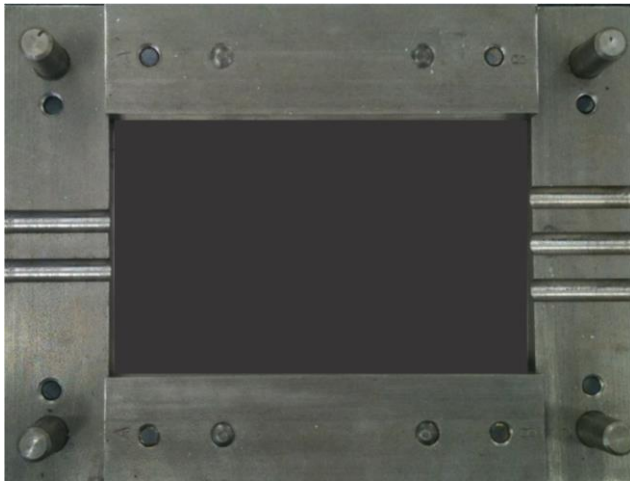
Figure 13. Splicing compound in mould.

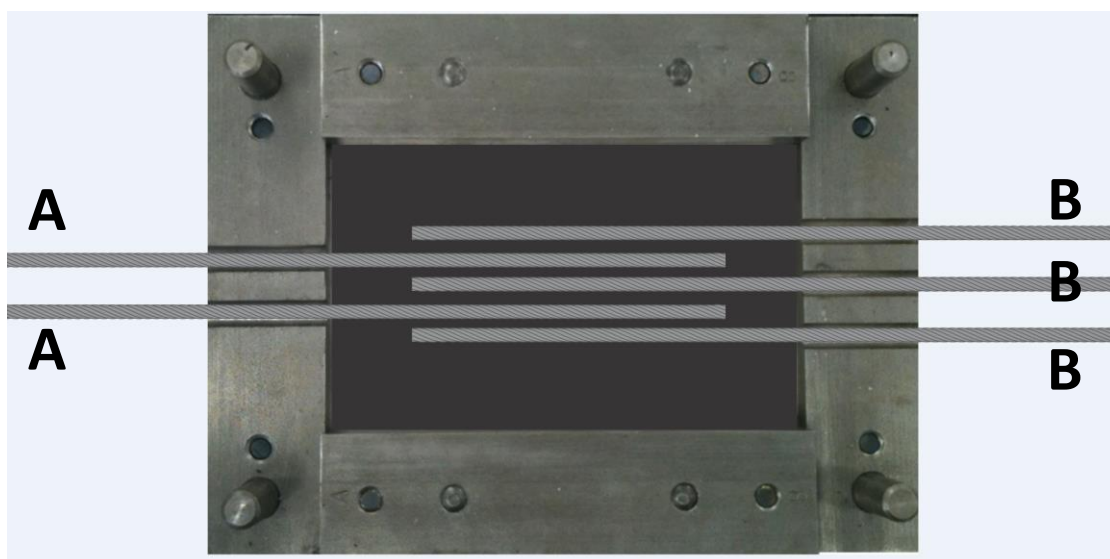
Two H-blocks are constructed by using cords from belt A either side of a cord from belt B. (A,B,A,B,A) and two H-blocks constructed by using cords from belt B on either side of cord from belt A (B,A,B,A,B).

Figure 14. H-block assembly.

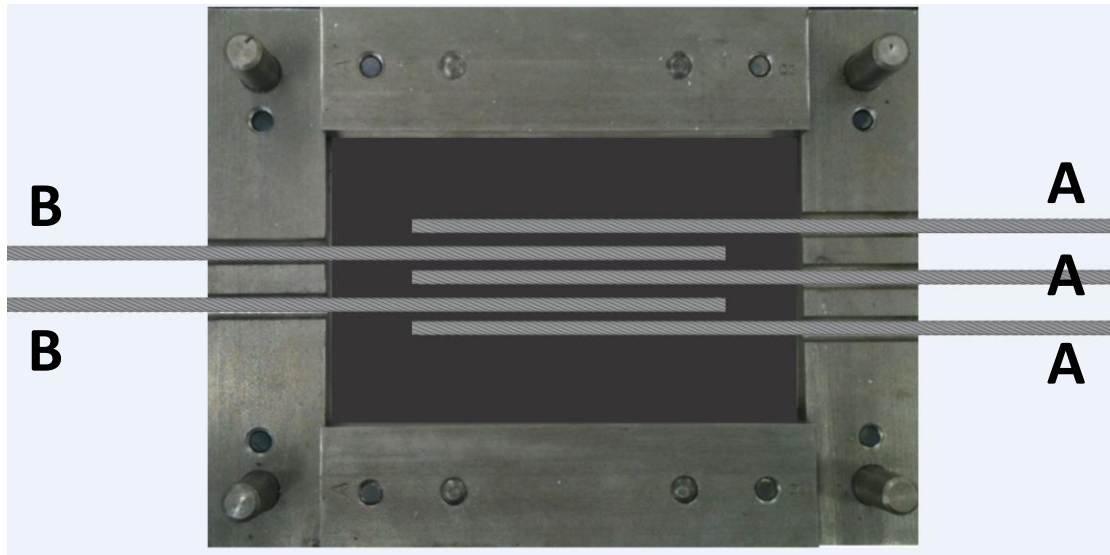
Figure 15. H-block assembly.
