BELT FEEDING SYSTEMS AT RICHARDS BAY COAL TERMINAL

AUTHOR OF PAPER : N.V. STEVENS

RICHARDS BAY COAL TERMINAL COMPANY LIMITED

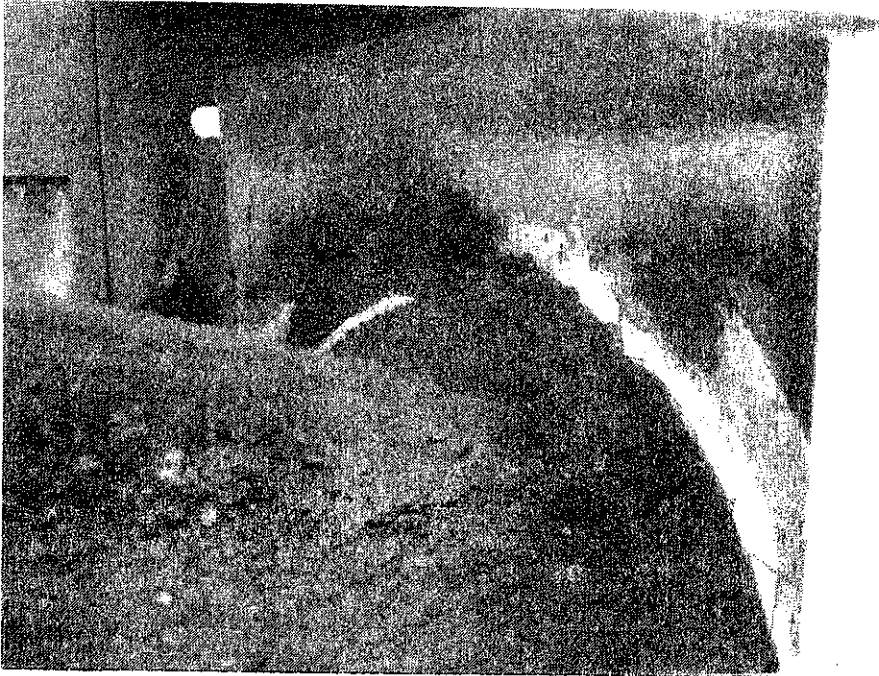
TWO VIEWS OF COAL FLOW ONTO THE BASH PLATE

Note the build up of coal on the bash plate, which tends to remain static while the material flow is uninterrupted.

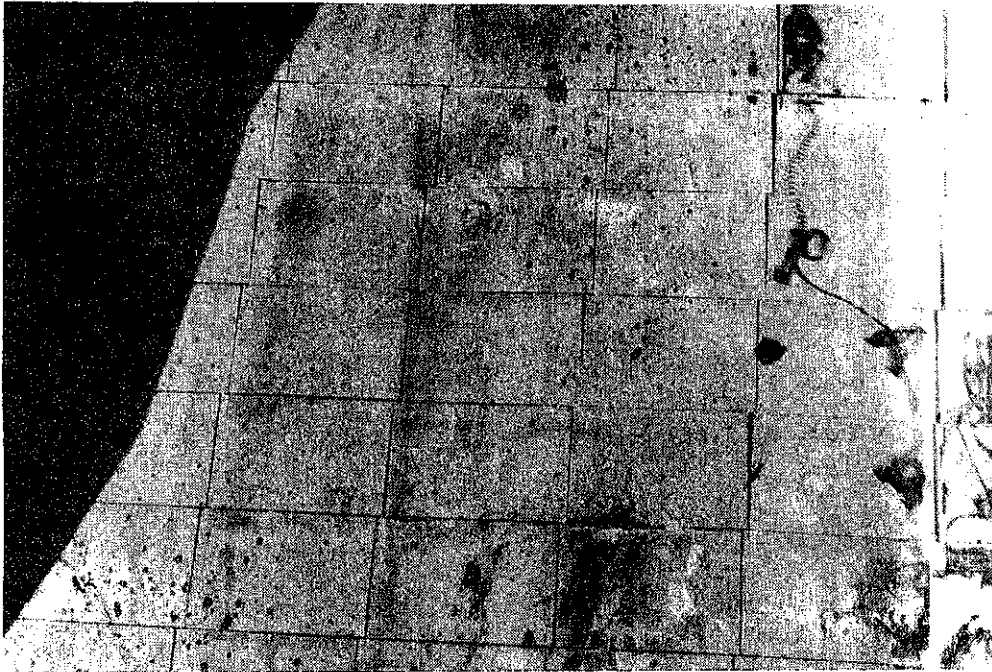
SMALLER (150 X 100 MM) TILES IN THE AREA BELOW THE FLOP GATE

The use of smaller sized tiles other than the standard 228 x 114 mm (9" x 4") size has the effect of reducing the bending stresses and the length of crack propagation.

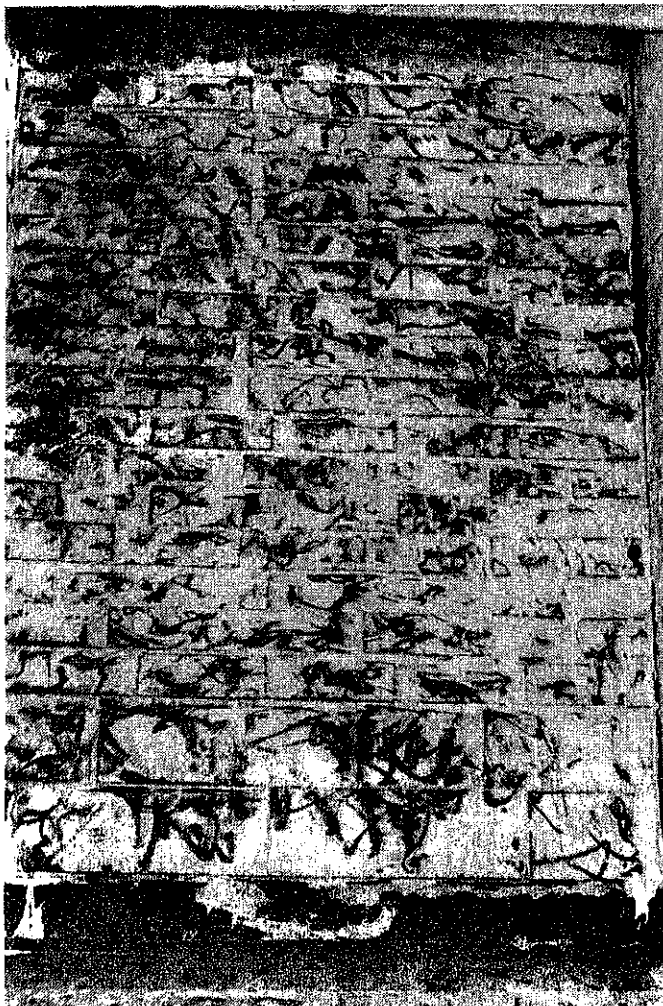
CLOSE UP OF FLOP GATE

Here 150 x 50 mm tiles have been installed, banded at 350 mm intervals with 6 mm flat bar. This is an attempt to avoid tiles "peeling off" due to the high impact and acute angle of attack in this area.

Banding by the use of flat bar to surround the tiled area is being tested together with smaller tiles on the Shiploader trimmer chute flop gate, a particularly strenuous area, where the coal undergoes a free fall of some 13 m before striking the flop gate at an angle of about 30

degrees to its surface. Experience with normal tiles has been that the tile removal starts in the area of highest impact, then continues down to the bottom of the gate. Tiles 150 x 50 mm in size were installed with the short side vertical, and 6 mm flat bar was welded on to the backing plate to band the whole gate. In addition horizontal strips were installed at 350 mm spacings, resulting in compartments 7 tiles high and the width of the flop gate. The trial has only recently been installed, and it is too early to judge the effectiveness of the changes.
