# **FIRE DETECTION AND SUPPRESSION ON UNDERGROUND CONVEYOR BELT INSTALLATIONS**

Brian P. O'Connor

Anglo American Platinum

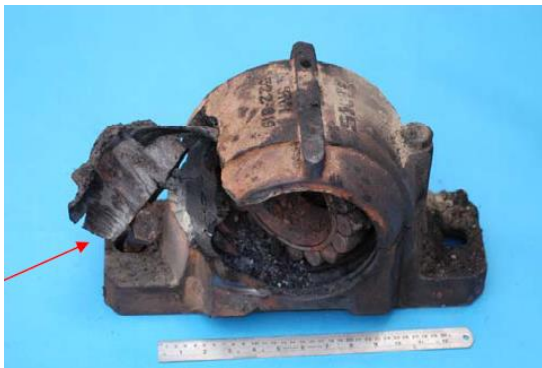
Figure 1. Collapsed bearing

On 20 September 2004, a fire occurred on a conveyor belt installation underground at a platinum mine in the western limb of the Bushveld Complex. Nine people died during the fire despite wearing self-rescuer apparatus and the relative availability of nearby refuge chambers. The cause of the fire was a poorly fitted bearing on the tension pulley that eventually seized due to misalignment. The bearing collapsed as shown in Figure 1 and the friction generated between the pulley shaft shown in Figure 2 and the bearing started the fire. No detection or suppression systems were installed and the entire conveyor belt installation burnt out.

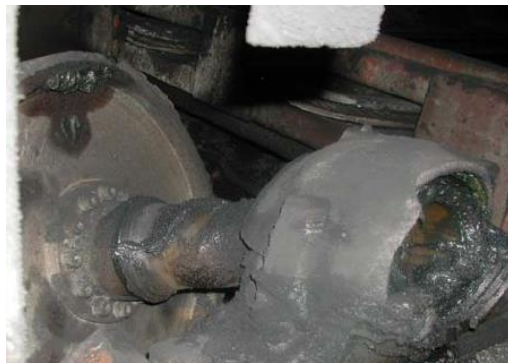
Figure 2. Pulley shaft

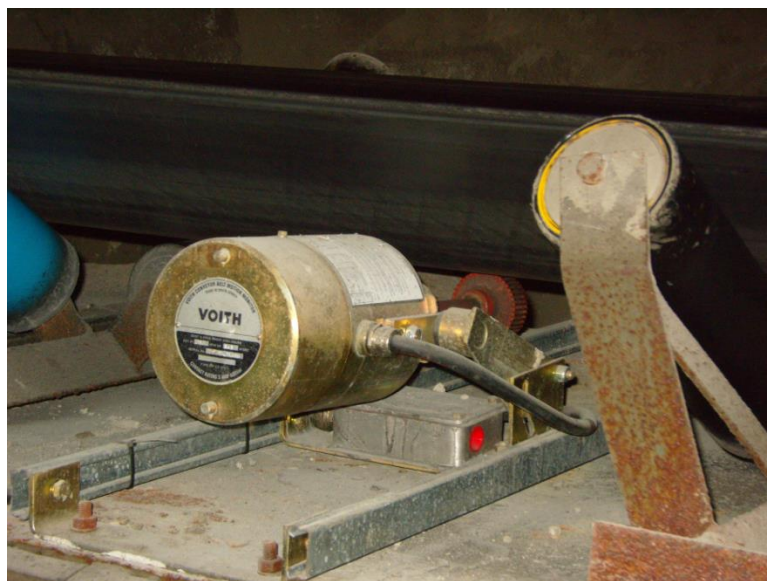
Most belt installations that are between elevations normally have anti-roll-back idlers or other means of arresting a broken belt. This situation is not likely to cause a fire even if the belt runs away. The big danger is a slipping or jammed belt for whatever reason. To monitor slip or jam conditions on conveyor belts, a simple anti-slip tachomotor device is fitted under the belt along the idler section as shown in Figure 3.

Figure 3. Anti-slip device

The anti-slip device is configured such that should the belt speed reduce by more than 20 per cent, the belt trips immediately and an alarm is sounded. The device is programmed in a way that it only takes effect after the belt runs up to full speed and stops functioning when the belt is stopped and runs down.

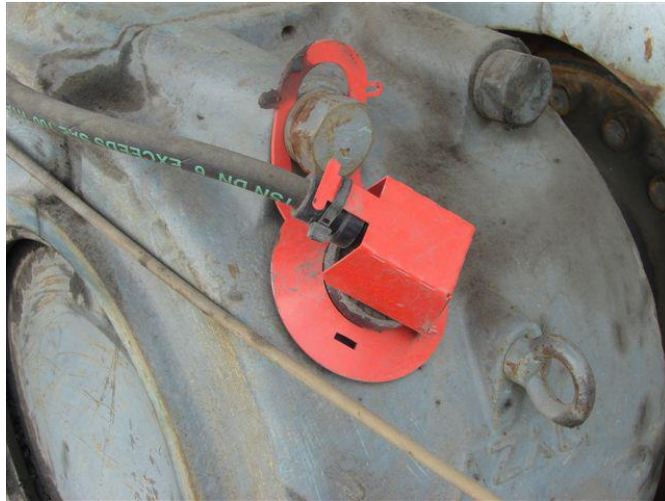
One of the fire detection and suppression companies established that the actual temperature of the bearing can be very closely estimated by measuring the surface temperature of the bearing housing. They developed their own temperature sensing device as shown in Figure 5. This was an analogue two-wire system.

Figure 5. Original bearing temperature sensor

It was estimated that when the surface temperature of a bearing housing is  $68^{\circ}\text{C}$  then the actual bearing temperature is about  $100^{\circ}\text{C}$ <sup>1</sup>. At this temperature the bearing grease liquefies and shortly afterwards the bearing seizes. To prevent this, the temperature sensor is calibrated to give an alarm and stop the belt should the surface temperature reach  $68^{\circ}\text{C}$ . If the temperature reaches the  $90^{\circ}\text{C}$  level, the system activates and initiates the full suppression sprays.

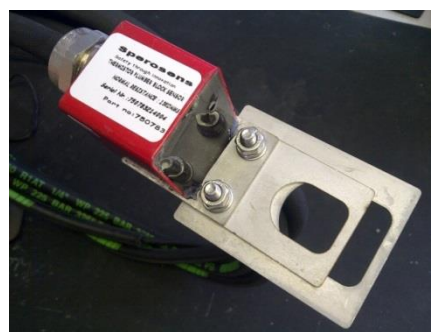
Although the first generation of bearing temperature sensors were reasonably robust, a later model was developed which is fitted between one of the housing bolts and the actual housing as shown in Figure 6 (a) and Figure 6 (b). This is a digital 4 – 20 mA system.

Figure 6 (b). Full view of sensor

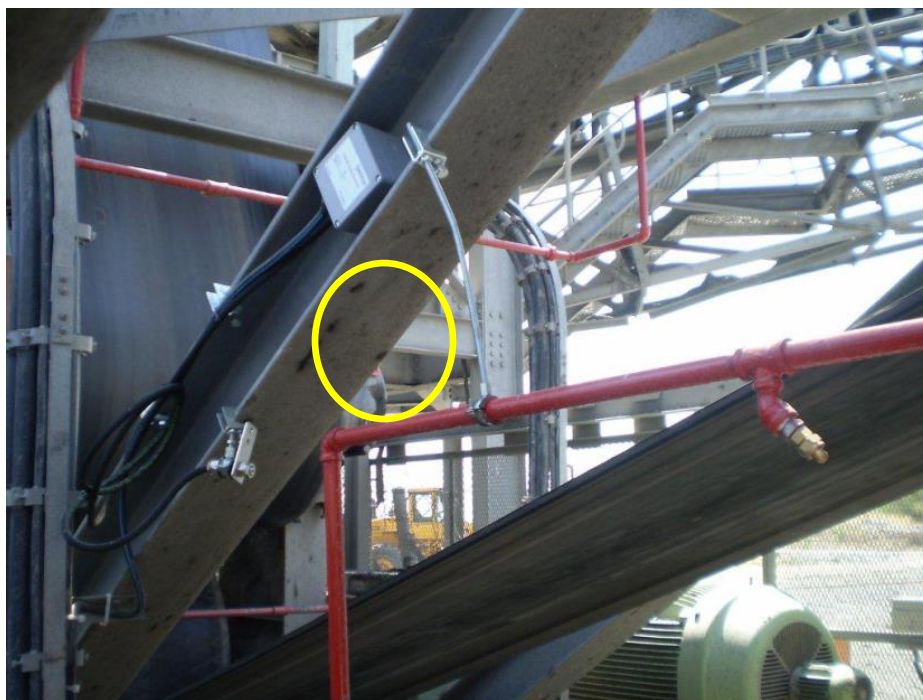
These temperature scanners are available in two different calibrated models – a 2:1 or 10:1 ratio. This means that a 2:1 ratio scanner can monitor a one metre wide surface from a distance of two metres. Similarly the 10:1 ratio scanner can monitor a one metre wide surface from ten metres. These would more than likely be used to monitor furnaces and other similar hot bodies. The conveyor belt fire models used are the 2:1 ratio due to the ability to fit them close to the pulleys. A typical installation is shown in Figure 7.

Figure 7. Temperature scanner mounted on conveyor structure

As for the bearing temperature monitoring, if a temperature of 68°C is measured on the surface of a pulley, the belt is tripped and an alarm sounded. If it measures 90°C, the full suppression system is activated.

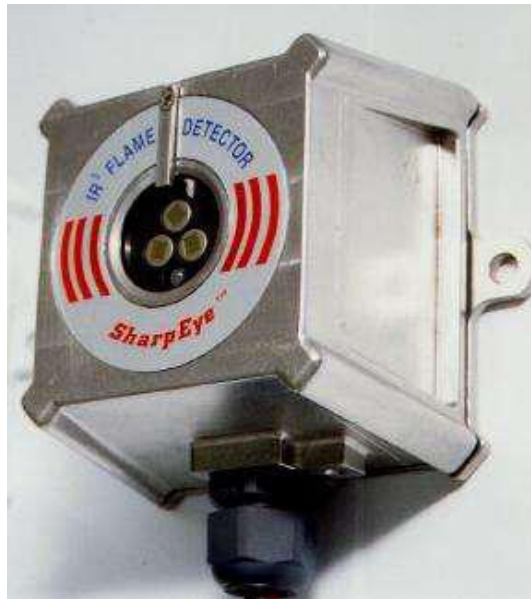
The third and final level of detection is for a flame condition. To detect a flame from a distance requires a special sensing device called a triple infra-red (IR3) sensor as shown in Figure 8.

Figure 8. IR3 flame detecting sensor

These devices are calibrated in that they only sense a flame between certain spectrums. It is configured such that background lighting and passing trackless vehicles will not set it off. Any flame detected by the IR3 immediately activates the suppression system. The sensors have an AUTO/MANUAL switch to enable maintenance personnel to bypass it whilst working in the area especially with cutting torches.

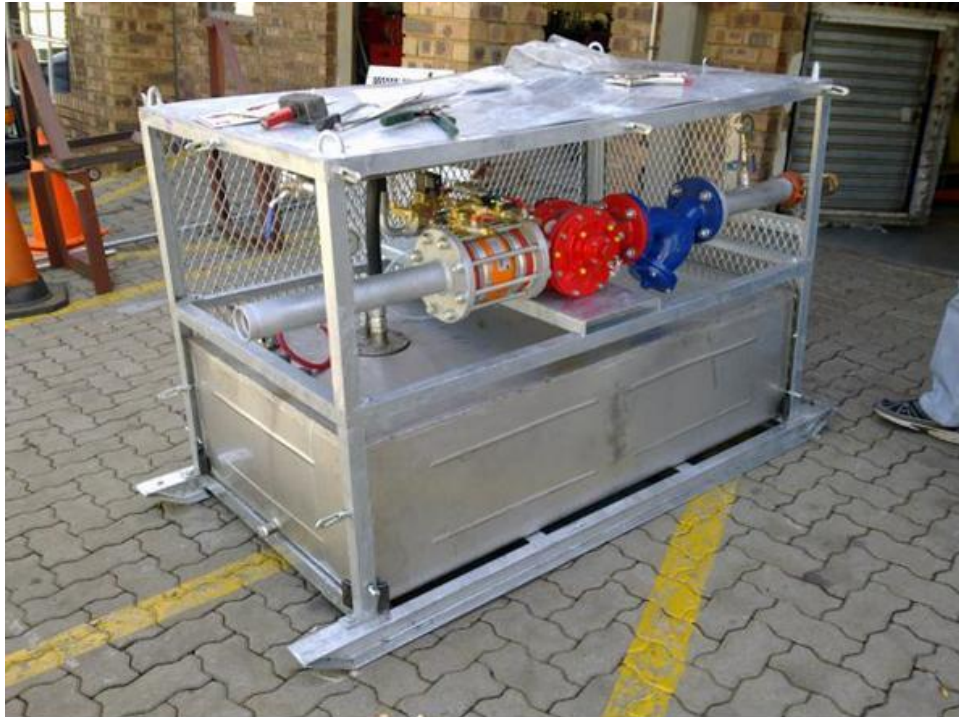
As mentioned previously, there are two options as to the mediums used, either water or foam. In both cases normal mine water supply is used to feed the suppression systems. For the foam systems, a special arrangement is made to dose the mine water with the 1 per cent AFFF as it flows through to the suppression installation. Such an installation is shown in Figure 11 with a special non-electric dosing pump mounted on top to feed the AFFF into the pipeline.

Figure 11. In-line AFFF dosing system in accordance with NFPA 16

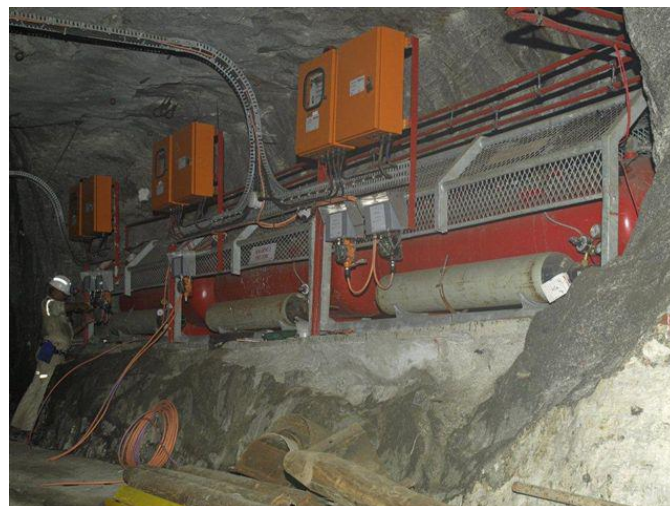
With the foam system, and mainly due to the low volumes required, a special stand-alone containerised system was developed especially for underground mining conveyor belt installations. It consists of a pressurised tank of pre-mixed foam feeding the suppression system. The tank volume is calculated according to the NFPA 16 formula and often more than one tank is required for an installation. The tank is pressurised using a nitrogen cylinder under 1 800 kPa pressure (18 bar). These systems are referred to as Compressed Air Foam systems (CAF). A typical installation underground showing the tanks and cylinders is shown in Figure 12.

Figure 12. A three tank CAF system installed underground

Every mine has the choice as to which system to install depending on their operational circumstances: water availability; pressure; storage volumes available; reliability of pipe networks and the like. The CAF system appears to be the preferred option due to its independence from the mine water supply and its stand-alone nature.

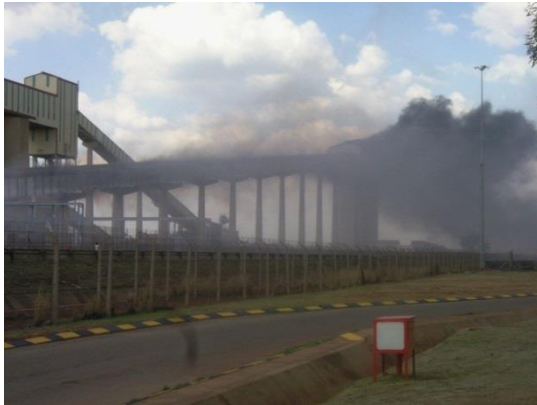
As stated earlier, bearings, pulleys and hot work account for probably 98 per cent of conveyor fires. In this incident on surface, a trackless vehicle was clearing material in close proximity to the drive pulley of a conveyor feeding from the main shaft to the plant silo. The trackless vehicle reversed up against the drive end and was left there, idling for a short period. The heat from the engine was sufficient to burn some dry grass close to the drive and the entire conveyor caught alight. Again, no detection and suppression system had been installed. The extent of the damage caused by the fire is shown in Figures 14 and 15.

Figure 14. Surface view of conveyor fire`

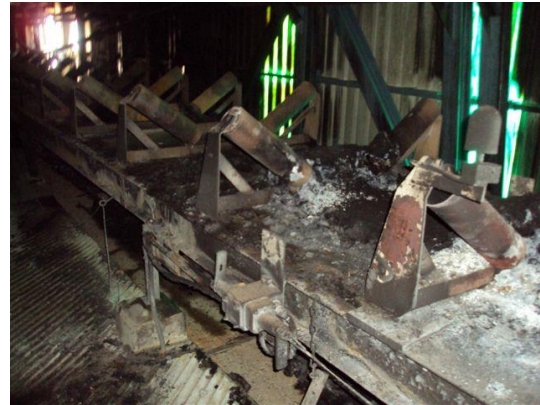
Figure 15. Damaged idler section

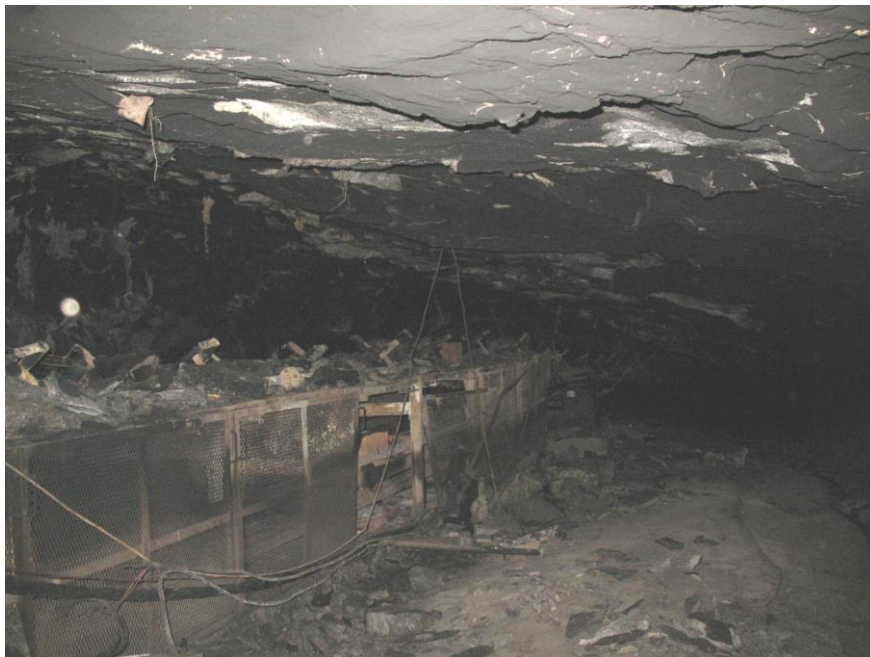
In March 2012, a fire broke out on an underground conveyor at the head pulley at an underground mine in the Rustenburg region. Five people tried with fire extinguishers and hoses to fight the fire but were beaten back. They were sent for medical observation and released shortly afterwards. This highlights the cosmetic nature of fire extinguishers and 25 mm hoses at underground conveyor installations. Figure 16 shows the extent of the damage. The mine personnel had to wait five days before they could re-enter the area due to the heat.

Figure 16. Damaged section of conveyor installation following fire
