SPLICE FAILURES

Ben-Piet Terblanche

Veyance Technologies, Inc.

This paper highlights examples of some splice failures and the possible causes. It covers steel cord, fabric and solid woven splices.

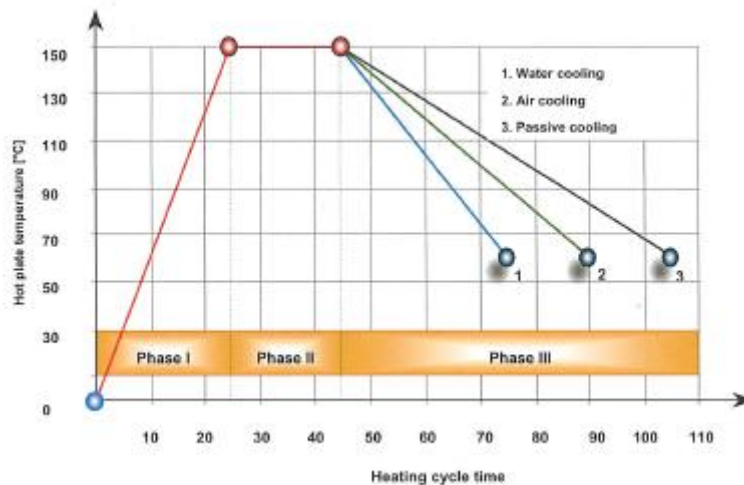
Figure 1. Typical splice cure cycle

1.1 Over-cure or under-cure of compounds resulting from improperly controlled temperature at the platens.

Over-curing occurs when the rubber is exposed to excessive heat. This is caused by either the temperature being too high ($>170^{\circ}\text{C}$) or the cure cycle being too long.

Under-curing occurs when insufficient heat is supplied during the vulcanizing process. This is caused by either the temperature being too low or the cure cycle being too short. Under-curing results in a low cross linking density and poor rubber strength.

Corrective Action: The use of thermocouples is required together with a data logging system.

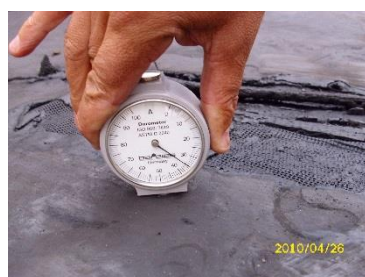
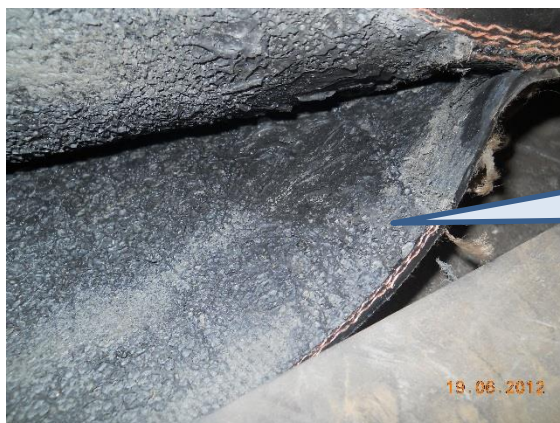
Figure 2. Results of under-curing

35° Shore A
(Spec 65+/-5
Shore A)

Rubber still soft and tacky

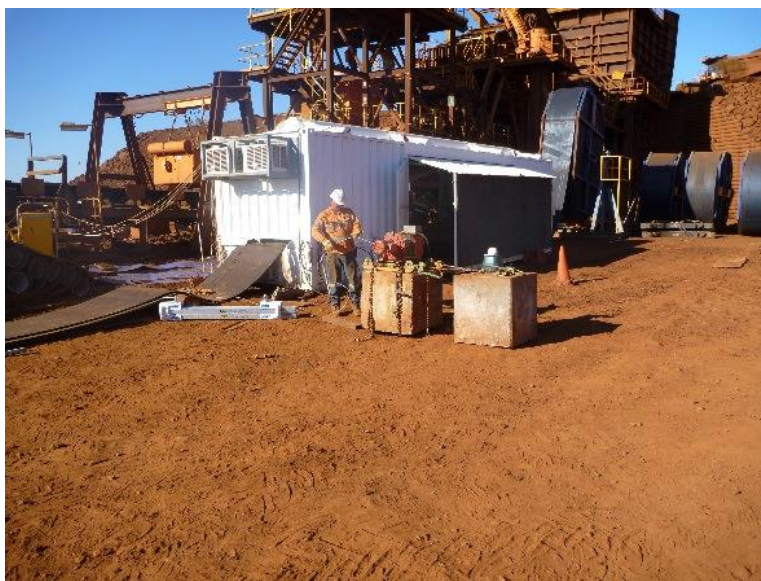
Figure 5. Example of a splicing container with temperature control

Dust and other contaminants decrease the bonding of the rubber to the belt. This also reduces the dynamic fatigue resistance of the splice. The splice area must be kept free of dust.

Corrective Actions: Splice stations need to be assembled over the splice area. Splice stations could be a building, container or even a tent.

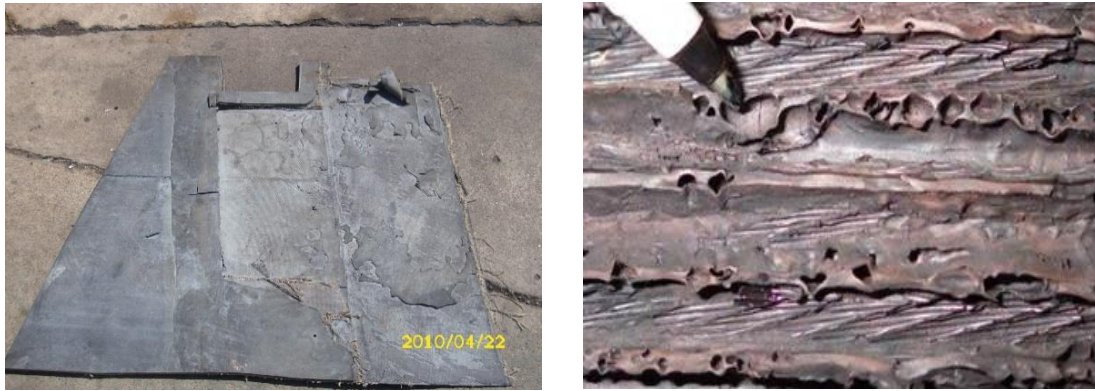
Figure 8. Result of insufficient pressure

Insufficient pressure is generally caused by one of the following factors:

- i. Vulcanizing press malfunction resulting in no or low pressure.
- ii. Use of edge bars that are too thick. The pressure is then applied to the edge bars and not the splice area.
- iii. Under-filling of the bridge sections.

Corrective Actions: Always use the correct edge bar thickness. Generally 1,5 mm less than the belt thickness. ALWAYS use the correct curing pressure. Steel cord 200 Psi and fabric 100 Psi.

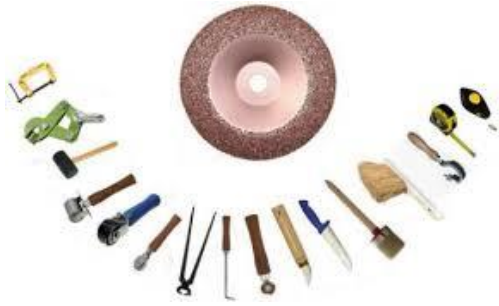
Figure 9. A range of splicing tools

The tools used during splicing are specially designed for the job required. The use of incorrect tools is a major contributor to failed splices and injuries during splicing.

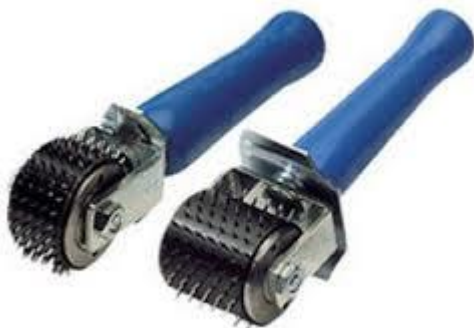
Figure 12. Sticker rollers

These are used to ensure all the air is removed from the splice.

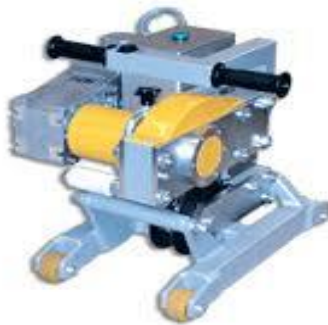
Figure 14. Steel cord belt cutter

There are now mechanized cutters available to reduce the use of Stanley blades. These cutters are safer, faster and more precise.

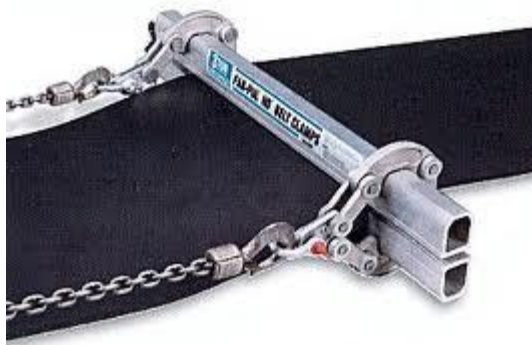
Figure 16. Belt clamp

During splicing, the belt must be clamped to prevent belt slip. The use of square tubing in place of belt clamps is not recommended.
