CONDITION MONITORING OF FABRIC-REINFORCED CONVEYOR BELTING USING DIGITAL X-RAY IMAGING

JH Fourie¹, MJ Alport², JF Basson², T Padayachee²

¹ Eskom Holdings (Pty) Ltd, ² Advanced Imaging Technologies (Pty) Ltd

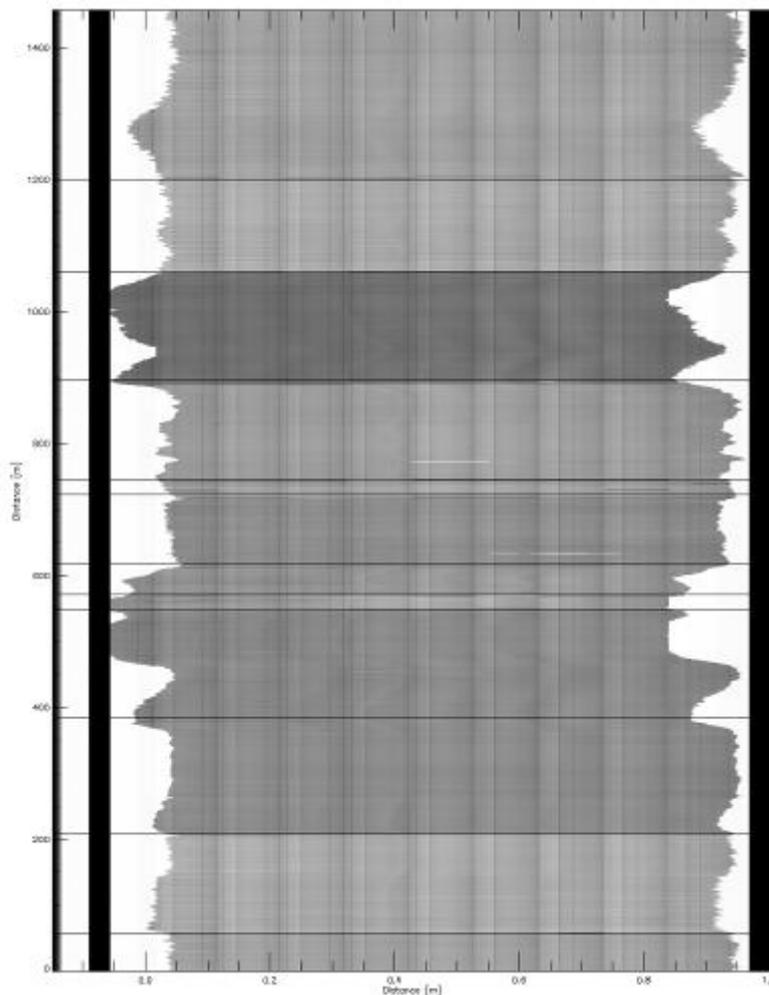
Figure 2 shows a compressed X-ray image of the full belt which is oriented vertically. The thin horizontal lines correspond to the location of the splices. The irregular tracking of the edges of the belt is accentuated by the compressed format of this belt image. However, it can be seen that often the presence of a splice produces a sudden transverse motion of the belt. Changes in belt compound can be seen as changes in the grey-level intensity between splices.

Figure 2: Full belt keogram. The splices are indicated by the black horizontal lines. The three dark wide vertical bands correspond to the steel beams on the conveyor belt support structure.

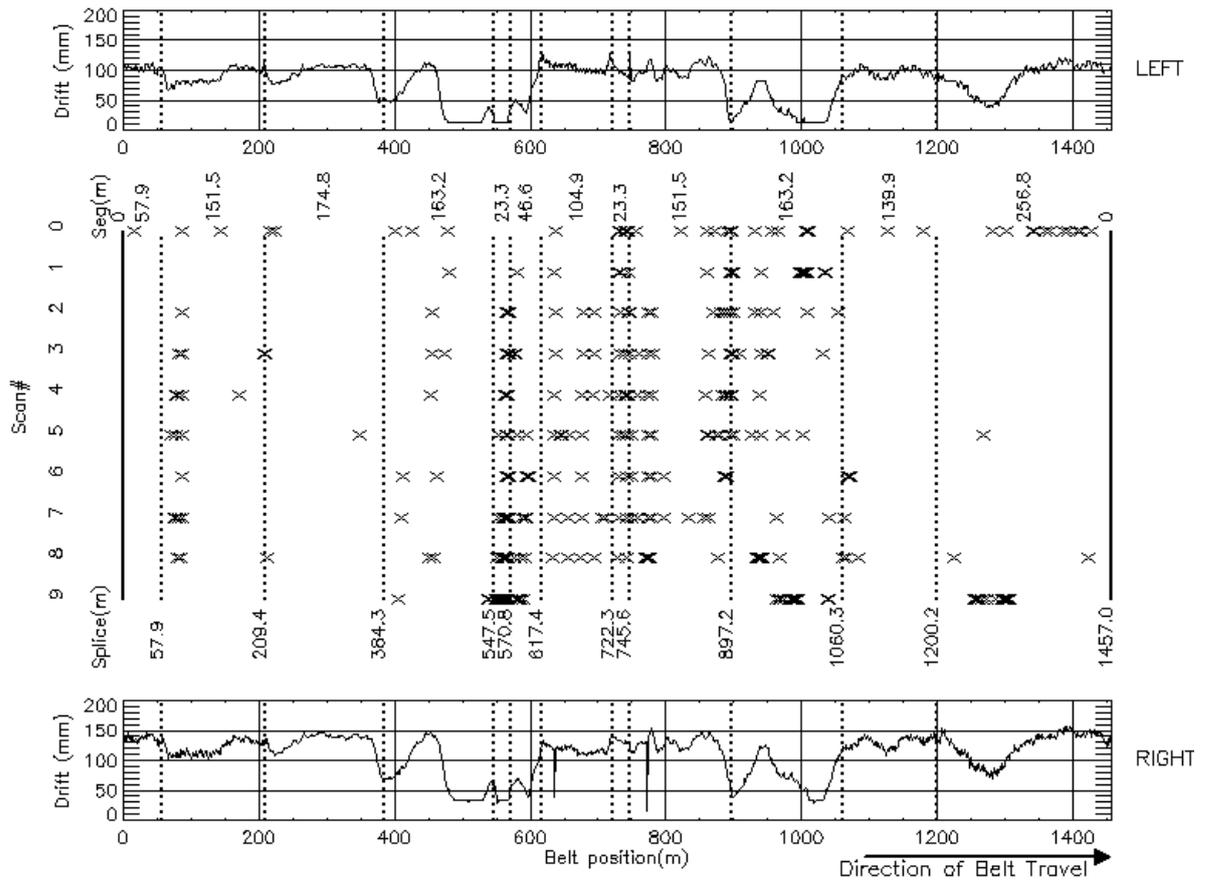
The results of the survey analysis can be represented in various table formats containing the positions of the splices and damages together with their images. However, it has also been found useful to represent the results in the form of a schematic as shown in **Figure 3**. The top and bottom panels show the belt edge tracking signature obtained directly from the X-ray data. The central region shows the longitudinal position of the detected splices and the damages relative to a reference splice.

Figure 3: An example belt schematic after analysis. The left and right hand side edge tracking signatures are shown in the panels at the top and bottom, respectively. The central region shows the longitudinal positions of the splices (vertical dashed lines) and the positions of the damages (crosses).

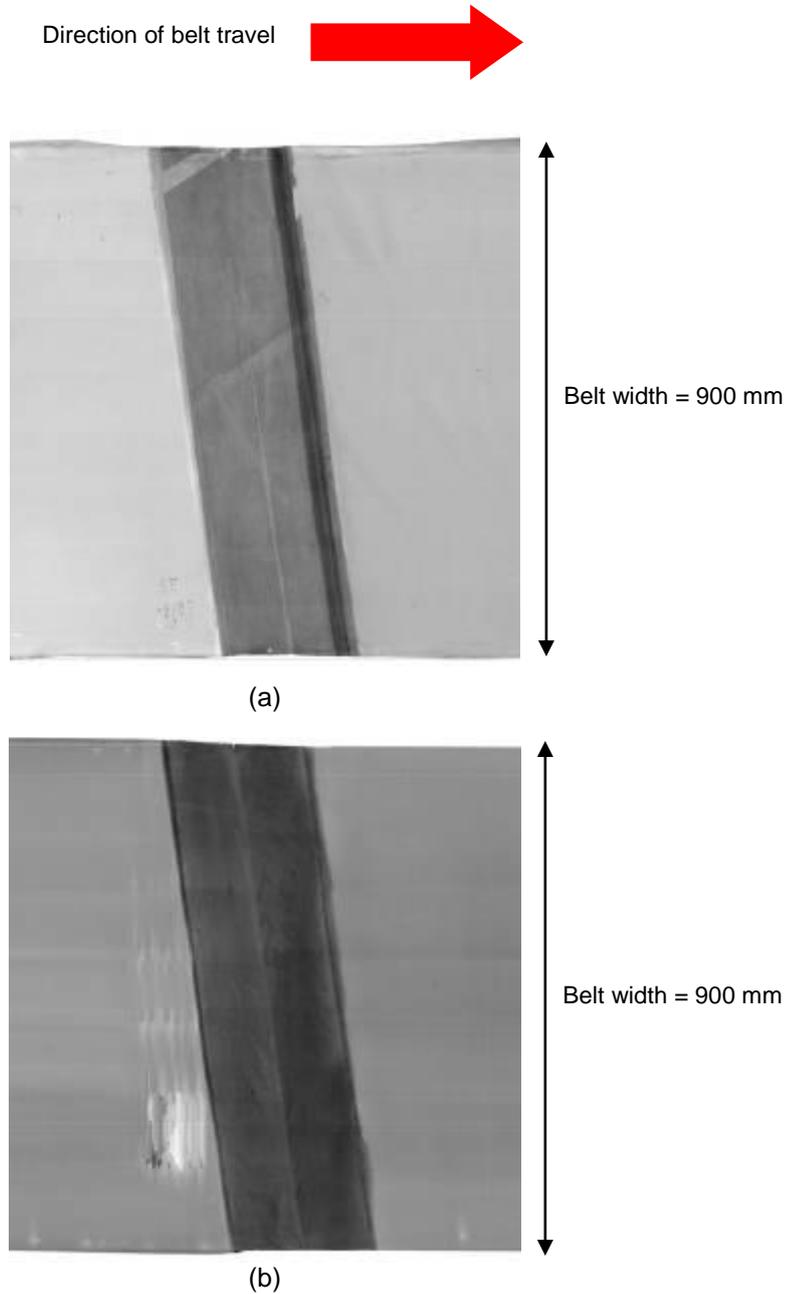
Typical X-ray images of splices are shown below in **Figure 4**. The splices are indicated by the darkened regions extending across the belt width (from the top to the bottom of the image).

Figure 4: Examples of X-ray images of splices.
