# **TECHNICAL EVALUATION OF THE MAJUBA POWER STATION 10 000 TONNE COAL SILO 20 FAILURE MECHANISMS/FACTORS**

A.P.Wiid and B.Marrai

Eskom

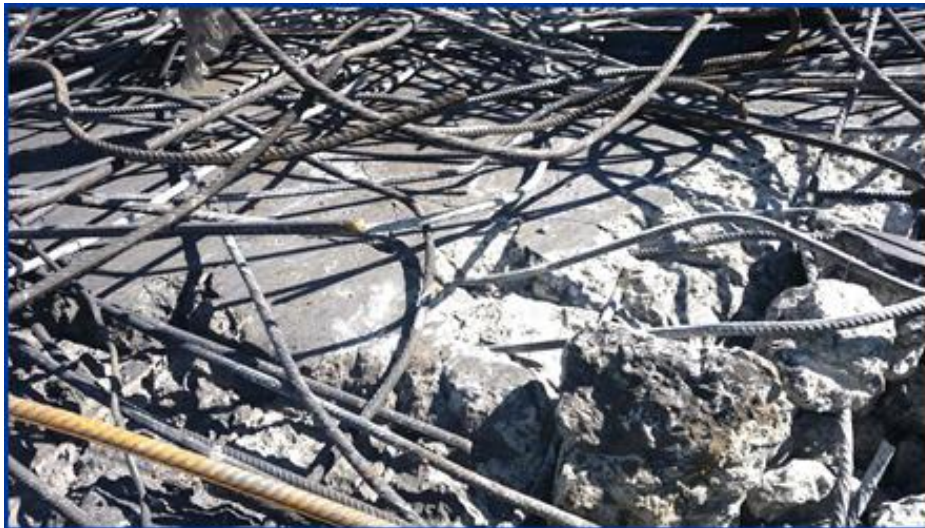
Figure 7. Concrete wall sections and reinforcement steel.

The test performed confirmed that the steel reinforcement was indeed 450 MPa high tensile steel and the concrete strength exceeded 30 MPa. By inspecting the reinforcement closely, it showed the classical neck fracture typical of a tensile failure.

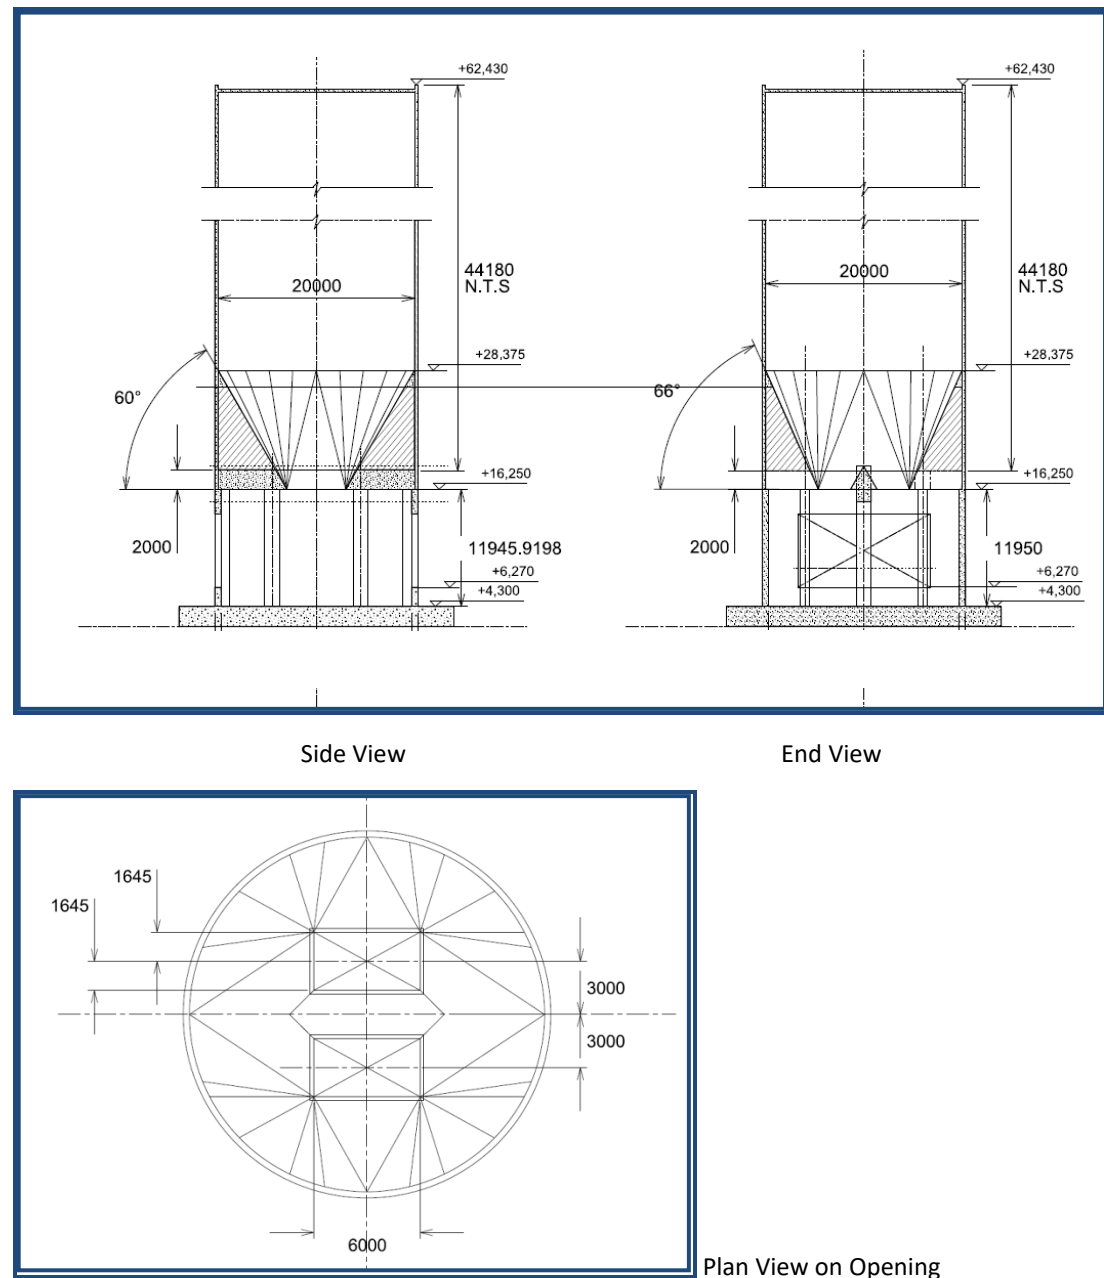
Figure 11. General arrangement of the 10 000 tonne silos.

Figure 11 shows the general arrangement of the existing silos. The cylinder wall thickness is 350 mm and the inner surface of the cylinder has a smooth concrete

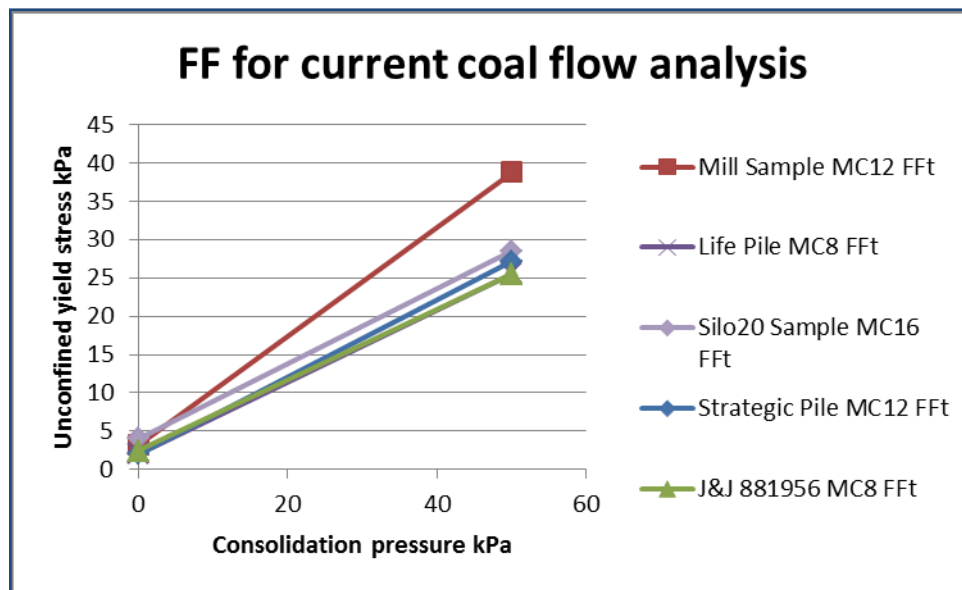
Figure 13. Comparison of the flow functions of coal property analysis information for the current coal in comparison to the original coal.

The analysis for the current coal shows that the properties of the coal are characterised by its cohesive nature and as such it presents a strong cohesive or sticky coal characteristic.

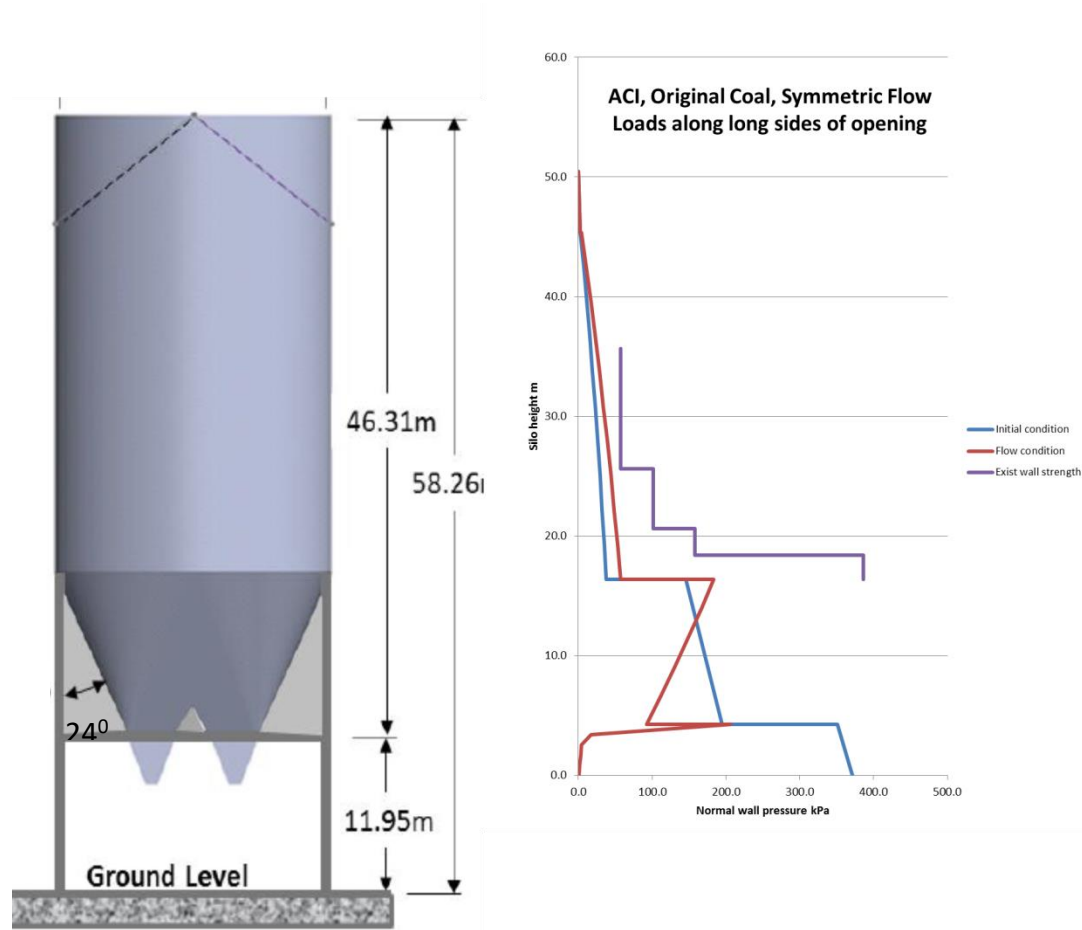
Figure 19. Wall load for the original coal base on the ACI 313 standard.

Figure 19 shows that the amount of reinforcement provided in accordance with the ACI 313-91 is more than sufficient.

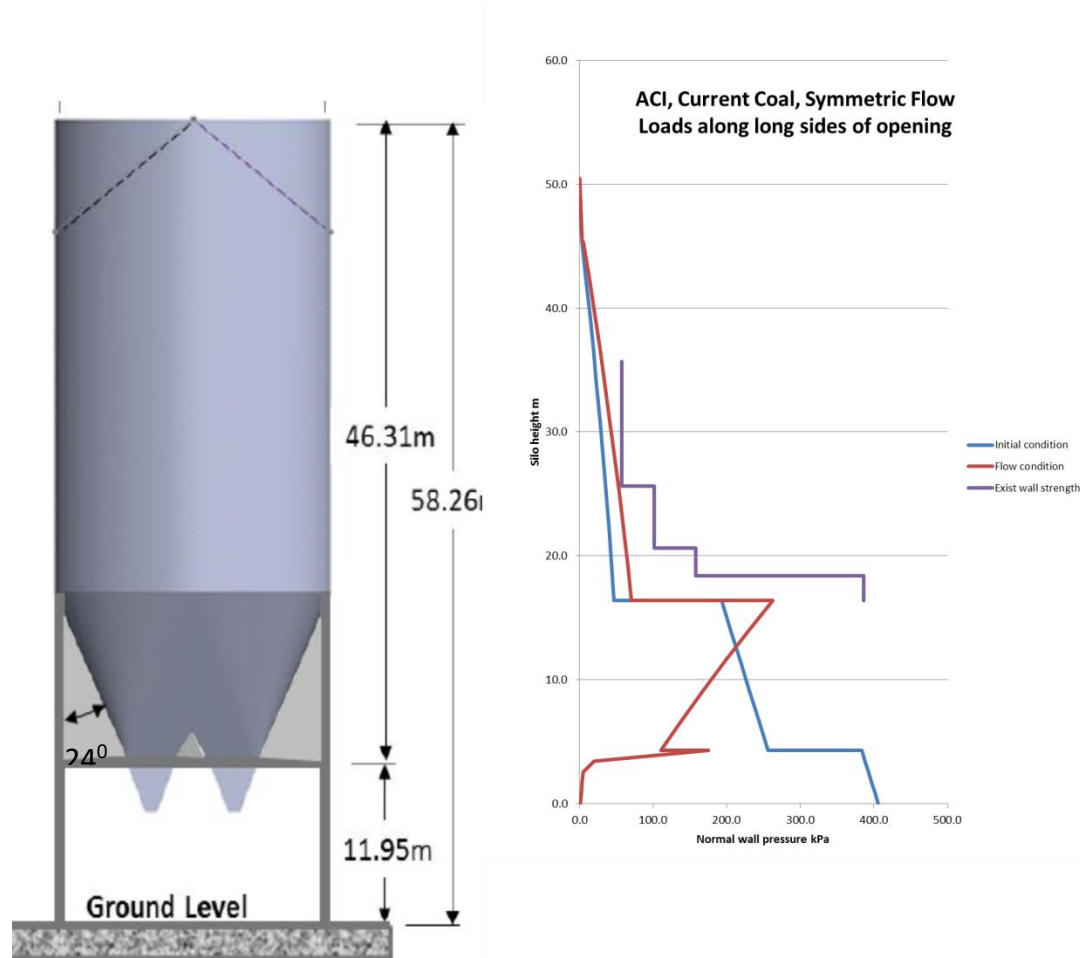
Figure 20. Wall load for the current coal based on the ACI 313-91 standard.

Figure 20 shows that the amount of reinforcement provided for the current coal adopting ACI 313-91 is still within the standard requirement.

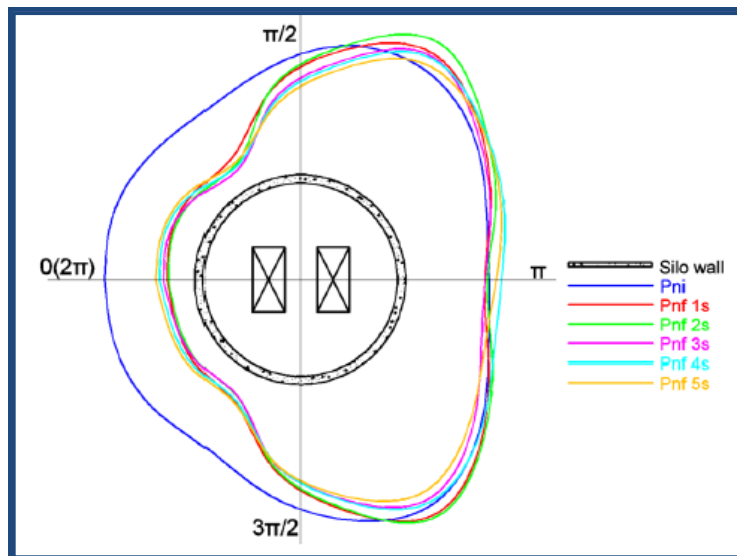
Figure 26. Wall load above the transition for eccentric discharge while filling coal at the same time.

The eccentric discharge from the silo by means of operating only one of the two feeders generates high eccentric wall loads that in turn results in complex bending stresses along the circumference of the silo at various levels on the silo vertical wall. This would cause the vertical crack development in the walls.

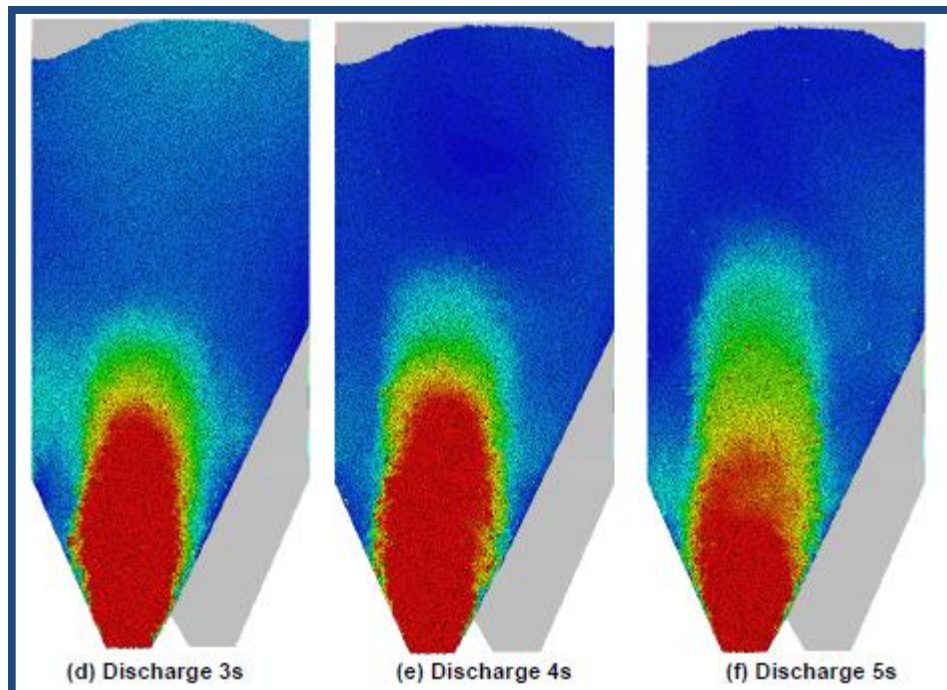
Figure 27. FEM (finite element modelling) presentation of simultaneous filling and discharge under eccentric condition.

The FEM confirms that as a result of the presence of coal build-ups on the hopper short ends, due to the hopper larger half angle, the development of a switch pressure at the convergence of the coal build-up and the vertical wall where the active pressure in the coal changes to passive pressure.

The complex stresses in the wall caused by these loads result in vertical and the horizontal bending moment for which the silo was not designed, causing vertical and horizontal cracks in the wall.

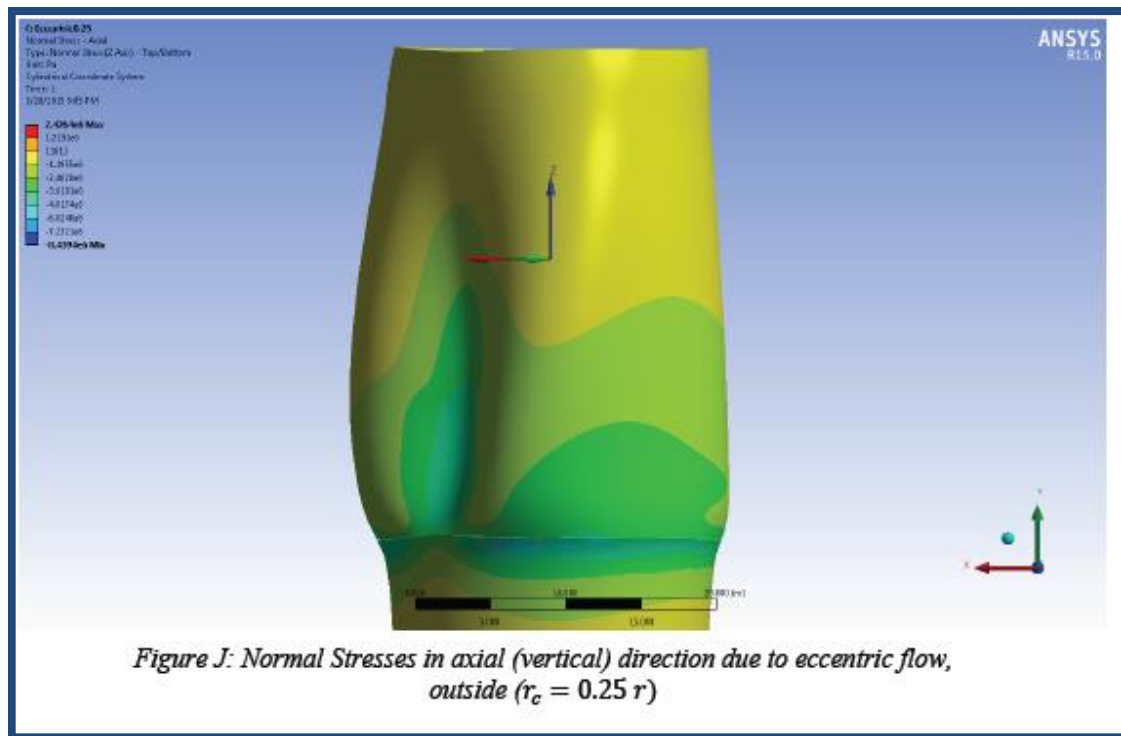
Figure 31. Extract from the Jenike and Johanson investigation.

The calculated maximum vertical compression stress of 6.4 MPa at the bottom of the cylinder (Figure 31) is well below the allowable compressive stress (11.547 MPa); therefore, it meets the requirement of BS EN 1991-4:2006. Given these results, one can conclude that compression is not the governing case in this eccentric load analysis.

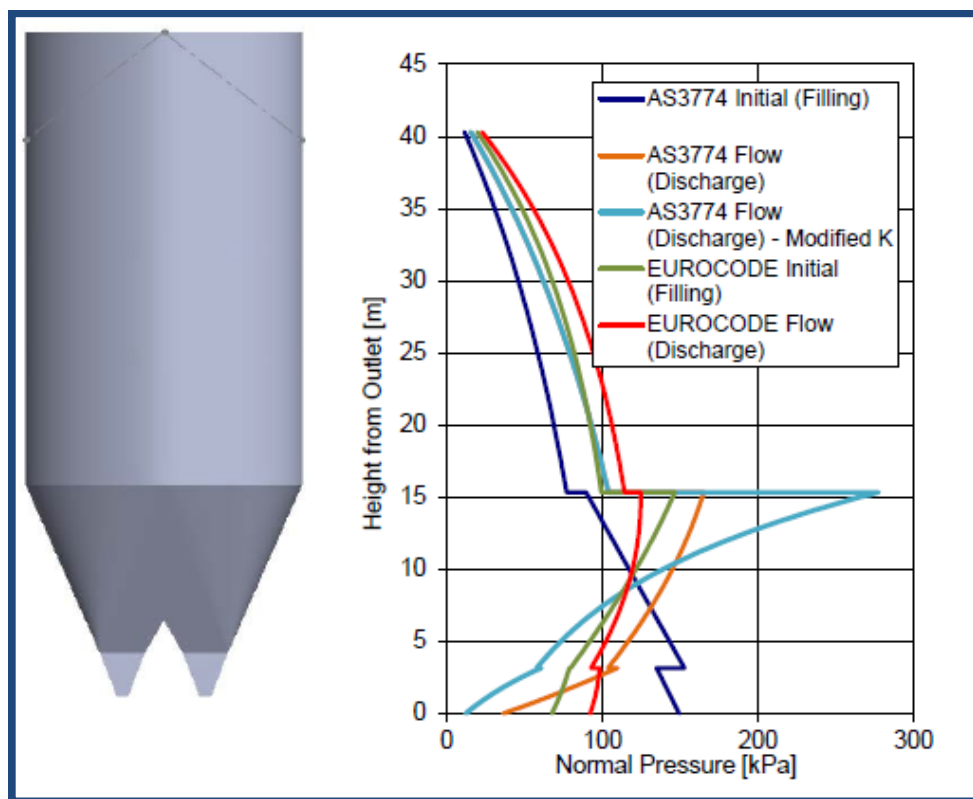
Figure 32. Comparison of the derived wall loads along the long side of the hopper opening for symmetric flow condition.

For the calculation of symmetric wall loads (Figure 32) the Eurocode yields greater wall loads than the Australian standard. The reason for this is that the Eurocode presents a more conservative  $K$  value than the Australian code.

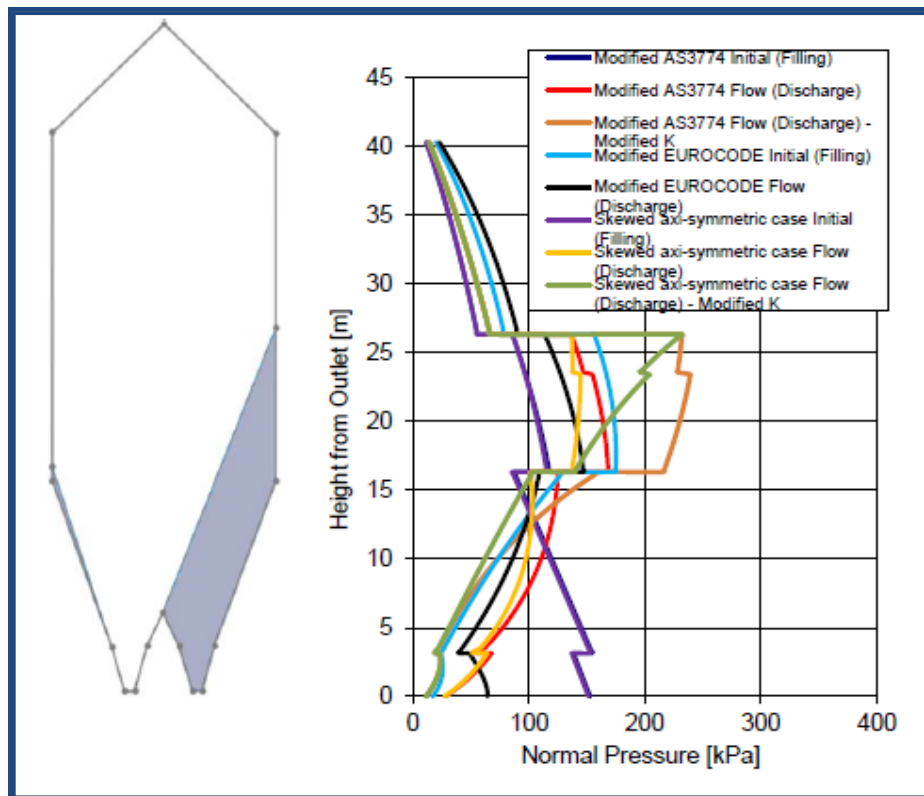
Figure 33. Comparison of the derived wall loads along the long side of the hopper opening for eccentric flow condition at the far side to the opening under operation.

In the case of the eccentric discharge with the coal build-up as presented in Figure 33, the modified Australian code presents the greater wall loads.
