IMPROVEMENTS IN CONVEYOR AVAILABILITY - DOUGLAS COLLIERY OVERLAND SYSTEM

**HENDRIK PIETERSE, PLANT ENGINEER,
DOUGLAS COLLIERY, VANDYKSDRIFT.**

**JIM PIERCE, VICE PRESIDENT,
BELTSCAN, INC**

**PAPER PRESENTED AT BELTCON 8
SOUTH AFRICA
OCTOBER 1995**

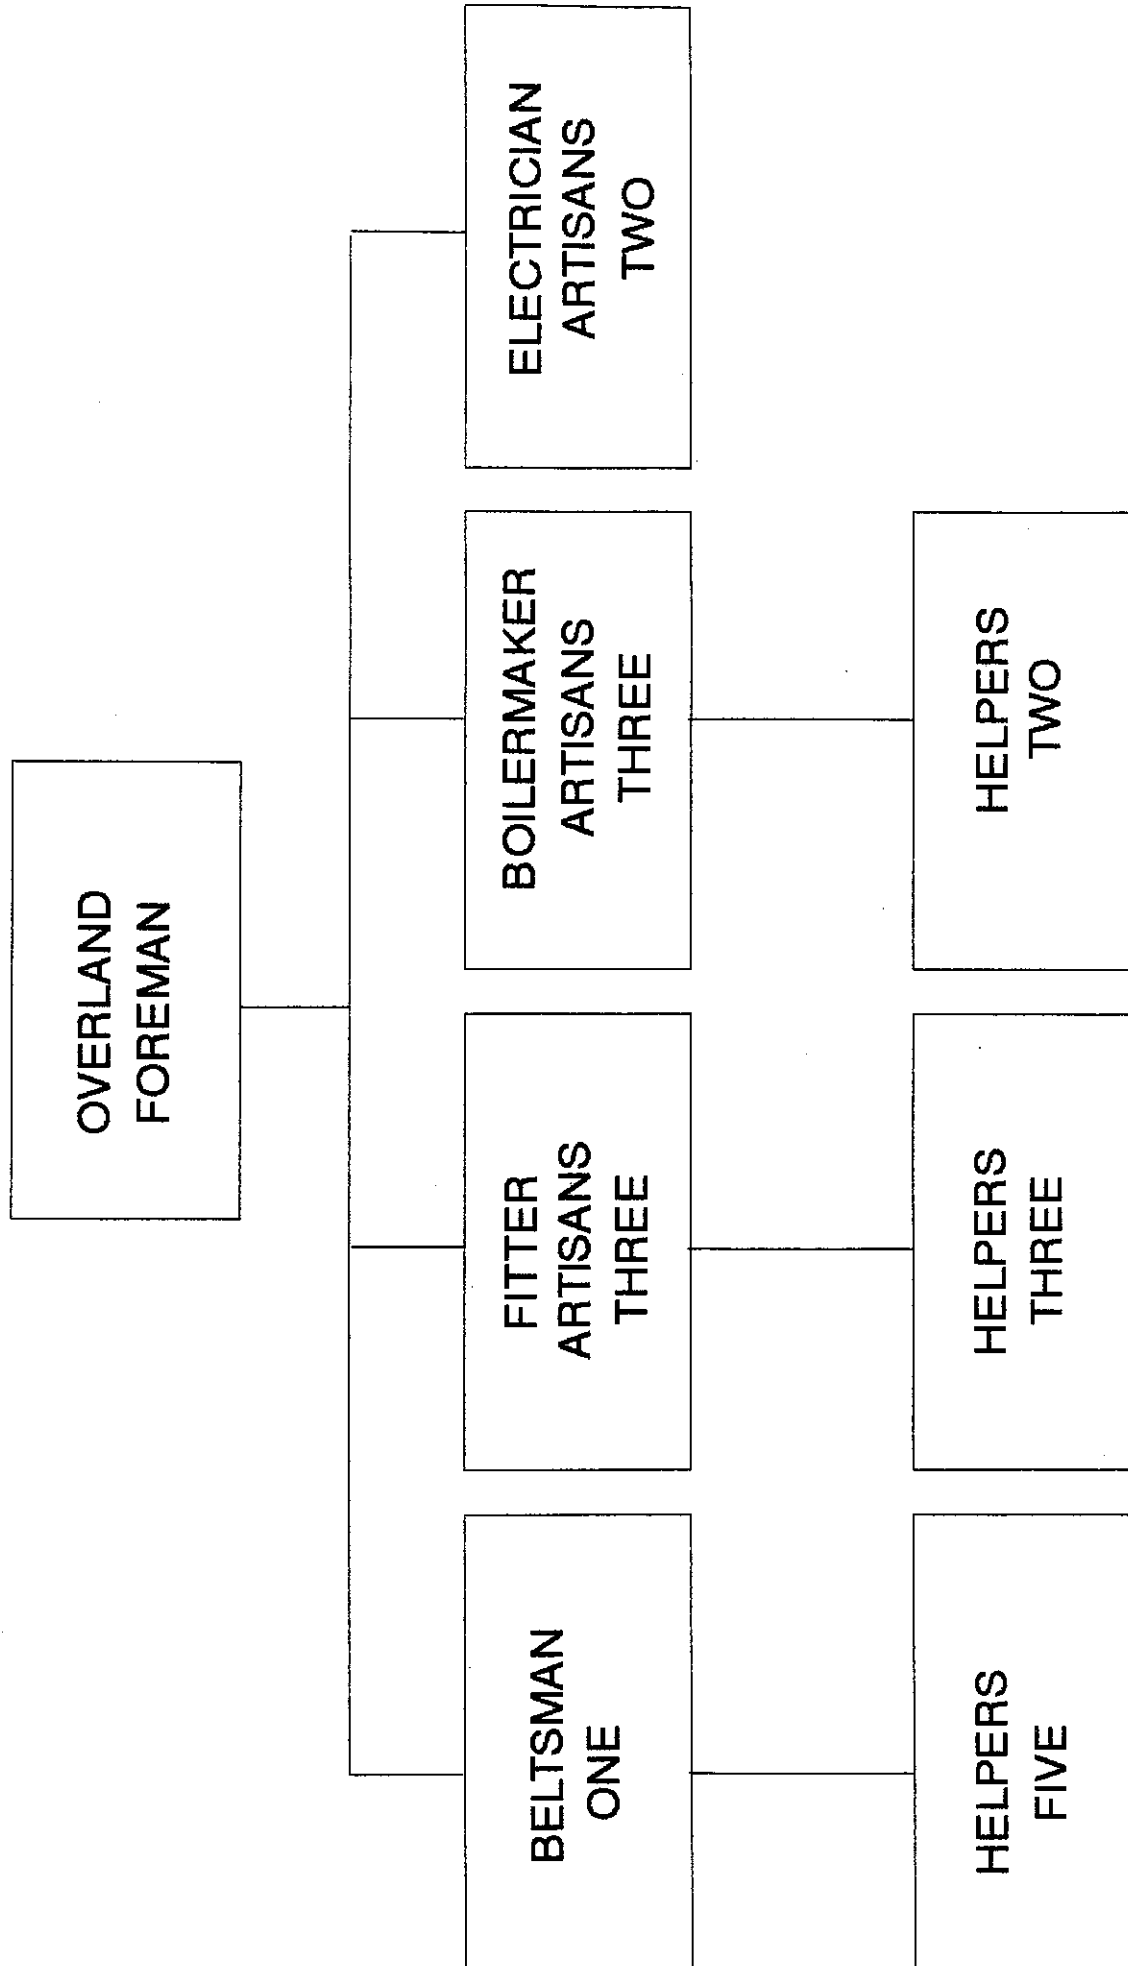
FIGURE 2

Artisans and helpers were allocated to the PSS plant and only when a breakdown / repairs were required then someone from the plant was sent to attend to it.
