# **THE NAMAKWA SANDS DUAL CARRY CONVEYOR (DCC)**

## **WHAT WE HAVE LEARNED FROM 13 YEARS OF OPERATION**

Graham Spriggs

LSL Tekpro

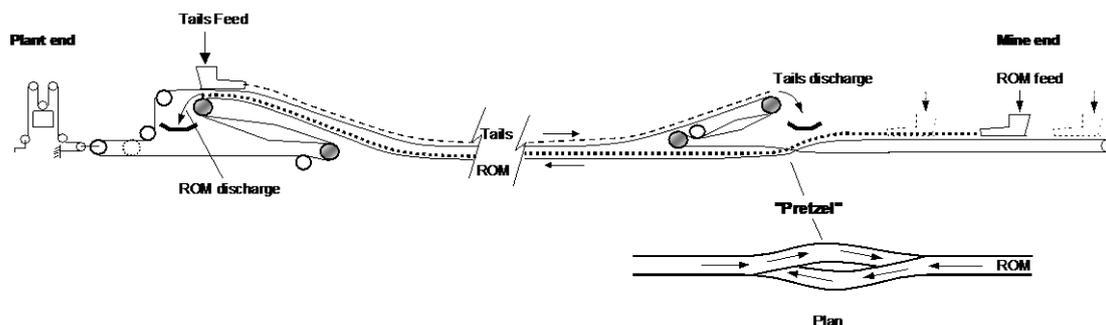
Figure 1. Both tails and ROM loaded

Initially, both the tails as well as the ROM had to be loaded onto the upper strands of the conveyor, as follows:

The tails are loaded at a fixed point at the plant end, whereas the ROM was initially loaded via a shiftable conveyor anywhere along the tail of the DCC.

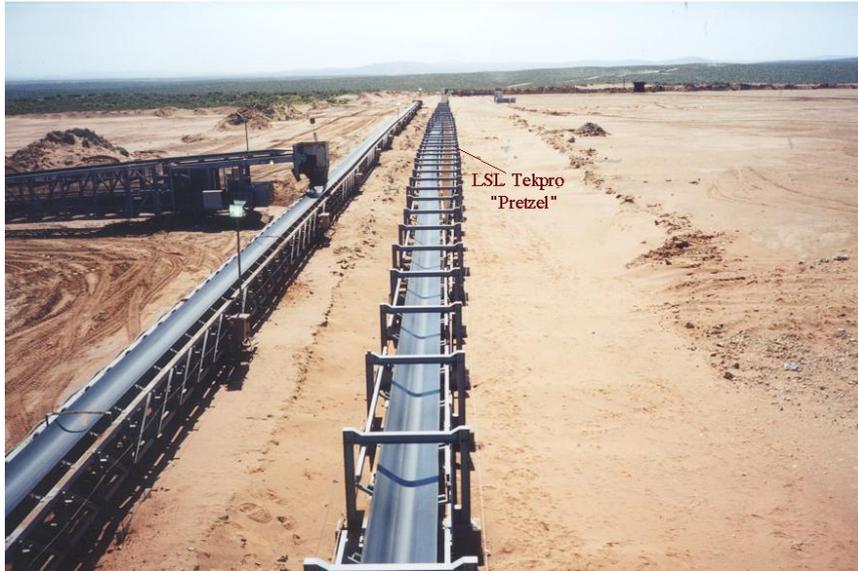
Figure 2. The Pretzel

For the above reasons, during the first years of operation, the DCC was fitted with the unique 'Pretzel' belt swop-around system, which performed very well.

The operation of the Pretzel was a total success, and worked perfectly from the very first press of the start button. This being despite being subjected to high belt tensions brought about by the mine-end C drive being lame during starting. This is discussed in the VSD section below.

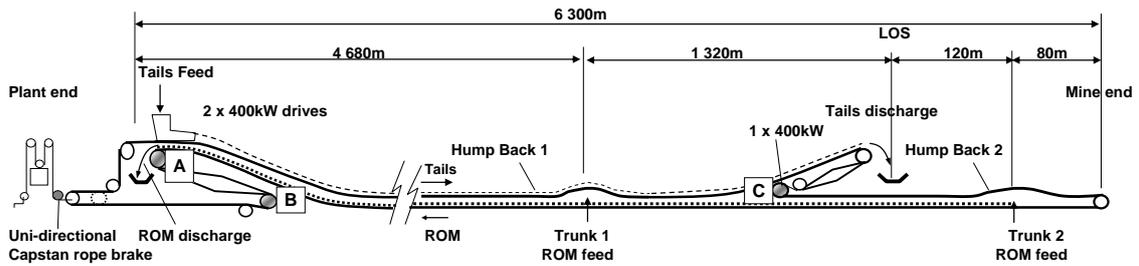
Figure 4. Current profile

The current configuration of the DCC is as follows:

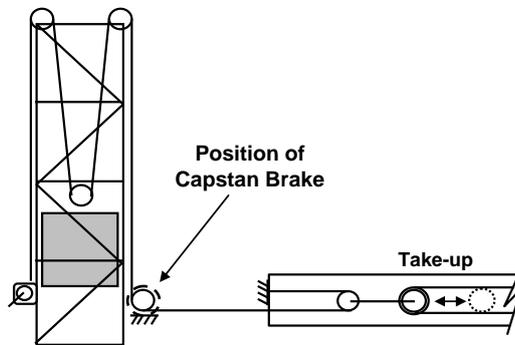
Figure 5. position of Capstan Brake

Our calculations showed that on extending the DCC from its initial length of 3.5 km to 4.7 km, a capstan brake would be needed on the gravity take-up tower. This is in order to dissipate some of the strain energy stored in the stretched belt, which would otherwise go directly into raising the counterweight as the conveyor coasts to a halt.

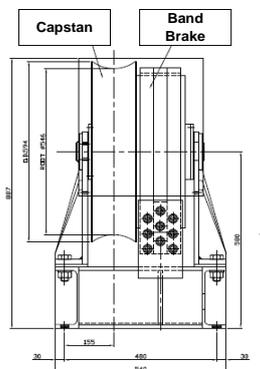
Figure 6. The capstan fitted with a special band brake

The selection of the type of capstan brake was driven by simplicity, and as such it is a counterweight band brake of the type that does not require any accessories or power/C&I connections. The type in service on the DCC is based on the following principle:

Essentially it is a horizontal capstan, shaped like a chimes wheel, around which the take-up rope is wrapped through 450 degrees at the base of the vertical gravity tower.

The capstan is fitted with a special band brake with 540 degrees of wrap. Referring to the diagrams below, one end of the band brake is securely fixed. A lever arm, fitted with an adjustable counterweight applies tension to the other end of the band brake.

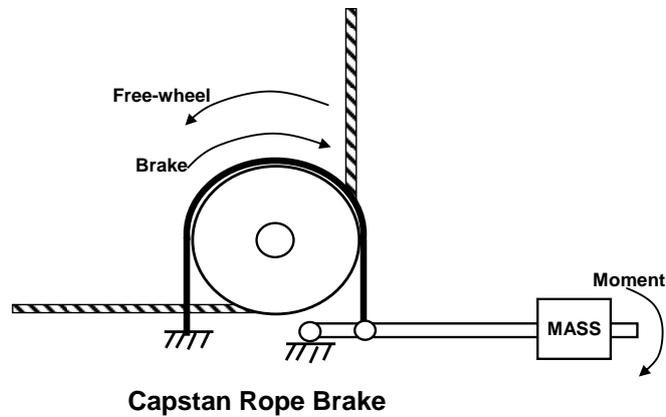
Figure 7. Operation of the capstan brake

On starting, the capstan brake all but free-wheels, thus allowing the counterweight to drop whilst at the same time delivering most of the counterweight's T2 to the take-up.

On stopping however, the take-up tries to retract, but has to overcome not only the force from the counterweight mass, but also the force from the capstan brake. The energy dissipated by the capstan brake no longer goes towards raising the counterweight. It has become clear that the reliable operation of the capstan brake is essential to the DCC.

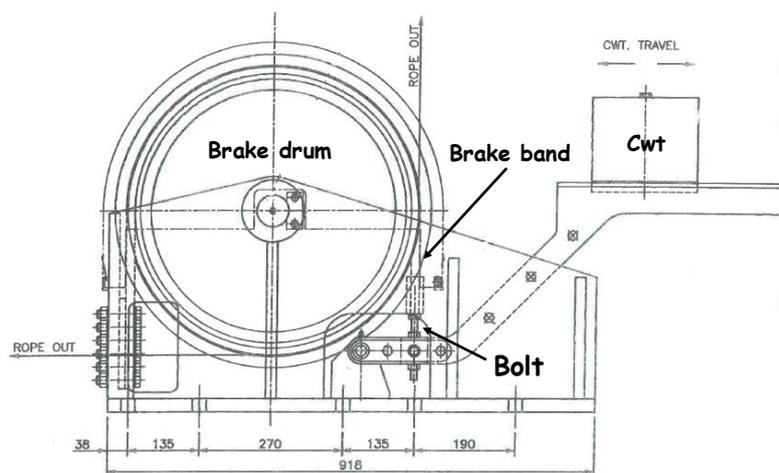
Figure 8. Failure of capstan brake

After a year or so, the bolt (as shown in the diagram below) which connects the end of the brake band to the counterweight arm broke due to metal fatigue:

Failure of the capstan brake caused the counterweight to rise uncontrollably during stopping and now, at its current length, the reliability of the DCC's operation depends

on the integrity of this one bolt, otherwise the take-up tower can get damaged, as can the plant end drive units, as discussed below.

The drives have been replaced with heavier duty ones, and the problematic bolt connection in the capstan brake has been upgraded. For the same reason, the high speed couplings have also been upgraded, as they only lasted two to three months. The new ones have now lasted over a year without failure.

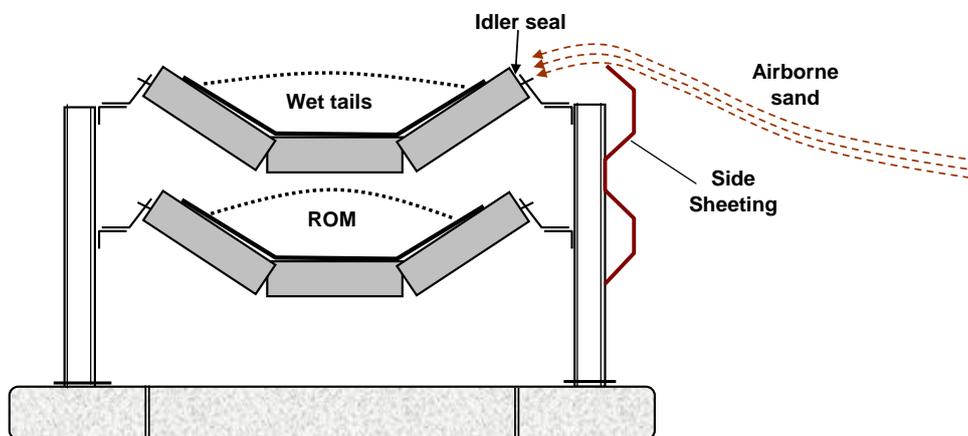
Figure 9. Aerodynamics of the module

Compounding the problem of seal failure, the configuration of the DCC's modules is not, in hindsight, ideal. The concept is that the lower belt strand carrying the dusty ROM sand is protected by the side sheeting and the upper strand, carrying wet tails:

However, the aerodynamics of the module with a strong side wind is such that airborne sand targets the upper wing roll idler seal on one side.

As a result, there was considerable premature idler bearing failure of these rolls, especially where the DCC passes through an area of very fine sand.

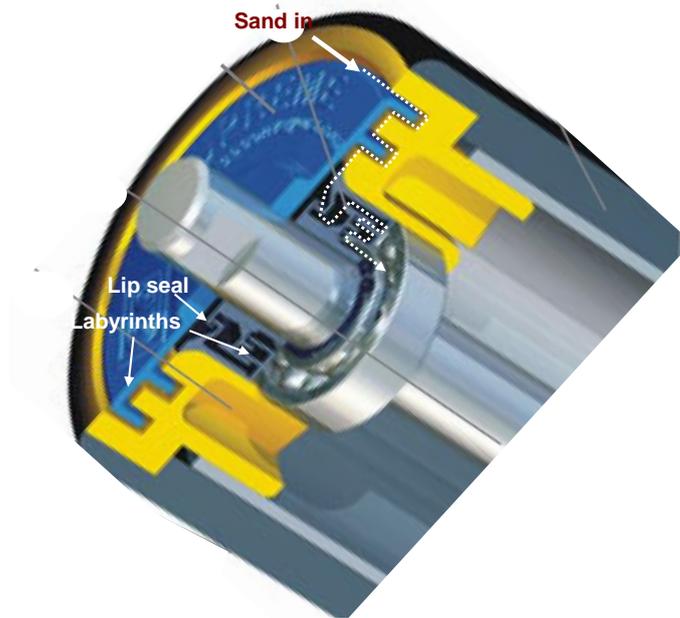
Figure 10. Sand in the end seal of the shaft

Although not the actual arrangement of the seals that failed, the following diagram is fairly typical of a sealing arrangement for a plastic idler roll:

The four minute start up time of the DCC enabled the sand that was collected in the outer labyrinth of the actual rolls to slowly gravitate into the seal on the shaft (without flinging it out) and thereafter destroy it.

On opening the seals and the bearings it was found that they were caked with fine sand embedded in grease.

In order to resolve the problem, the replacement rolls were fitted with dust covers as well as an additional lip seal.

As a result of the operation of the DCC, idler manufactures could consider using the same sealing arrangement typically found on the wheel bearings of 4x4 vehicles. This consists of an oil seal with two lips. Not only does this arrangement keep the dust out of the bearing, but such vehicles are often driven for miles off-road, including across rivers and sand dunes, with no long term ill effects.

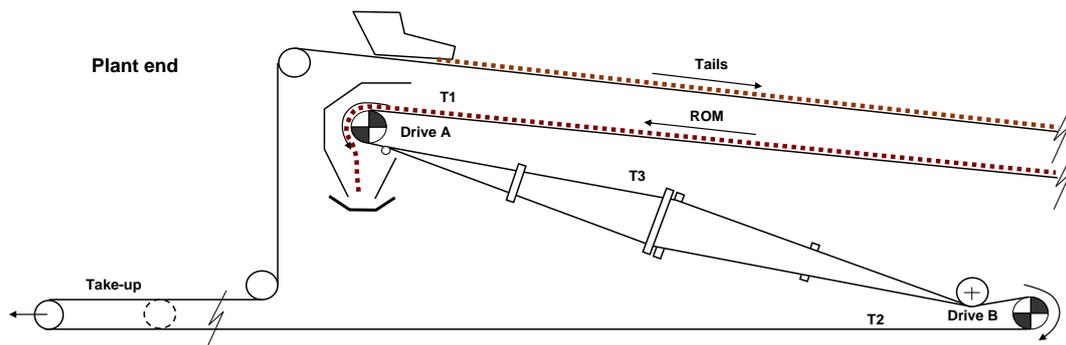
Figure 11. Drive arrangement with intermediate turn-over design

Eyebrows were raised when the above drive arrangement with intermediate turn-over design was proposed. The 'old school' maintained that:

For the DCC however, the situation is totally different, and we have used the above configurations have been used at both ends of the conveyor because:

- The belt has to be turned upside down to always run top cover side up, as it is a dual carry
- Putting the turn-over inclined between the drive pulleys, and not putting all the drives at ground level, dramatically reduces the number of pulleys and support steelwork required, and is therefore considerably more economical.

Despite breaking the above 'old-school' rules, both the DCC's belt turn-overs have operated with suitable reliability over the long period of the DCC's operation. There is absolutely no reason not to use this configuration in future.

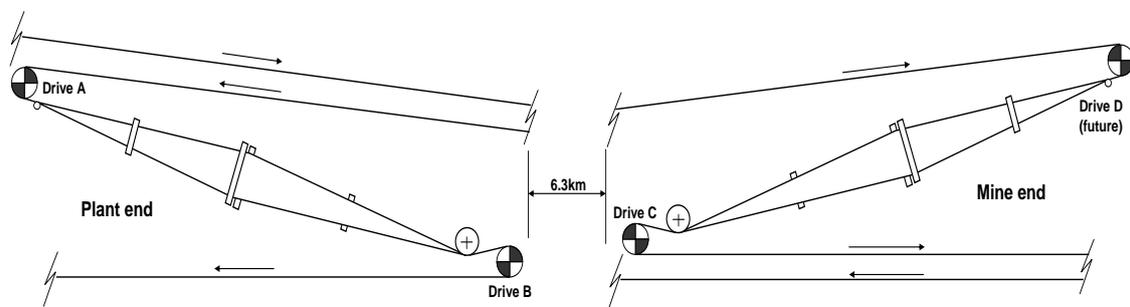
Figure 12. DCC drive configuration

The drive configuration of the DCC is as follows:

Since the active take-up is at the plant end, the A and B drives start first. Once the ROM belt has stretched sufficiently to give movement of the belt at the mine end, C drive is to start and follow the A and B drives. The control philosophy was originally such that to avoid the mine end drives lifting the counterweight when the ROM belt is full, but with the tails belt empty, the mine end drive(s) are limited to provide 80% of the torque provided by the plant end drives.

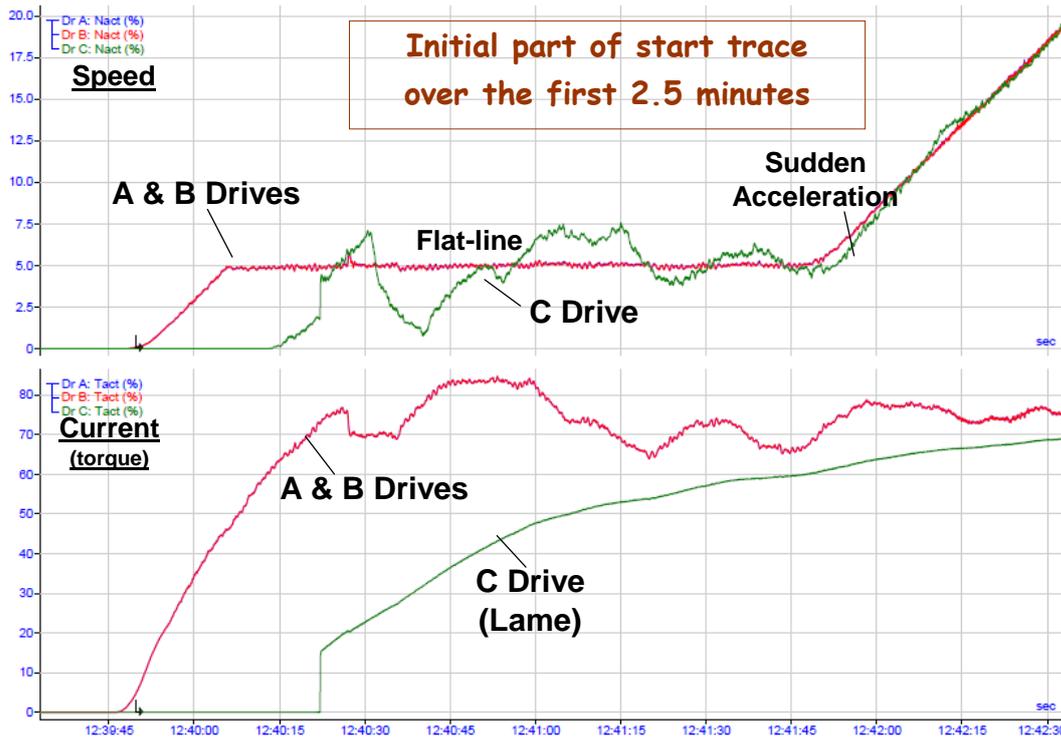
Figure 13. Initial part of start trace over the first 2.5 minutes

The plant end drives follow each other faithfully, and their traces are completely superimposed. The C drive however, does not pull its weight until four minutes after the start has been initiated. This is purely a fault of the VSD control.

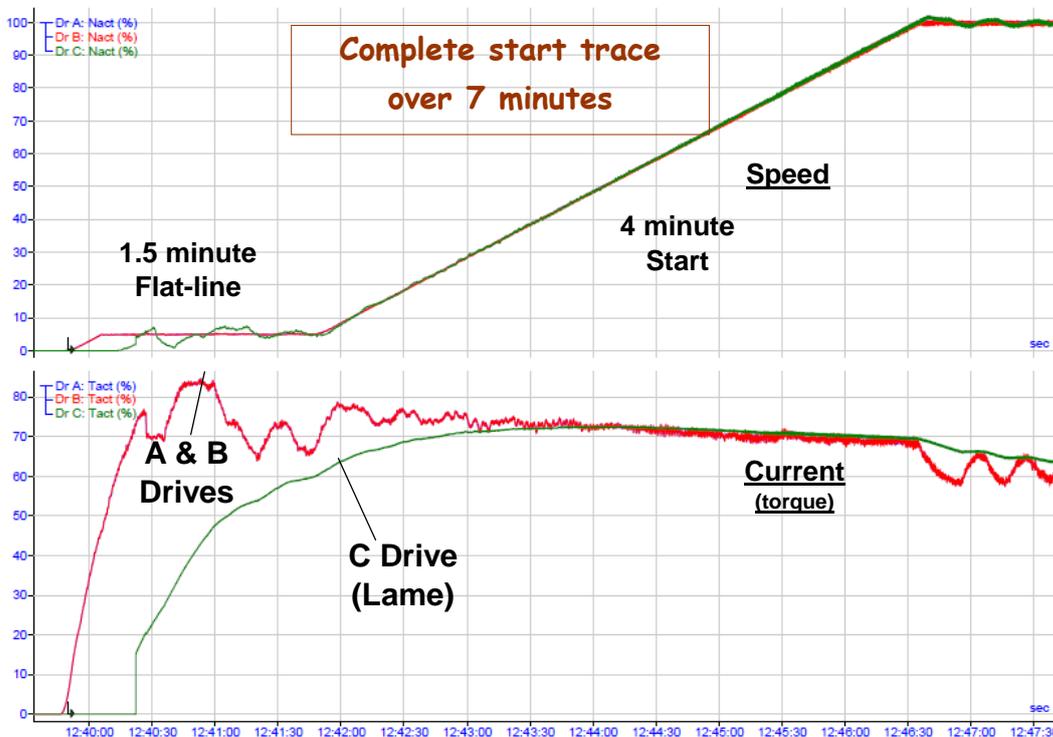
Figure 14. Complete start trace over seven minutes

In addition, it can be seen that there is now a one and a half minute flat line at 5% speed which is not part of the original philosophy, and thereafter a sudden (and

undesirable) acceleration at the beginning of the four minute uniform acceleration to full speed.

Because of the above, when the conveyor is fully loaded with ROM as well as tails, drives A and B at the plant end are overloaded, and consequently over-stress the belt.
